# ACCESSIBILITY ASSESSMENT

145366.21R000-003.160

## **ADA TITLE II ASSESSMENT**

Brinkley Hills  
6021 Thunder Hill Court  
Fort Washington, Maryland 20744

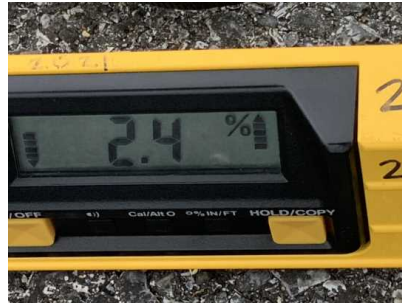
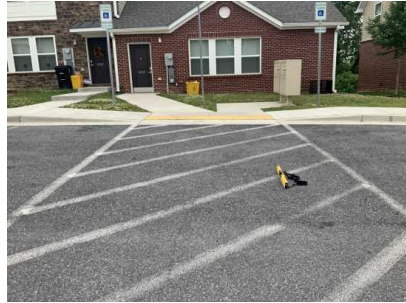
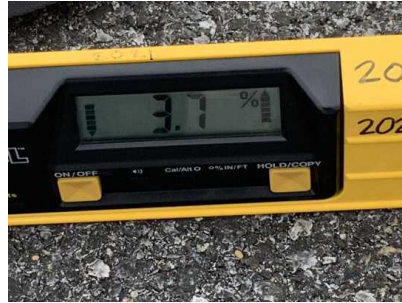
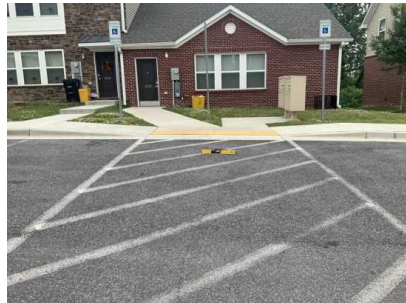
Assembly	Accessible Parking
Type	Parking Space-Van
ADA Standard	UFAS 4.6.3
Barrier Detail	The slope of the parking space is greater than 1:50 (2%).
Location Description	Accessible Parking Space P1
Observed	May 19, 2021 by Ouraccessibleworld@gmail.com
Site Conditions	The accessible space has slope of up to 5.9%.

Remove and replace with a van space that has no more than 1:50 (2%) slope in all directions. Parking spaces and access aisles shall be level with surface slopes not exceeding 1:50 (2%) in all directions. Parking access aisles shall be part of an accessible route to the building or facility entrance. Parked vehicle overhangs shall not reduce the clear width of an accessible circulation route. The quantity and order of magnitude cost estimate provided for this barrier are limited to the extent of the area identified as non-compliant. Additional costs that may be associated with removal of the barrier are not included.

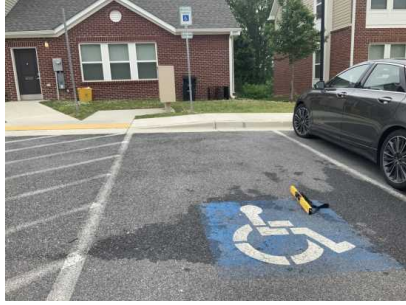
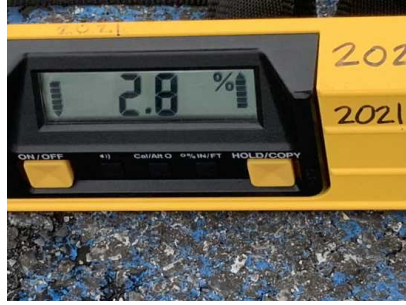
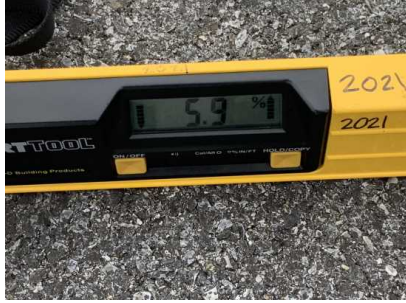
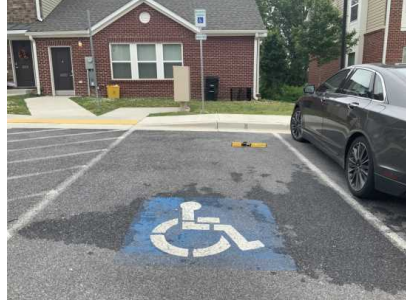
Assembly	Accessible Parking
Type	Parking Space-Car
ADA Standard	UFAS 4.6.3
Barrier Detail	The slope of the standard car parking space is greater than 1:50 (2%).
Location Description	Accessible Parking Space P2
Observed	May 18, 2021 by Ouraccessibleworld@gmail.com
Site Conditions	The accessible space has slopes of up to 2.8%.

Remove and replace with a parking space that has no more than 1:50 (2%) slope in all directions. Parking spaces for disabled people shall be at least 96" wide and shall have an adjacent access aisle 60" wide minimum (see Fig. 9). [EXCEPTION: If accessible parking spaces for vans are provided, each should have an adjacent access aisle at least 96" wide.] Parking access aisles shall be part of an accessible route to the building or facility entrance. Two accessible parking spaces may share a common access aisle. Parked vehicle overhangs shall not reduce the clear width of an accessible circulation route. Parking spaces and access aisles shall be level with surface slopes not exceeding 1:50 in all directions. The quantity and order of magnitude cost estimate provided for this barrier are limited to the extent of the area identified as non-compliant. Additional costs that may be associated with removal of the barrier are not included.

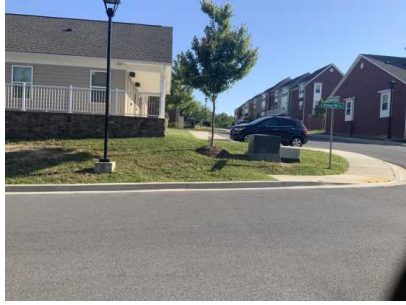
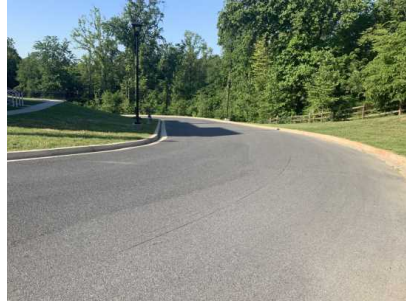
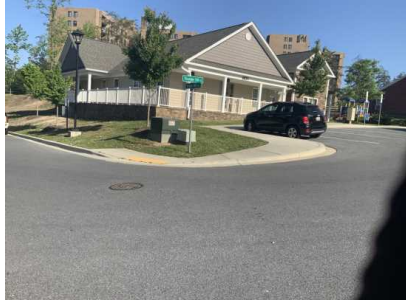
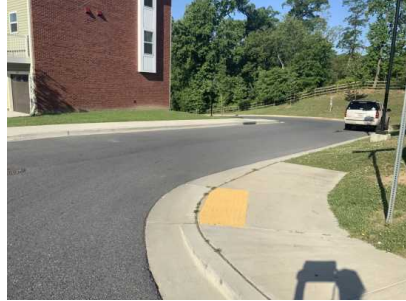
Assembly	Exterior Access Route
Type	Curb Ramp
ADA Standard	304, 406.4
Barrier Detail	The parallel curb ramp landing is not compliant.
Location Description	Curb Ramp CR1
Observed	May 18, 2021 by Ouraccessibleworld@gmail.com

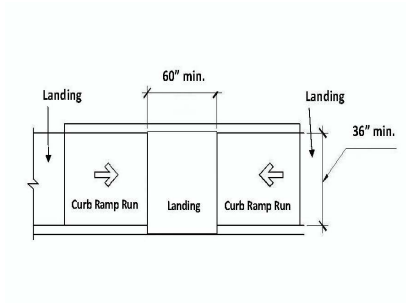
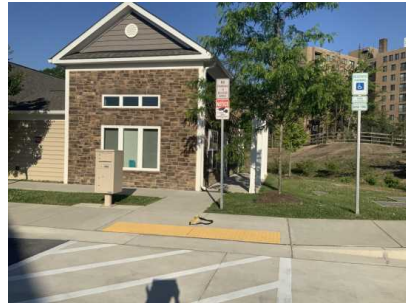
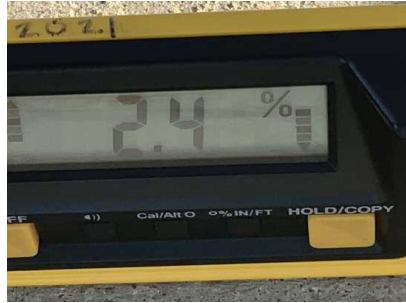
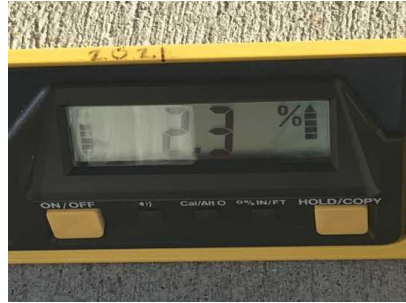
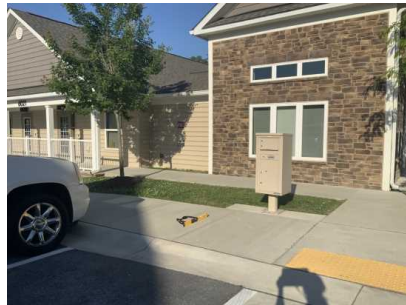
<b>Assembly</b>	Exterior Access Route
<b>Type</b>	Curb Ramp
<b>ADA Standard</b>	405.2; Table 405.2; 406; 406.2
<b>Barrier Detail</b>	The curb ramp does not meet the slope requirements.
<b>Location Description</b>	Curb Ramp CR2
<b>Observed</b>	May 18, 2021 by Ouraccessibleworld@gmail.com
<b>Site Conditions</b>	The curb ramp has a running slope of up to 17%.

The curb ramp should be removed and replaced with a compliant curb ramp with no greater than the maximum allowable slopes of a ramp. Curb ramp runs shall have a running slope not steeper than 1:12 (8.33%). Cross slope of curb ramp runs shall not be steeper than 1:48. The running slope in new construction shall be 1:12 (8.33%) maximum. [EXCEPTION: In existing sites, buildings, and facilities built before 1/26/92, ramps and curb ramps shall be permitted to have running slopes steeper than 1:12 where such slopes are necessary due to space limitations. In facilities built before 1/26/92, the running slope can be 1:10 to 1:8 (10% to 12.5%) for a maximum rise of 3" OR 1:10 to 1:12 (8.3% to 10%) for a maximum rise of 6".] Where flares are provided, flare slopes shall not be greater than 1:10 (10%). [EXCEPTION: In alterations, where there is no landing at the top of curb ramps, curb ramp flares shall be provided and shall not be steeper than 1:12.]

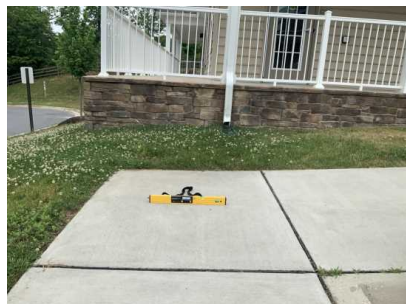
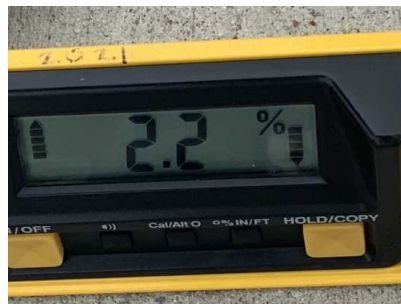
Photos for Barrier ID: AX240360

Assembly	Exterior Access Route
Type	Exterior Accessible Route
ADA Standard	403.3
Barrier Detail	The accessible route has cross slopes greater than 1:50 (2%).
Location Description	Curb Ramp CR2 to Office
Observed	May 18, 2021 by Ouraccessibleworld@gmail.com

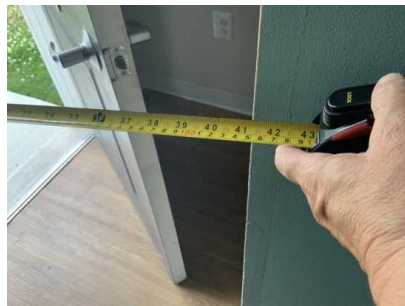
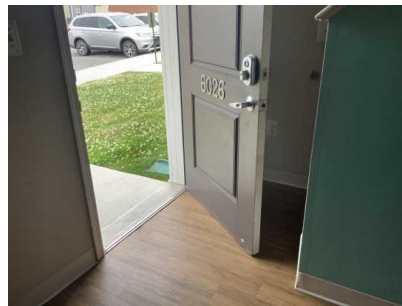
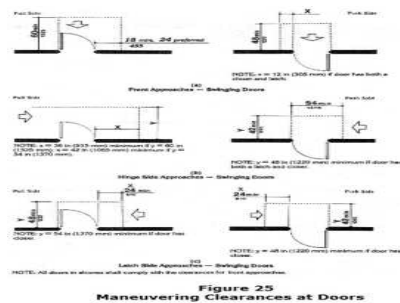
### Photos for Barrier ID: AX240372

<b>Assembly</b>	Entrance to Building
<b>Type</b>	Building Entrance-Door
<b>ADA Standard</b>	UFAS 4.13.6; Fig. 25
<b>Barrier Detail</b>	The accessible door does not have the required maneuvering clearance.
<b>Location Description</b>	Door Clearance - Unit 6026, 6028 and 6030
<b>Observed</b>	May 19, 2021 by Ouraccessibleworld@gmail.com

Replace with a compliant maneuvering clearance area that is level and clear. Minimum maneuvering clearances at doors that are not automatic or power-assisted shall be as shown in Figure 25. The required depth of the maneuvering clearance is 48" minimum. The required side clearance is 24" minimum on the latch side of the door. Maneuvering clearance shall extend the full width of the doorway and the required latch side clearance. The floor or ground area within the required clearances shall be level and clear. Entry doors to acute care hospital bedrooms for in-patients shall be exempted from the requirement for space at the latch side of the door (see dimension 'x' in Figure 25), if the door is at least 44" wide.

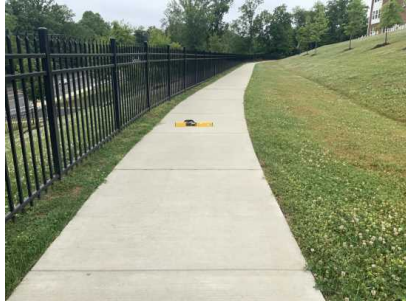
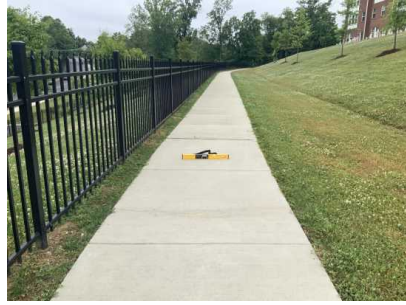
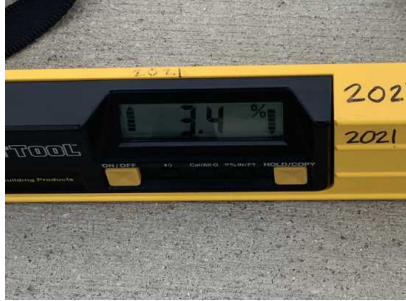
<b>Assembly</b>	Exterior Access Route
<b>Type</b>	Exterior Accessible Route
<b>ADA Standard</b>	403.3
<b>Barrier Detail</b>	The accessible route has cross slopes greater than 1:50 (2%).
<b>Location Description</b>	PROW From Street to Leasing Office - East Side
<b>Observed</b>	May 18, 2021 by Ouraccessibleworld@gmail.com

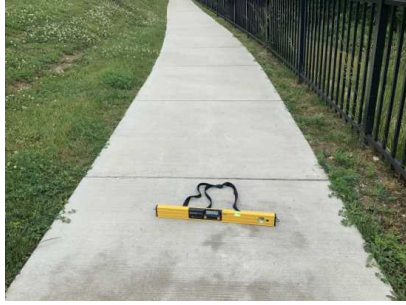
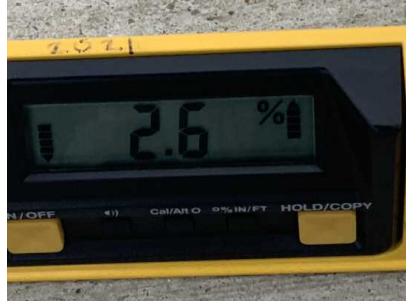
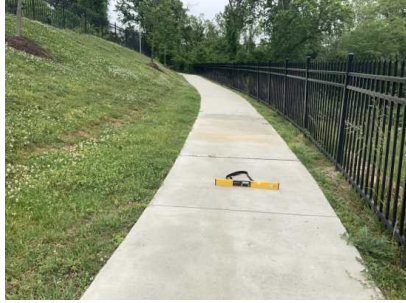
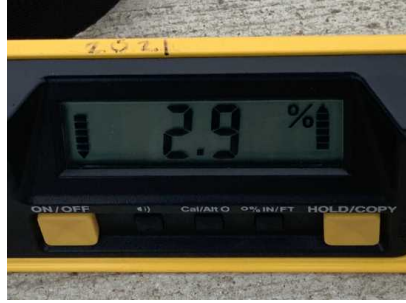
<b>Assembly</b>	Exterior Access Route
<b>Type</b>	Exterior Accessible Route
<b>ADA Standard</b>	403.3
<b>Barrier Detail</b>	The accessible route has cross slopes greater than 1:50 (2%).
<b>Location Description</b>	PROW From Street to Leasing Office - West Side
<b>Observed</b>	May 18, 2021 by Ouraccessibleworld@gmail.com

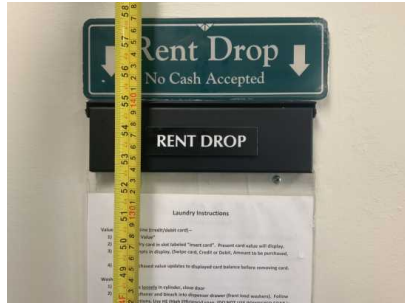
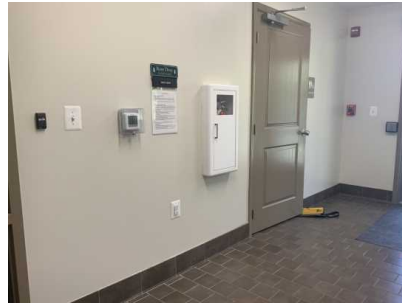
### Photos for Barrier ID: AX240349

<b>Location Description</b>	Laundry
<b>Observed</b>	May 19, 2021 by Ouraccessibleworld@gmail.com
<b>Site Conditions</b>	The drop box is mounted at 55" above the floor.

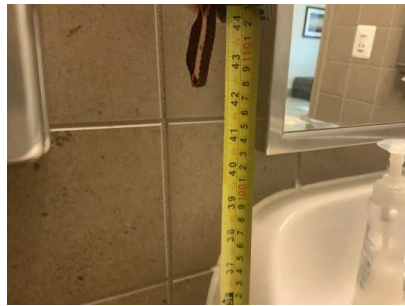
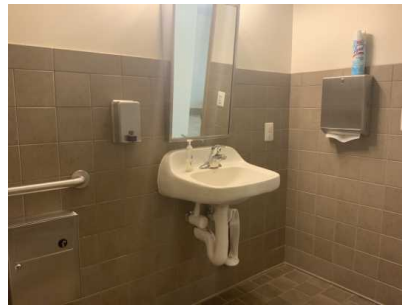
**Photos for Barrier ID: AX240342**

<b>Location Description</b>	Common Area Restroom
<b>Observed</b>	May 19, 2021 by Ouraccessibleworld@gmail.com
<b>Site Conditions</b>	The bottom edge of the reflective surface of the mirror is 41" above the floor.

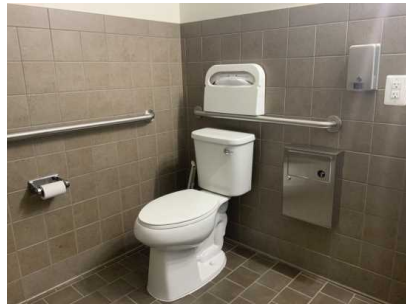
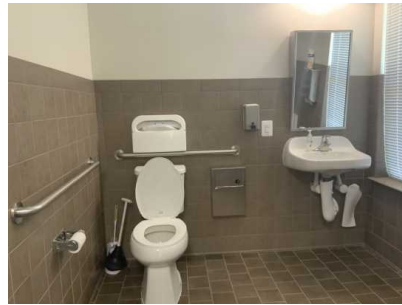
**Photos for Barrier ID: AX241416**

<b>Location Description</b>	Laundry Restroom
<b>Observed</b>	May 18, 2021 by Ouraccessibleworld@gmail.com
<b>Site Conditions</b>	The toilet seat cover dispenser is 0" above the grab bar.

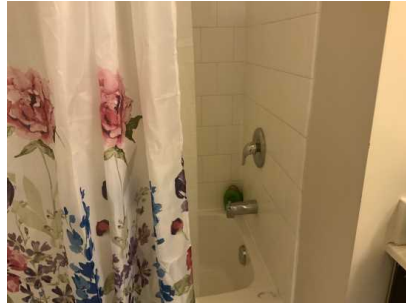
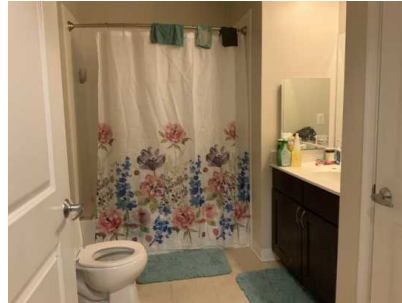
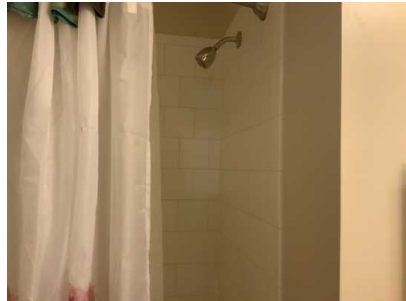
### Photos for Barrier ID: AX240371

<b>Assembly</b>	Residential Dwelling
<b>Type</b>	Restroom/Bathroom-Bath Tub
<b>ADA Standard</b>	UFAS 4.34.5.4(5)
<b>Barrier Detail</b>	A shower spray unit with 60" long hose is not provided in the bathtub.
<b>Location Description</b>	Unit 6026, 6028 , 6030
<b>Observed</b>	May 19, 2021 by Ouraccessibleworld@gmail.com
<b>Site Conditions</b>	A hand held sprayer is not provided in the bath tub.

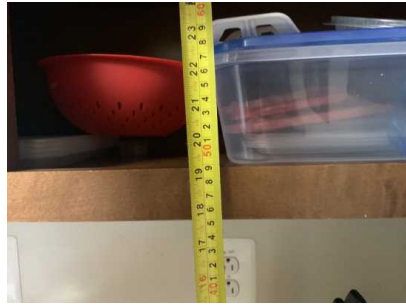
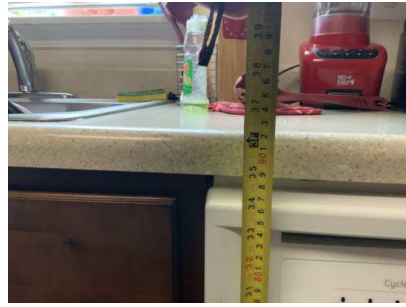
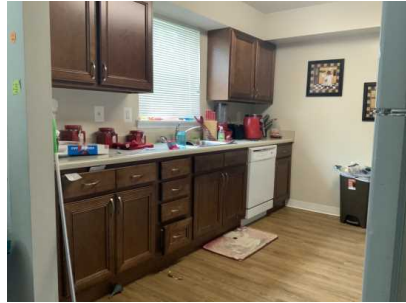
<b>Assembly</b>	Residential Dwelling
<b>Type</b>	Kitchen-General
<b>ADA Standard</b>	UFAS 4.34.6.4
<b>Barrier Detail</b>	A compliant work surface is not provided in the kitchen.
<b>Location Description</b>	Unit 6026, 6028, 6030
<b>Observed</b>	May 18, 2021 by Ouraccessibleworld@gmail.com

Install at least one compliant work surface. At least one 30" section of counter shall provide a work surface that complies with the following requirements (see Figure 50): (1) The counter shall be mounted at a maximum height of 34" above the floor, measured from the floor to the top of the counter surface, or shall be adjustable or replaceable as a unit to provide alternative heights of 28", 32", and 36", measured from the top of the counter surface. (2) Base cabinets, if provided, shall be removable under the full 30" minimum frontage of the counter. The finished floor shall extend under the counter to the wall. (3) Counter thickness and supporting structure shall be 2" maximum over the required clear area. (4) A clear floor space 30" by 48" shall allow a forward approach to the counter. 19" maximum of the clear floor space may extend underneath the counter. The knee space shall have a minimum clear width of 30" and a minimum clear depth of 19". (5) There shall be no sharp or abrasive surfaces under such counters. .
