ACCESSIBILITY ASSESSMENT

ADA TITLE II ASSESSMENT

Central Gardens
6804 Central Avenue
Pepper Mill Village, Maryland 20743

145366.21R000-008.160

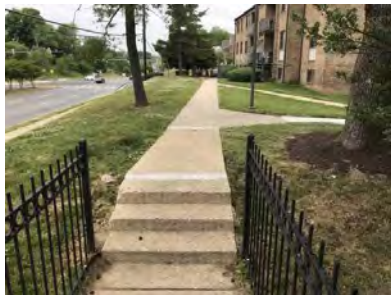
Photos for Barrier ID: AX240214

Assembly	Amenity Not Evaluated
Type	Amenity Not Evaluated
ADA Standard	None
Barrier Detail	The amenity cannot be accessed and, therefore, cannot be evaluated.
Location Description	Children's Pool
Observed	May 28, 2021 by Lloyd.fojas@bureauveritas.com

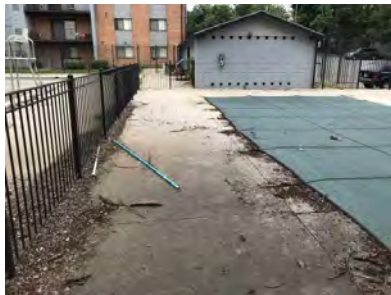
Photos for Barrier ID: AX239665

Assembly	Amenity Not Evaluated
Type	Amenity Not Evaluated
ADA Standard	None
Barrier Detail	The amenity cannot be accessed and, therefore, cannot be evaluated.
Location Description	Pool House
Observed	May 28, 2021 by Lloyd.fojas@bureauveritas.com
Site Conditions	The pool house was locked with no access, therefore it was not evaluated.

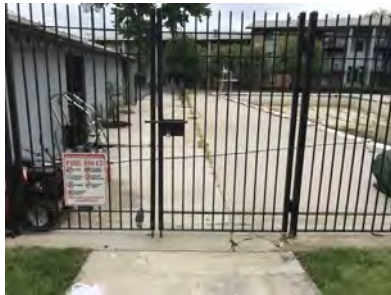
Photos for Barrier ID: AX240309

Assembly	Entrance to Building
Type	Building Entrance-Door
ADA Standard	305.2; 404.2
Barrier Detail	The maneuvering clearance at the accessible door is not level and clear.
Location Description	6800-Building Entrance Door
Observed	May 28, 2021 by Lloyd.fojas@bureauveritas.com

Remove and replace the surface within the required maneuvering clearance area so that the surface is level and clear with maximum slope 1:48 (2.08%) in any direction. The required depth of the maneuvering clearance is 60" minimum. The required side clearance is 18" minimum on the latch side of the door. Maneuvering clearance shall extend the full width of the doorway and the required latch side clearance. Floor or ground space within the required maneuvering clearance shall be maximum 1:48 (2.08%) slope. Changes in level are not permitted.

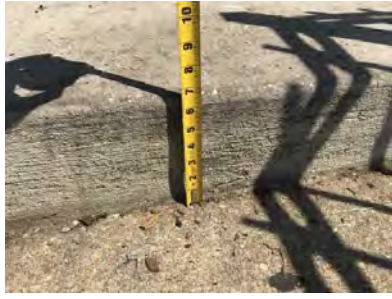
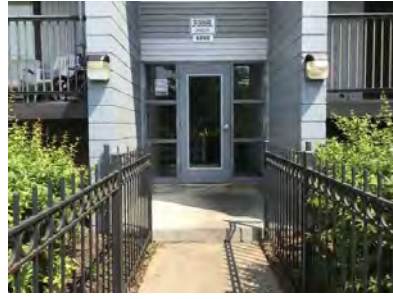
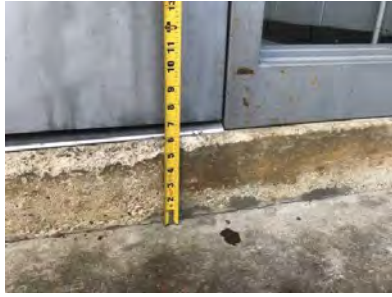
Assembly	Entrance to Building
Type	Building Entrance-Door
ADA Standard	305.2; 404.2
Barrier Detail	The maneuvering clearance at the accessible door is not level and clear.
Location Description	6802-Building Entrance Door
Observed	May 28, 2021 by Lloyd.fojas@bureauveritas.com

Remove and replace the surface within the required maneuvering clearance area so that the surface is level and clear with maximum slope 1:48 (2.08%) in any direction. The required depth of the maneuvering clearance is 60" minimum. The required side clearance is 18" minimum on the latch side of the door. Maneuvering clearance shall extend the full width of the doorway and the required latch side clearance. Floor or ground space within the required maneuvering clearance shall be maximum 1:48 (2.08%) slope. Changes in level are not permitted.

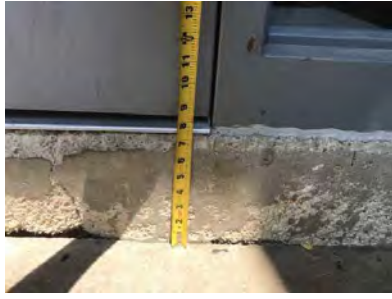
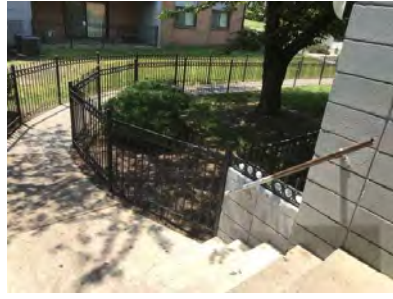
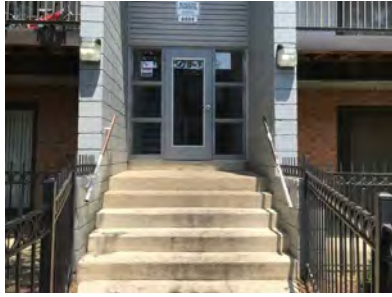
Assembly	Entrance to Building
Type	Building Entrance-Door
ADA Standard	305.2; 404.2
Barrier Detail	The maneuvering clearance at the accessible door is not level and clear.
Location Description	6806-Building Entrance Door
Observed	May 28, 2021 by Lloyd.fojas@bureauveritas.com

Remove and replace the surface within the required maneuvering clearance area so that the surface is level and clear with maximum slope 1:48 (2.08%) in any direction. The required depth of the maneuvering clearance is 60" minimum. The required side clearance is 18" minimum on the latch side of the door. Maneuvering clearance shall extend the full width of the doorway and the required latch side clearance. Floor or ground space within the required maneuvering clearance shall be maximum 1:48 (2.08%) slope. Changes in level are not permitted.

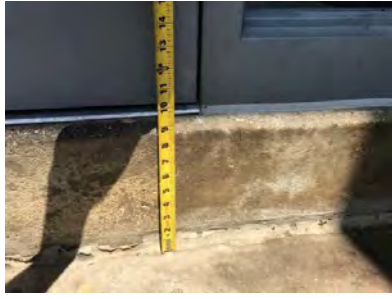
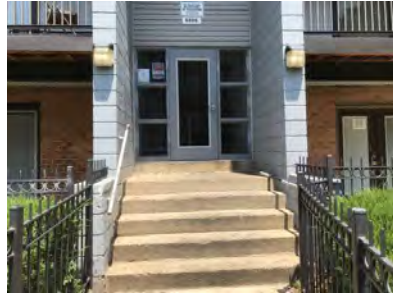
Assembly	Entrance to Building
Type	Building Entrance-Door
ADA Standard	305.2; 404.2
Barrier Detail	The maneuvering clearance at the accessible door is not level and clear.
Location Description	6810-Building Entrance Door
Observed	May 28, 2021 by Lloyd.fojas@bureauveritas.com

Remove and replace the surface within the required maneuvering clearance area so that the surface is level and clear with maximum slope 1:48 (2.08%) in any direction. The required depth of the maneuvering clearance is "X" minimum. The required side clearance is "Y" minimum on the latch/hinge side of the door. Maneuvering clearance shall extend the full width of the doorway and the required latch side or hinge side clearance. Floor or ground space within the required maneuvering clearance shall be maximum 1:48 (2.08%) slope. Changes in level are not permitted.

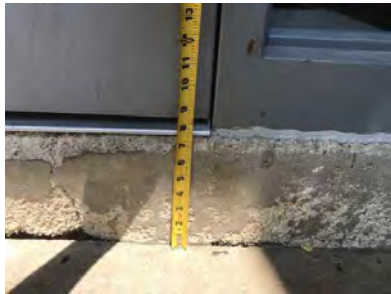
Photos for Barrier ID: AX239674

Assembly	Entrance to Building
Type	Building Entrance-Door
ADA Standard	305.2; 404.2
Barrier Detail	The maneuvering clearance at the accessible door is not level and clear.
Location Description	6812-Building Entrance Door
Observed	May 28, 2021 by Lloyd.fojas@bureauveritas.com

Remove and replace the surface within the required maneuvering clearance area so that the surface is level and clear with maximum slope 1:48 (2.08%) in any direction. The required depth of the maneuvering clearance is 60" minimum. The required side clearance is 18" minimum on the latch side of the door. Maneuvering clearance shall extend the full width of the doorway and the required latch side clearance. Floor or ground space within the required maneuvering clearance shall be maximum 1:48 (2.08%) slope. Changes in level are not permitted.

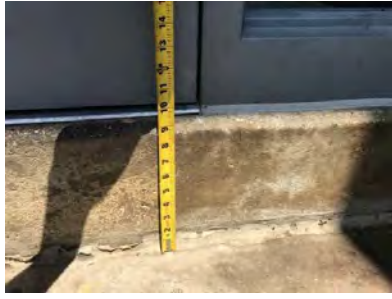
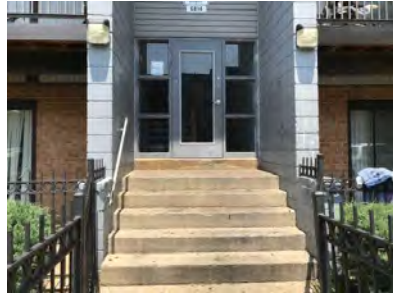
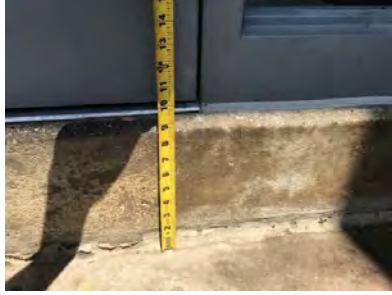
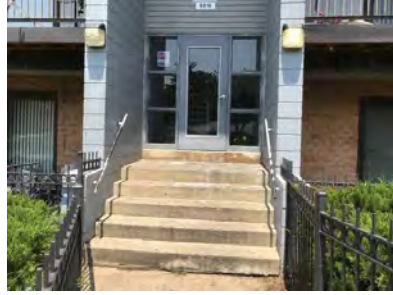
Assembly	Entrance to Building
Type	Building Entrance-Door
ADA Standard	305.2; 404.2
Barrier Detail	The maneuvering clearance at the accessible door is not level and clear.
Location Description	6816-Building Entrance Door
Observed	May 28, 2021 by Lloyd.fojas@bureauveritas.com

Remove and replace the surface within the required maneuvering clearance area so that the surface is level and clear with maximum slope 1:48 (2.08%) in any direction. The required depth of the maneuvering clearance is X" minimum. The required side clearance is Y" minimum on the latch/hinge side of the door. Maneuvering clearance shall extend the full width of the doorway and the required latch side or hinge side clearance. Floor or ground space within the required maneuvering clearance shall be maximum 1:48 (2.08%) slope. Changes in level are not permitted.

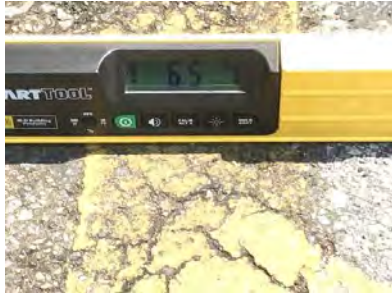
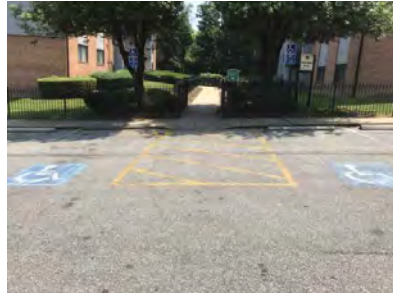
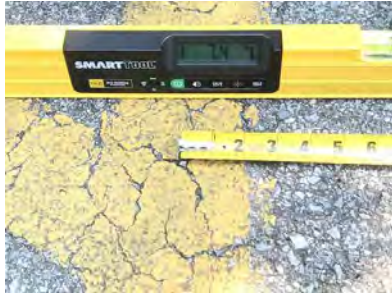
Assembly	Accessible Parking
Type	Parking Space-Van
ADA Standard	502.4, State of MD 05.07.C (2)(d)
Barrier Detail	MARYLAND: The access aisle slope is greater than 1:50 (2%).
Location Description	Access Aisle at Accessible Parking Space P1-E
Observed	May 28, 2021 by Lloyd.fojas@bureauveritas.com
Site Conditions	The van access aisle has a cross slope of 4.1% to 5.2%.

Remove and replace with an adjacent access aisle that is at least 96" wide and has a slope of maximum 1:50 (2%) in all directions. [EXCEPTION: Slopes not steeper than 1:48 (2.08%) shall be permitted.] Parking spaces and access aisles serving them shall be compliant. Changes in level are not permitted. Access aisles shall be at the same level as the parking spaces they serve. Measurements shall be made to the centerline of the stripe. [EXCEPTION: Where accessible stalls and aisles are not adjacent to another stall or aisle, measurements shall be permitted to include the full width of the line defining the accessible parking space or aisle.] The quantity and order of magnitude cost estimate provided for this barrier are limited to the extent of the area identified as non-compliant. Additional costs that may be associated with removal of the barrier are not included.

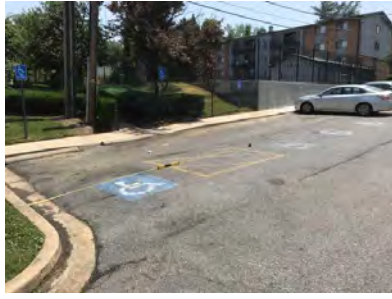
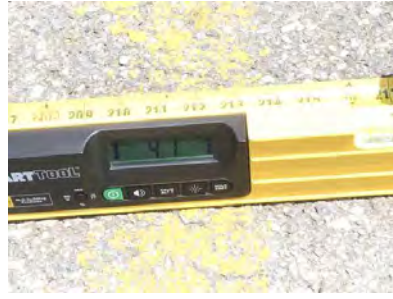
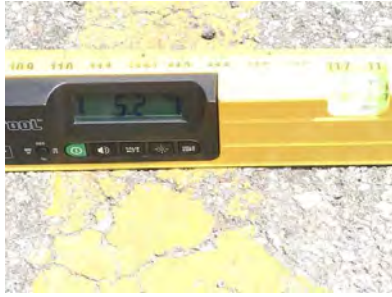
Assembly	Accessible Parking
Type	Parking Space-Car
ADA Standard	502.4
Barrier Detail	The access aisle slope is greater than 1:50 (2%).
Location Description	Access Aisle at Accessible Parking Space P1-G and P1-H
Observed	May 28, 2021 by Lloyd.fojas@bureauveritas.com
Site Conditions	The access aisle has a cross slope of 4.2%.

Remove and replace with an adjacent access aisle that is at least 60" wide and has a slope of maximum 1:50 (2%) in all directions. [EXCEPTION: Slopes not steeper than 1:48 (2.08%) shall be permitted.] Changes in level are not permitted. Parking spaces and access aisles serving them shall be compliant. Access aisles shall be at the same level as the parking spaces they serve. Width measurements shall be made from the centerline of the markings. [EXCEPTION: Where parking spaces or access aisles are not adjacent to another parking space or access aisle, measurements shall be permitted to include the full width of the line defining the parking space or access aisle.] The quantity and order of magnitude cost estimate provided for this barrier are limited to the extent of the area identified as non-compliant. Additional costs that may be associated with removal of the barrier are not included.

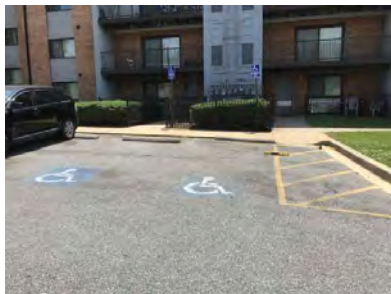
Photos for Barrier ID: AX240315

Assembly	Accessible Parking
Type	Parking Space-Car
ADA Standard	502.1, 502.2
Barrier Detail	Accessible car aisle markings do not define the aisle width.
Location Description	Access Aisle at Accessible Parking Space P1-G and P1-H
Observed	May 28, 2021 by Lloyd.fojas@bureauveritas.com
Site Conditions	The access aisle markings are faded.

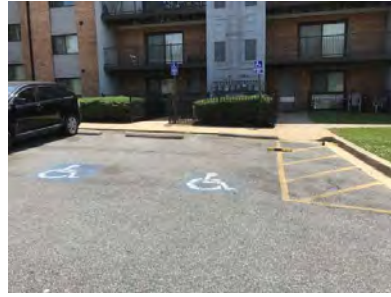
Photos for Barrier ID: AX240322

Assembly	Exterior Access Route
Type	Parking Space-Van
ADA Standard	502.4, State of MD 05.07.C (2)(d)
Barrier Detail	MARYLAND: The access aisle slope is greater than 1:50 (2%).
Location Description	Access Aisle at Accessible Parking Space P1-I
Observed	May 28, 2021 by Lloyd.fojas@bureauveritas.com

Remove and replace with an adjacent access aisle that is at least 96" wide and has a slope of maximum 1:50 (2%) in all directions. [EXCEPTION: Slopes not steeper than 1:48 (2.08%) shall be permitted.] Parking spaces and access aisles serving them shall be compliant. Changes in level are not permitted. Access aisles shall be at the same level as the parking spaces they serve. Measurements shall be made to the centerline of the stripe. [EXCEPTION: Where accessible stalls and aisles are not adjacent to another stall or aisle, measurements shall be permitted to include the full width of the line defining the accessible parking space or aisle.] The quantity and order of magnitude cost estimate provided for this barrier are limited to the extent of the area identified as non-compliant. Additional costs that may be associated with removal of the barrier are not included.

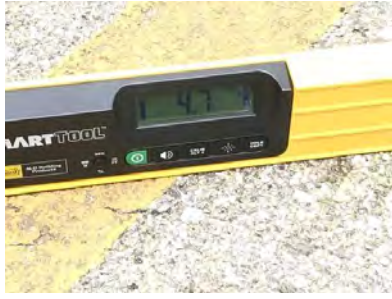
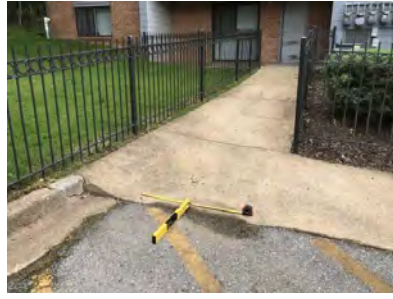
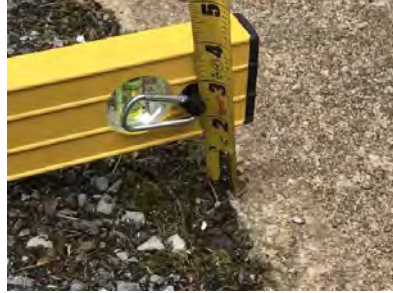
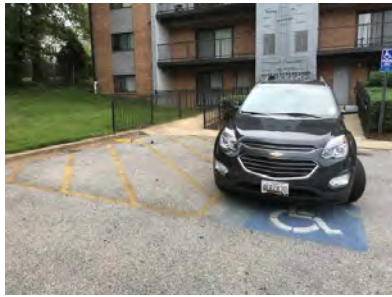
Assembly	Accessible Parking
Type	Parking Space-Van
ADA Standard	502.1, 502.3
Barrier Detail	Accessible van aisle markings do not define the aisle width.
Location Description	Access Aisle at Accessible Parking Spaces P1-A, P-1 B, P1-E and P1-I
Observed	May 28, 2021 by Lloyd.fojas@bureauveritas.com
Site Conditions	The van access aisle markings are faded.

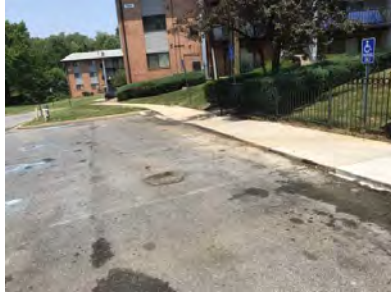
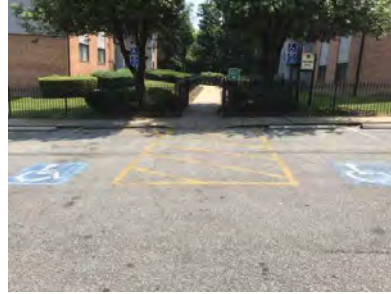
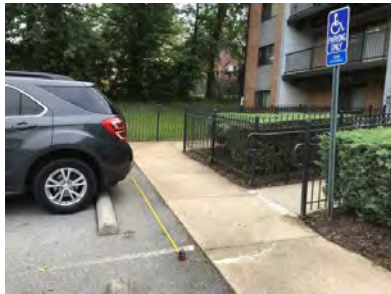
Photos for Barrier ID: AX240321

Assembly	Accessible Parking
Type	Parking Space-Van
ADA Standard	502.4
Barrier Detail	The parking space slope is greater than 1:50 (2%).
Location Description	Accessible Parking Space P1-A and P1-B
Observed	May 28, 2021 by Lloyd.fojas@bureauveritas.com

Remove and replace with a van space which has a slope of maximum 1:50 (2%) in all directions. [EXCEPTION: Slopes not steeper than 1:48 (2.08%) shall be permitted.] Changes in level are not permitted. Parking spaces and access aisles serving them shall be compliant. Width measurements shall be made from the centerline of the markings. [EXCEPTION: Where parking spaces or access aisles are not adjacent to another parking space or access aisle, measurements shall be permitted to include the full width of the line defining the parking space or access aisle.] The quantity and order of magnitude cost estimate provided for this barrier are limited to the extent of the area identified as non-compliant. Additional costs that may be associated with removal of the barrier are not included.

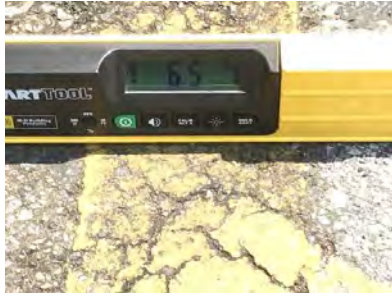
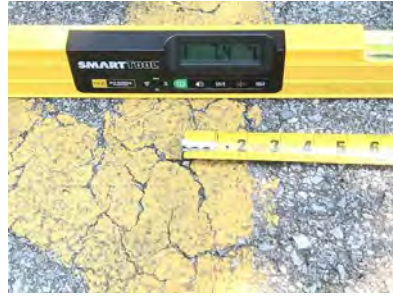
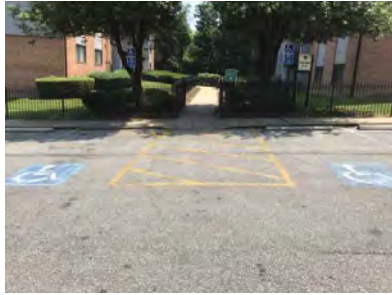
Assembly	Accessible Parking
Type	Parking Space-Car
ADA Standard	502.4
Barrier Detail	The slope of the parking space is greater than 1:50 (2%).
Location Description	Accessible Parking Space P1-C
Observed	May 28, 2021 by Lloyd.fojas@bureauveritas.com
Site Conditions	The accessible parking space has a cross slope of 9.7%

Remove and replace with a parking space that has no more than 1:50 (2%) slope in all directions. [EXCEPTION: Slopes not steeper than 1:48 (2.08%) shall be permitted.] Changes in level are not permitted. Parking spaces and access aisles shall be level with surface slopes not exceeding 1:50 in all directions. Parking spaces and access aisles serving them shall be compliant. Access aisles shall be at the same level as the parking spaces they serve. The quantity and order of magnitude cost estimate provided for this barrier are limited to the extent of the area identified as non-compliant. Additional costs that may be associated with removal of the barrier are not included.

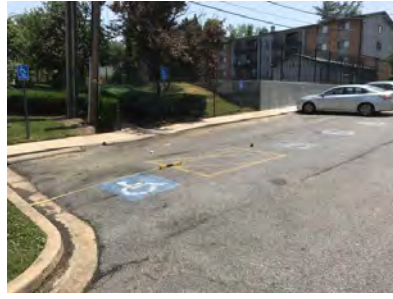
Assembly	Accessible Parking
Type	Parking Space-Car
ADA Standard	502.1, 502.2
Barrier Detail	Accessible car stall markings do not define the stall width.
Location Description	Accessible Parking Space P1-C, P1-D, P1-F, P1-G and P1-H
Observed	May 28, 2021 by Lloyd.fojas@bureauveritas.com
Site Conditions	The accessible parking space markings are faded.

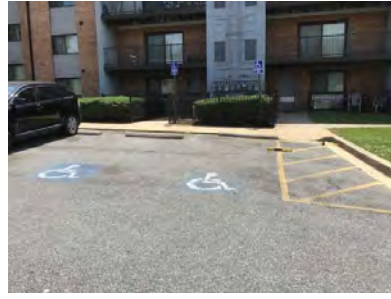
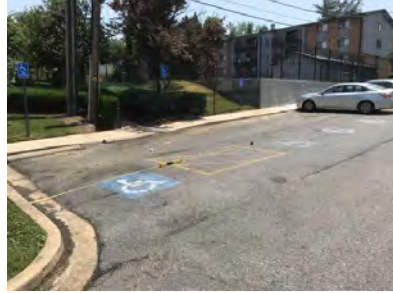
Photos for Barrier ID: AX240067

Assembly	Accessible Parking
Type	Parking Space-Car
ADA Standard	State of MD 05.07.D (2)(a)and (b),(3) & (6)
Barrier Detail	MARYLAND: Compliant signage is not provided at the space.
Location Description	Accessible Parking Space P1-D
Observed	May 28, 2021 by Lloyd.fojas@bureauveritas.com
Site Conditions	A sign is not provided at the accessible parking space.

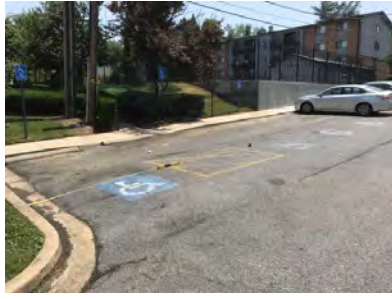
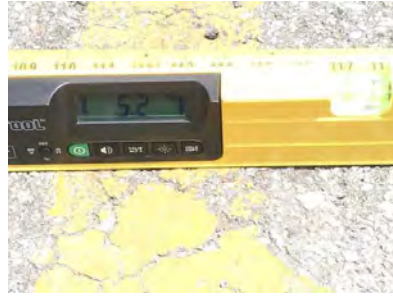
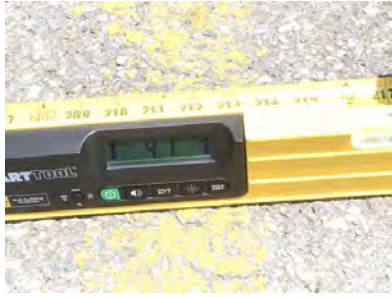
Assembly	Exterior Access Route
Type	Parking Space-Car
ADA Standard	502.4
Barrier Detail	The slope of the parking space is greater than 1:50 (2%).
Location Description	Accessible Parking Space P1-F
Observed	May 28, 2021 by Lloyd.fojas@bureauveritas.com
Site Conditions	The accessible parking space has a cross slope of 5.2%.

Remove and replace with a parking space that has no more than 1:50 (2%) slope in all directions. [EXCEPTION: Slopes not steeper than 1:48 (2.08%) shall be permitted.] Changes in level are not permitted. Parking spaces and access aisles shall be level with surface slopes not exceeding 1:50 in all directions. Parking spaces and access aisles serving them shall be compliant. Access aisles shall be at the same level as the parking spaces they serve. The quantity and order of magnitude cost estimate provided for this barrier are limited to the extent of the area identified as non-compliant. Additional costs that may be associated with removal of the barrier are not included. Re-stripe for a van accessible space at a location closest to an accessible facility entrance. For every six or fraction of six parking spaces required to comply, at least one shall be a van parking space. Van parking spaces shall be 132" wide minimum, shall be marked to define the width, and shall have a compliant adjacent access aisle. [EXCEPTION: Van parking spaces shall be permitted to be 96" wide minimum where the access aisle is 96" wide minimum.] Measurements shall be made to the centerline of the stripe. [EXCEPTION: Where accessible stalls and aisles are not adjacent to another stall or aisle, measurements shall be permitted to include the full width of the line defining the accessible parking space or aisle.] Parking spaces for vans, access aisles serving van spaces, and vehicular routes serving them shall provide a vertical clearance of 98" minimum.

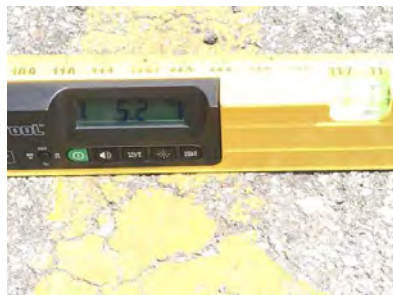
Photos for Barrier ID: AX240312

Assembly	Exterior Access Route
Type	Parking Space-Car
ADA Standard	502.4
Barrier Detail	The slope of the parking space is greater than 1:50 (2%).
Location Description	Accessible Parking Space P1-G and P1-H
Observed	May 28, 2021 by Lloyd.fojas@bureauveritas.com
Site Conditions	The accessible parking space has a cross slope of 4.2%.

Remove and replace with a parking space that has no more than 1:50 (2%) slope in all directions. [EXCEPTION: Slopes not steeper than 1:48 (2.08%) shall be permitted.] Changes in level are not permitted. Parking spaces and access aisles shall be level with surface slopes not exceeding 1:50 in all directions. Parking spaces and access aisles serving them shall be compliant. Access aisles shall be at the same level as the parking spaces they serve. The quantity and order of magnitude cost estimate provided for this barrier are limited to the extent of the area identified as non-compliant. Additional costs that may be associated with removal of the barrier are not included. Re-stripe for a car accessible space at a location closest to an accessible facility entrance. Car parking spaces shall be 96" wide minimum, shall be marked to define the width, and shall have a compliant adjacent access aisle. Measurements shall be made to the centerline of the stripe. [EXCEPTION: Where accessible stalls and aisles are not adjacent to another stall or aisle, measurements shall be permitted to include the full width of the line defining the accessible parking space or aisle.] Parking spaces for cats, access aisles serving parking spaces, and vehicular routes serving them shall provide a vertical clearance of 98" minimum.

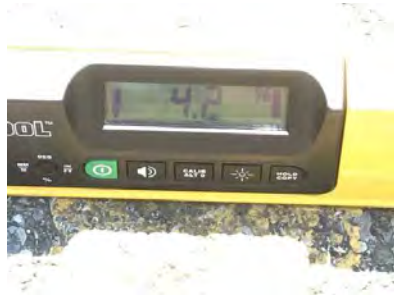
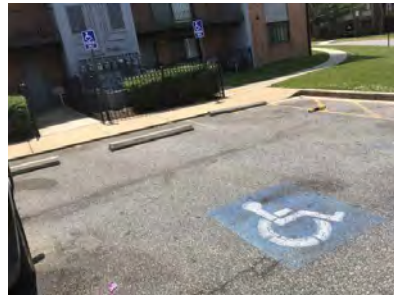
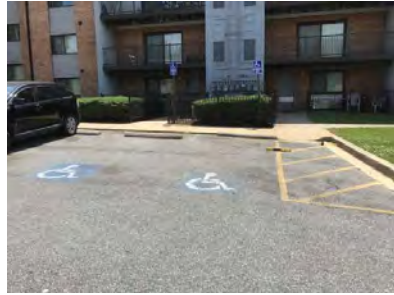
Assembly	Exterior Access Route
Type	Parking Space-Van
ADA Standard	502.4
Barrier Detail	The parking space slope is greater than 1:50 (2%).
Location Description	Accessible Parking Space P1-I
Observed	May 28, 2021 by Lloyd.fojas@bureauveritas.com
Site Conditions	The accessible parking space has a cross slope of 5.5%.

Remove and replace with a van space which has a slope of maximum 1:50 (2%) in all directions. [EXCEPTION: Slopes not steeper than 1:48 (2.08%) shall be permitted.] Changes in level are not permitted. Parking spaces and access aisles serving them shall be compliant. Width measurements shall be made from the centerline of the markings. [EXCEPTION: Where parking spaces or access aisles are not adjacent to another parking space or access aisle, measurements shall be permitted to include the full width of the line defining the parking space or access aisle.] The quantity and order of magnitude cost estimate provided for this barrier are limited to the extent of the area identified as non-compliant. Additional costs that may be associated with removal of the barrier are not included.

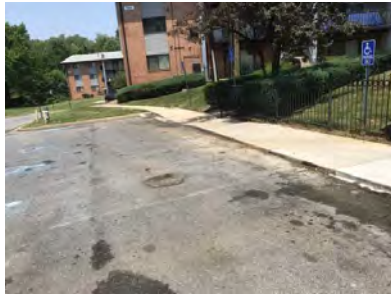
Photos for Barrier ID: AX240314

Assembly	Accessible Parking
Type	Parking Space-Van
ADA Standard	502.1, 502.3
Barrier Detail	Accessible van stall markings do not define the stall width.
Location Description	Accessible Parking Spaces P1-A, P-1 B, P1-E and P1-I
Observed	May 28, 2021 by Lloyd.fojas@bureauveritas.com
Site Conditions	The van accessible parking spaces are faded.

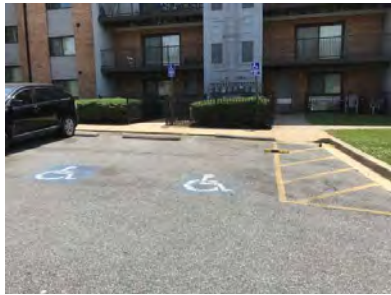
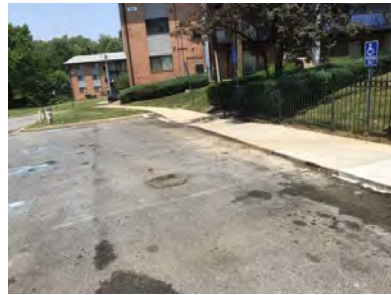
Photos for Barrier ID: AX240066

Assembly	Exterior Access Route
Type	Curb Ramp
ADA Standard	406.2
Barrier Detail	A curb ramp is not provided where the accessible route crosses a curb.
Location Description	Curb Ramp CR-1 and CR-2
Observed	May 28, 2021 by Lloyd.fojas@bureauveritas.com
Site Conditions	Curb ramps are not provided where the accessible route crosses the curbs.

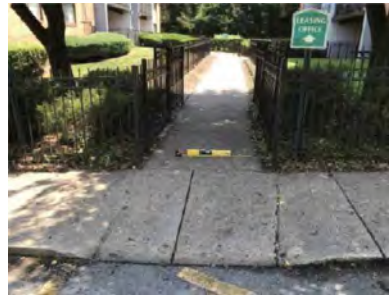
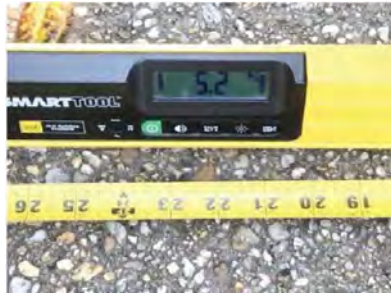
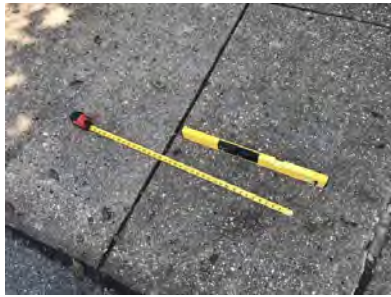
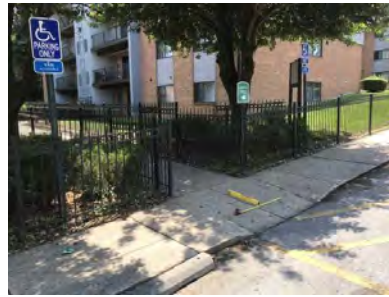
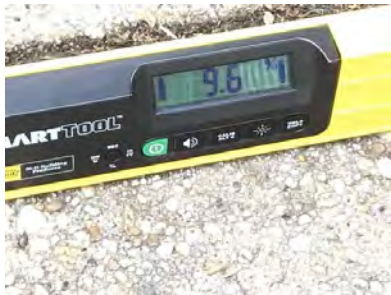
Assembly	Exterior Access Route
Type	Curb Ramp
ADA Standard	405.2; Table 405.2; 406; 406.2
Barrier Detail	The curb ramp does not meet the slope requirements.
Location Description	Curb Ramp CR-5
Observed	May 28, 2021 by Lloyd.fojas@bureauveritas.com

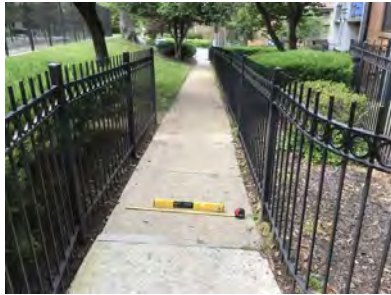
Photos for Barrier ID: AX239589

Assembly	Exterior Access Route
Type	Exterior Accessible Route
ADA Standard	403.3
Barrier Detail	The accessible route has running slopes greater than 1:20 (5%).
Location Description	From Accessible Parking to Buildings 6810 and 6812 Entrances
Observed	May 28, 2021 by Lloyd.fojas@bureauveritas.com
Site Conditions	The accessible route has running slopes up to 9.4%.

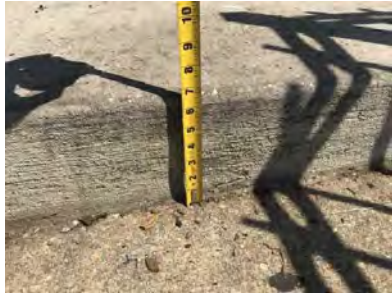
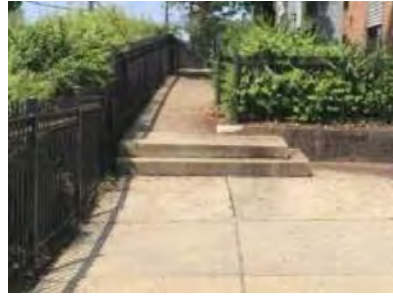
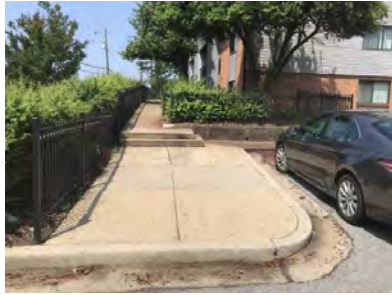
Assembly	Exterior Access Route
Type	Ramp
ADA Standard	405.8 and 505
Barrier Detail	The ramp run has a rise greater than 6"; however, handrails are not provided.
Location Description	From Parking to Building 6800
Observed	May 28, 2021 by Lloyd.fojas@bureauveritas.com

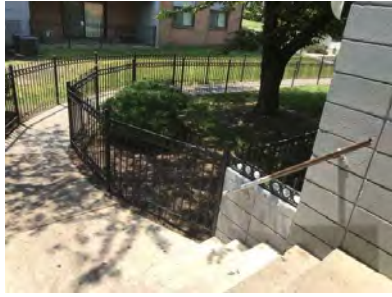
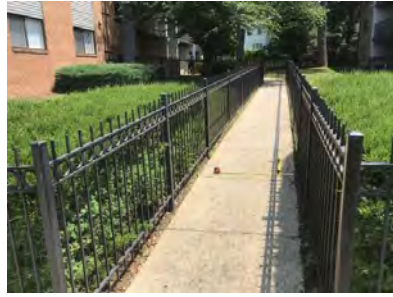
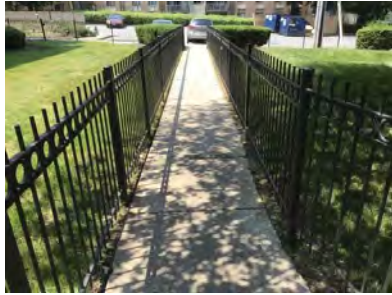
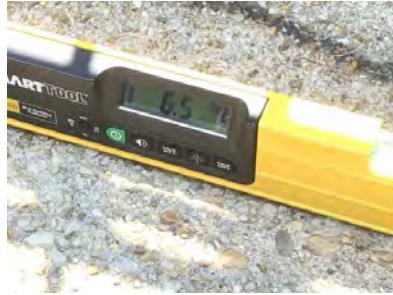
Assembly	Exterior Access Route
Type	Exterior Accessible Route
ADA Standard	403.3
Barrier Detail	The accessible route has cross slopes greater than 1:50 (2%).
Location Description	From Parking to Building 6806
Observed	May 28, 2021 by Lloyd.fojas@bureauveritas.com
Site Conditions	The accessible route has a cross slope of 3.6%.

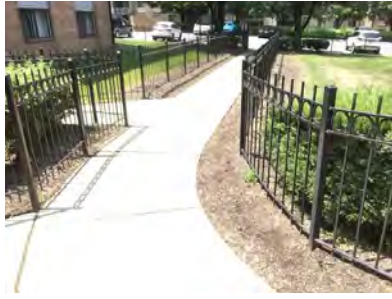
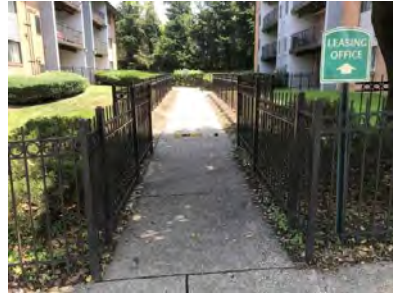
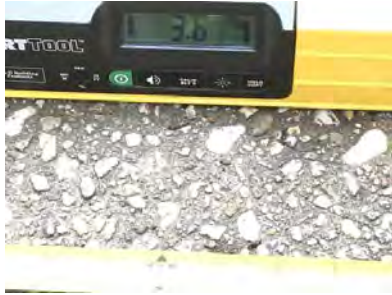
Assembly	Exterior Access Route
Type	Exterior Accessible Route
ADA Standard	403.3
Barrier Detail	The accessible route has running slopes greater than 1:20 (5%).
Location Description	Near Building 6804
Observed	May 28, 2021 by Lloyd.fojas@bureauveritas.com
Site Conditions	The accessible route has a running slope of 7.7%.
