ACCESSIBILITY ASSESSMENT

July 19, 2021

ADA TITLE II ASSESSMENT

Cottage City Towers
4142 Bunker Hill Road
Cottage City, Maryland 20722

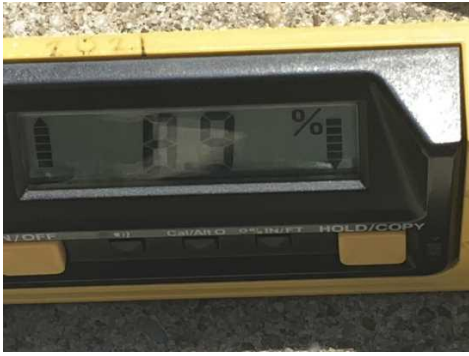
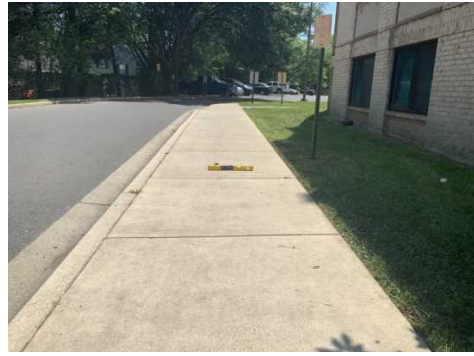
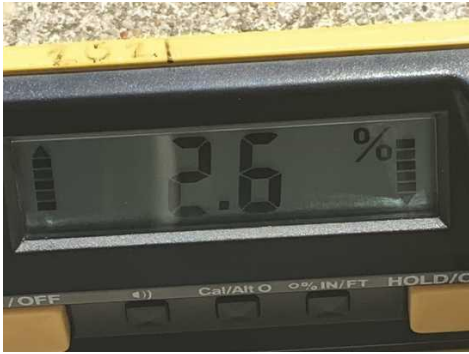
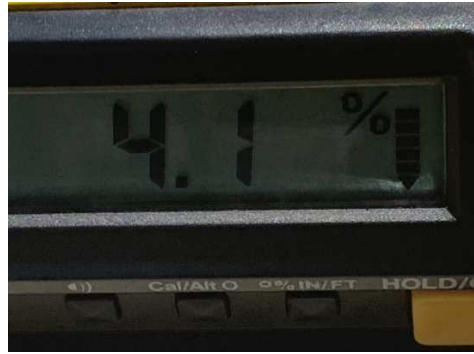
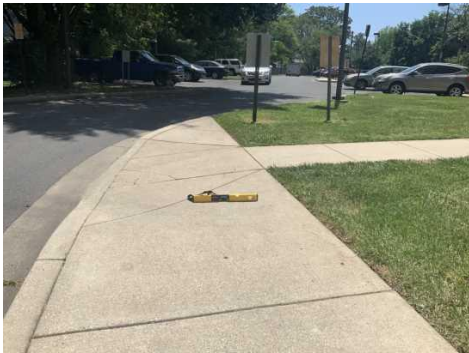
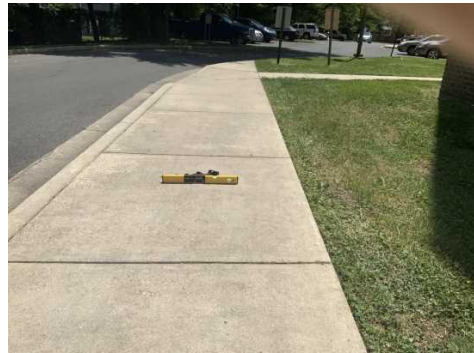
139 +38.939842, -76.948739

Assembly	Exterior Access Route
Type	Curb Ramp
ADA Standard	405.2; Table 405.2; 406; 406.2
Barrier Detail	The curb ramp does not meet the slope requirements.
Location Description	Curb Ramp CR2
Observed	May 17, 2021 by Ouraccessibleworld@gmail.com
Site Conditions	The curb ramp has a running slope of up to 10.6%.

The curb ramp should be removed and replaced with a compliant curb ramp with no greater than the maximum allowable slopes of a ramp. Curb ramp runs shall have a running slope not steeper than 1:12 (8.33%). Cross slope of curb ramp runs shall not be steeper than 1:48. The running slope in new construction shall be 1:12 (8.33%) maximum. [EXCEPTION: In existing sites, buildings, and facilities built before 1/26/92, ramps and curb ramps shall be permitted to have running slopes steeper than 1:12 where such slopes are necessary due to space limitations. In facilities built before 1/26/92, the running slope can be 1:10 to 1:8 (10% to 12.5%) for a maximum rise of 3" OR 1:10 to 1:12 (8.3% to 10%) for a maximum rise of 6".] Where flares are provided, flare slopes shall not be greater than 1:10 (10%). [EXCEPTION: In alterations, where there is no landing at the top of curb ramps, curb ramp flares shall be provided and shall not be steeper than 1:12.]

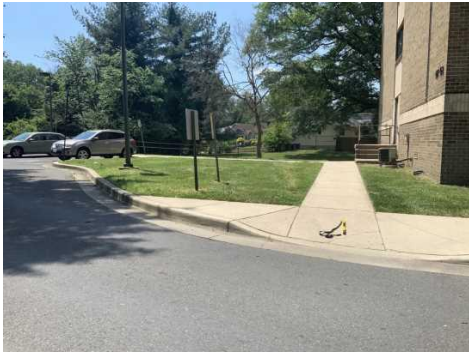
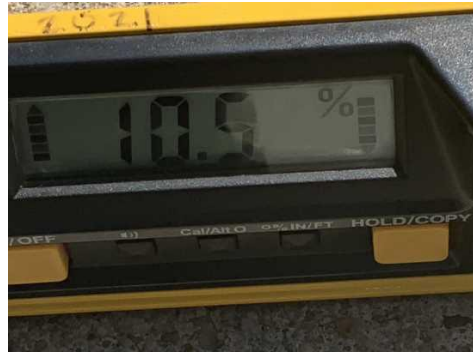
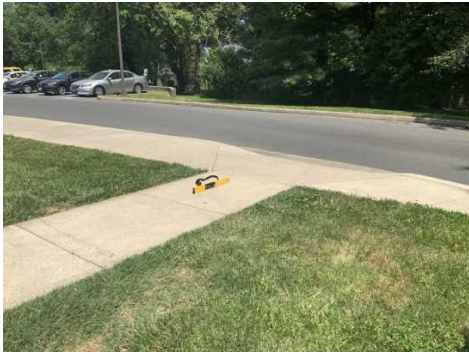
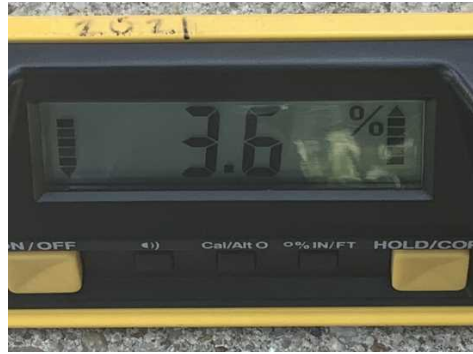
140 38.93970930185071,-76.94879327116394

Assembly	Exterior Access Route
Type	Exterior Accessible Route
ADA Standard	403.3
Barrier Detail	The accessible route has cross slopes greater than 1:50 (2%).
Location Description	Curb Ramp CR3 to Curb Ramp CR4
Observed	May 17, 2021 by Ouraccessibleworld@gmail.com

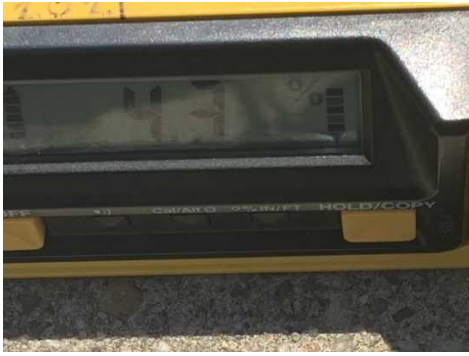
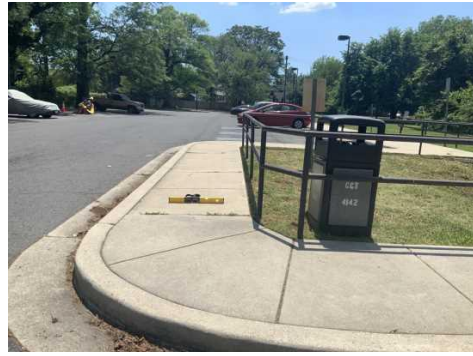
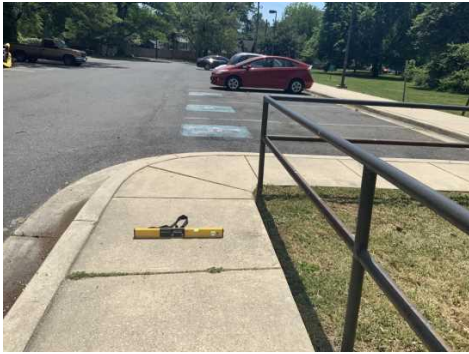
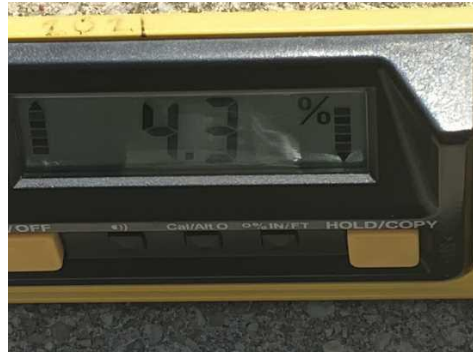
Photos for Barrier ID: AX240431

Assembly	Exterior Access Route
Type	Exterior Accessible Route
ADA Standard	403.3
Barrier Detail	The accessible route has cross slopes greater than 1:50 (2%).
Location Description	Curb Ramp CR4 to Street
Observed	May 17, 2021 by Ouraccessibleworld@gmail.com

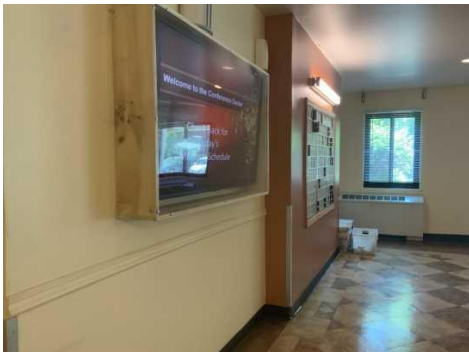
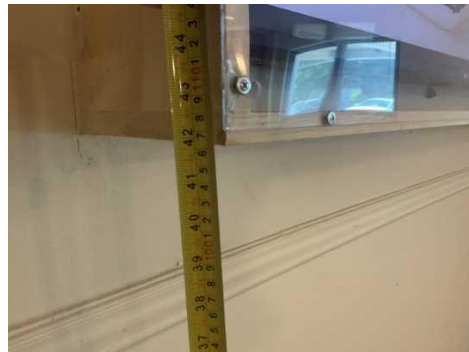
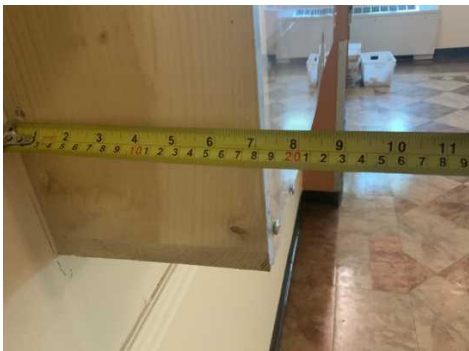
Photos for Barrier ID: AX240391

Site Conditions The display case projects 7" into the accessible route at 42" above the floor.

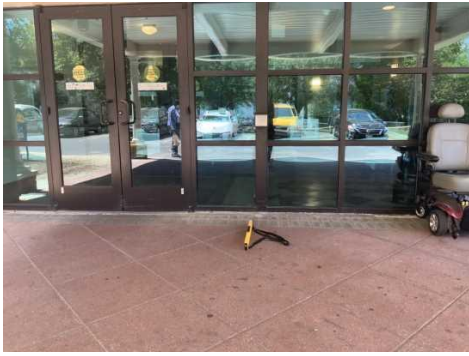
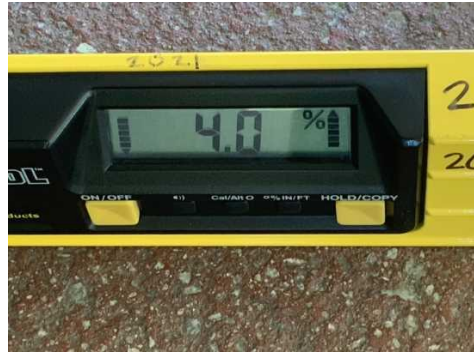
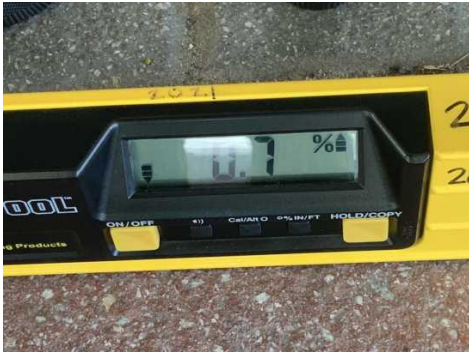
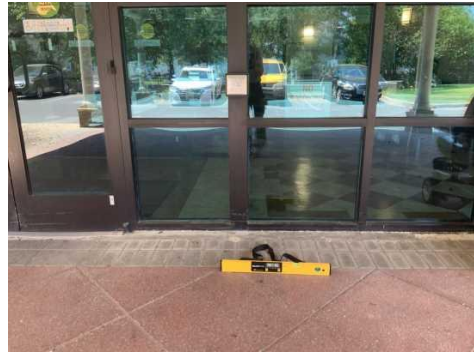
Photos for Barrier ID: AX240398

Assembly	Entrance to Building
Type	Building Entrance-Door
ADA Standard	305.2; 404.2
Barrier Detail	The maneuvering clearance at the accessible door is not level and clear.
Location Description	Main Entrance
Observed	May 17, 2021 by Ouraccessibleworld@gmail.com

Remove and replace the surface within the required maneuvering clearance area so that the surface is level and clear with maximum slope 1:48 (2.08%) in any direction. This barrier must be removed in conjunction with barrier ID 240399. The required depth of the maneuvering clearance is 60" minimum. The required side clearance is 18" minimum on the latch side of the door. Maneuvering clearance shall extend the full width of the doorway and the required latch side clearance. Floor or ground space within the required maneuvering clearance shall be maximum 1:48 (2.08%) slope. Changes in level are not permitted.

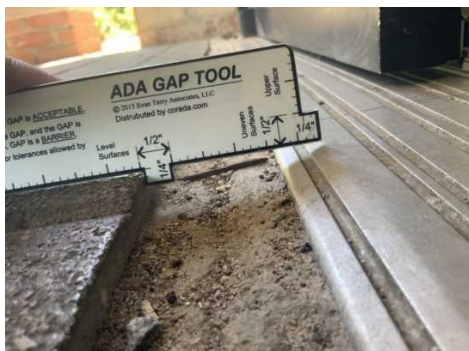
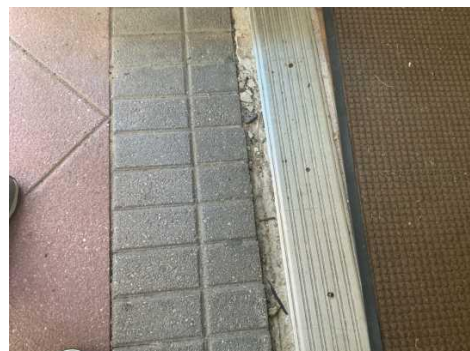
Photos for Barrier ID: AX240399

Assembly	Exterior Access Route
Type	Exterior Accessible Route
ADA Standard	302.3
Barrier Detail	The accessible route has gaps in the surface greater than 1/2" wide.
Location Description	Main Entrance
Observed	May 17, 2021 by Ouraccessibleworld@gmail.com
Site Conditions	The threshold area at the main entrance has a gap of up to 2" wide.

Repair the accessible route to eliminate openings in the surface greater than 1/2" wide. This barrier must be removed in conjunction with barrier ID 240398. The cost of this barrier removal is covered under ID 240398 and therefore, the cost of this ID is shown as \$0. Openings in the ground surface of the accessible route shall not allow passage of a sphere more than 1/2" diameter. Elongated openings shall be placed so that the long dimension is perpendicular to the dominant direction of travel.

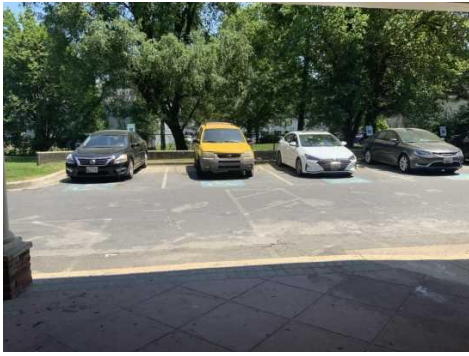
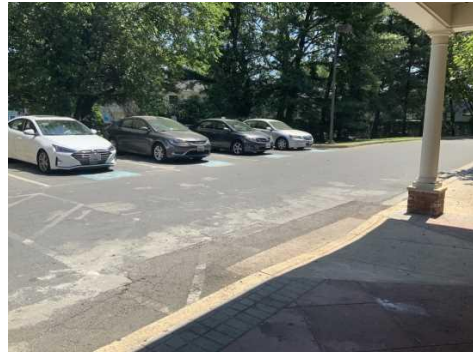
Photos for Barrier ID: AX240396

Assembly	Accessible Parking
Type	Parking Space-Car
ADA Standard	502.3; 502.4; 502.5
Barrier Detail	An access aisle is not provided.
Location Description	Parking Lot
Observed	May 17, 2021 by Ouraccessibleworld@gmail.com

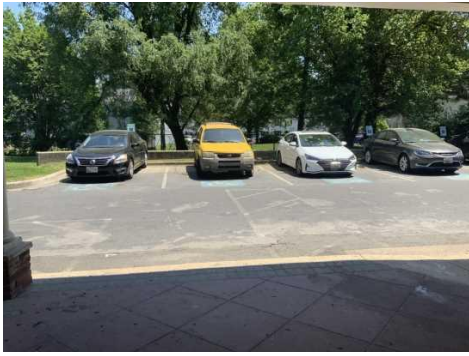
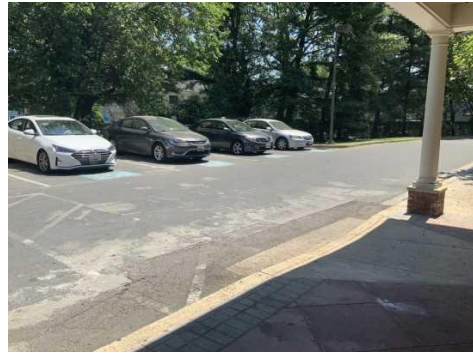
Photos for Barrier ID: AX241387

Assembly	Accessible Parking
Type	Parking Space-Van
ADA Standard	UFAS 4.6.3
Barrier Detail	The slope of the parking space is greater than 1:50 (2%).
Location Description	Parking Lot
Observed	May 17, 2021 by Ouraccessibleworld@gmail.com

Remove and replace with a van space that has no more than 1:50 (2%) slope in all directions. Parking spaces and access aisles shall be level with surface slopes not exceeding 1:50 (2%) in all directions. Parking access aisles shall be part of an accessible route to the building or facility entrance. Parked vehicle overhangs shall not reduce the clear width of an accessible circulation route. The quantity and order of magnitude cost estimate provided for this barrier are limited to the extent of the area identified as non-compliant. Additional costs that may be associated with removal of the barrier are not included.

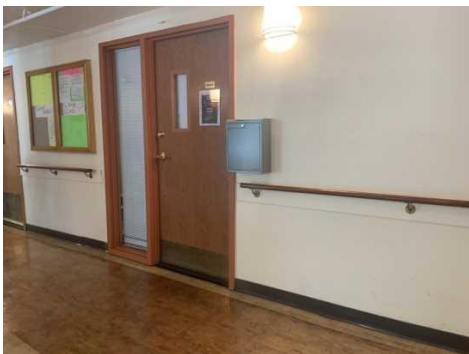
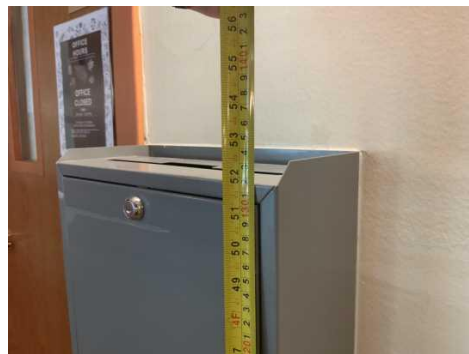
Photos for Barrier ID: AX240392

Assembly	Interior Access Route
Type	Reach Range
ADA Standard	308
Barrier Detail	Items that require a forward reach motion require more than 48" height reach.
Location Description	Lobby
Observed	May 17, 2021 by Ouraccessibleworld@gmail.com
Site Conditions	The slot in the comment box is mounted at 52" above the floor.

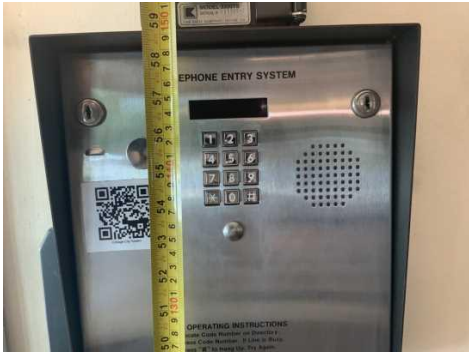
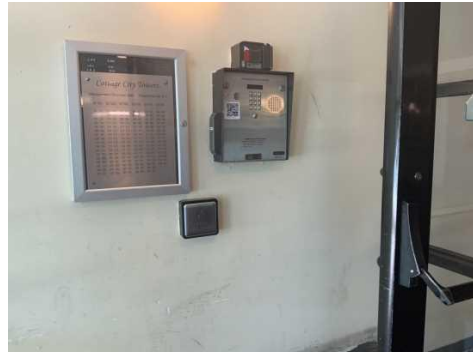
Photos for Barrier ID: AX240400

Site Conditions	The controls for the entry system are mounted up to 56" above the sidewalk.
------------------------	---

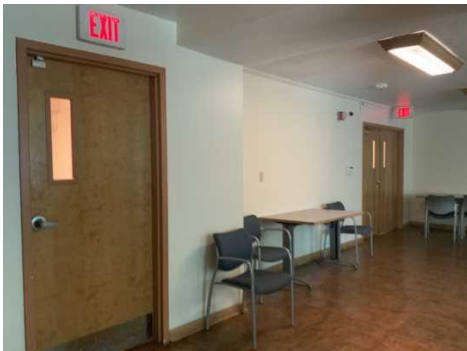
Photos for Barrier ID: AX240395

Assembly	Interior Access Route
Type	Signage
ADA Standard	216.4, 703.1, 703.4
Barrier Detail	Means of egress signage is not provided.
Location Description	Common Room
Observed	May 17, 2021 by Ouraccessibleworld@gmail.com
Site Conditions	Means of egress signage with tactile characters is not provided.

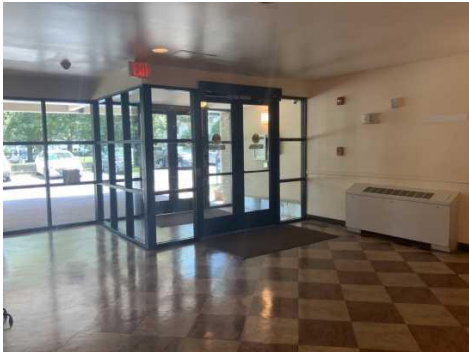
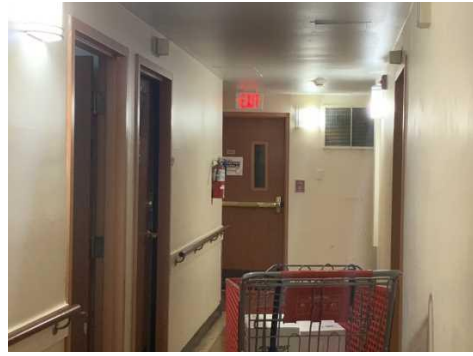
Photos for Barrier ID: AX240386

Assembly	Interior Access Route
Type	Signage
ADA Standard	216.4, 703.1, 703.4
Barrier Detail	Means of egress signage is not provided.
Location Description	Lobby
Observed	May 17, 2021 by Ouraccessibleworld@gmail.com
Site Conditions	Means of egress signage with tactile characters is not provided at the exits.

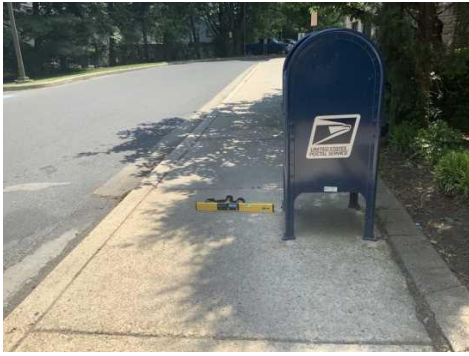
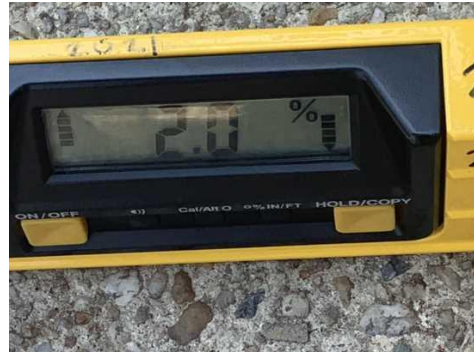
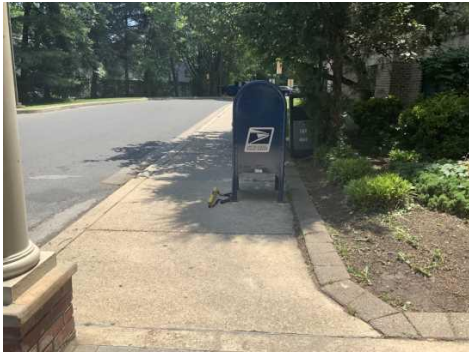
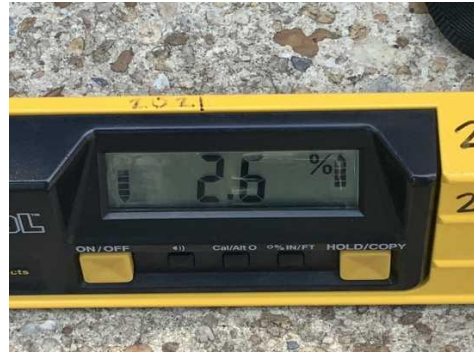
Photos for Barrier ID: AX240427

Assembly	Exterior Access Route
Type	Clear Space
ADA Standard	305; 309.2
Barrier Detail	Clear space is not provided at the operable part.
Location Description	Main Entrance
Observed	May 17, 2021 by Ouraccessibleworld@gmail.com
Site Conditions	The clear space at the mail box has slopes of up to 2.6%.
Resolution	
Provide clear space at the operable part. Floor or ground surfaces of a clear floor or ground space shall have slopes not steeper than 1:48, and shall be stable, firm, and slip resistant. Clear space shall be 30" minimum by 48" minimum, positioned for a forward or parallel approach. One full unobstructed side shall adjoin an accessible route or adjoin another clear floor or ground space. Clear floor or ground space shall include knee and toe clearance.	
Quantity	
12 SF	
Priority	3

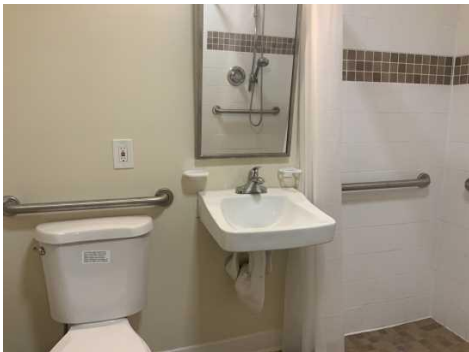
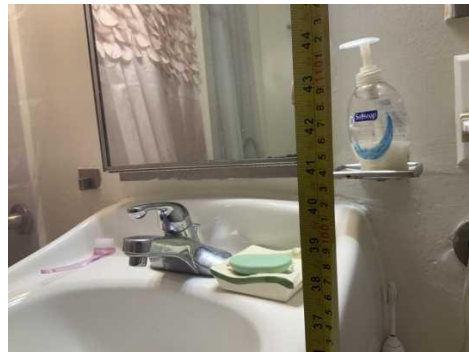
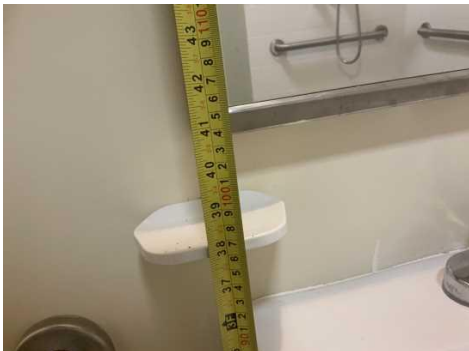
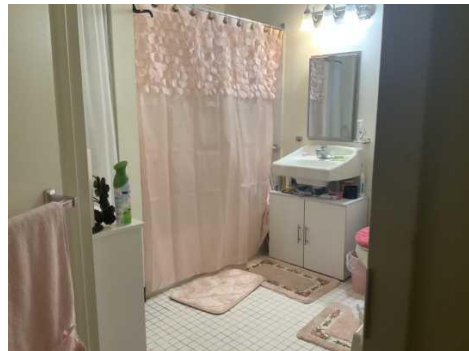
Photos for Barrier ID: AX240414

Assembly	Residential Dwelling
Type	Restroom/Bathroom-Mirror
ADA Standard	UFAS 4.19.6

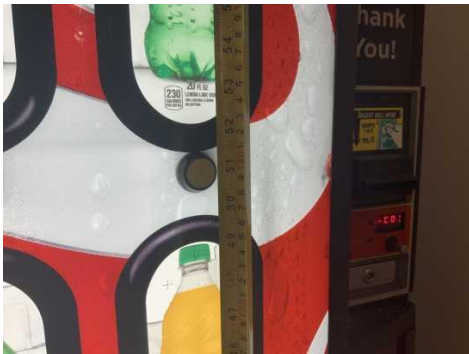
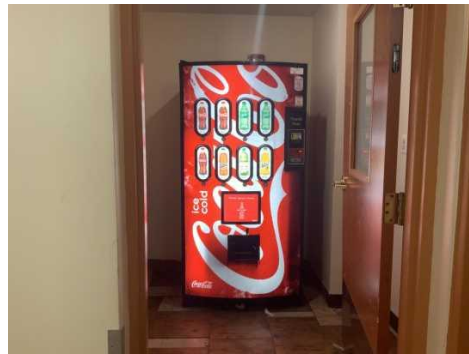
Photos for Barrier ID: AX240388

Assembly	Common Areas
Type	Vending Machine
ADA Standard	228.1; 305; 308; 309
Barrier Detail	The vending machines have operable parts which are not within reach range.
Location Description	Lobby
Observed	May 17, 2021 by Ouraccessibleworld@gmail.com
Site Conditions	The vending machine has controls up to 51" above the floor surface.
