# ACCESSIBILITY ASSESSMENT

July 13, 2021

## **ADA TITLE II ASSESSMENT**

Marlborough Town  
1847 Tanow Place  
District Heights, Maryland 20747

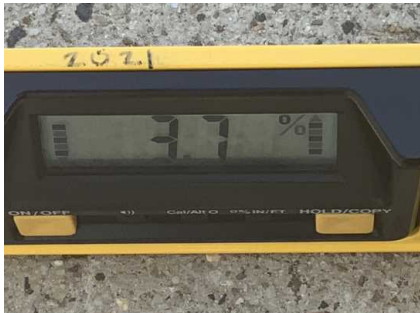
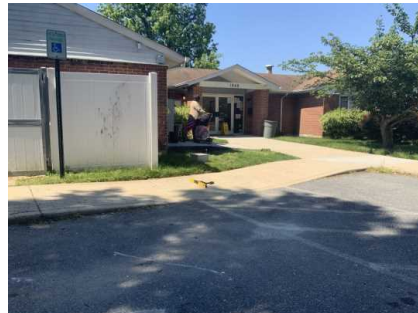
**Photos for Barrier ID: AX240005**

**Site Conditions** The bottom curb ramp landing has a slope of up to 3.7%.

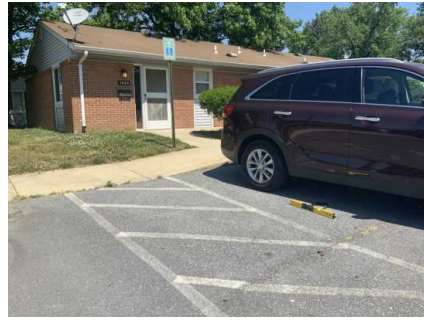
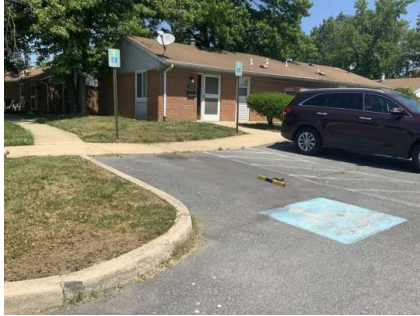
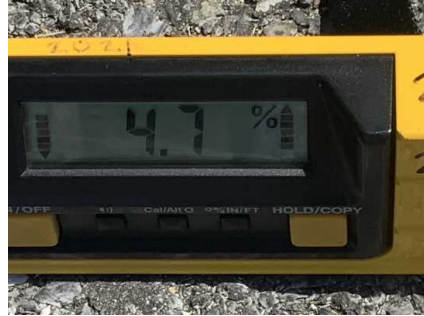
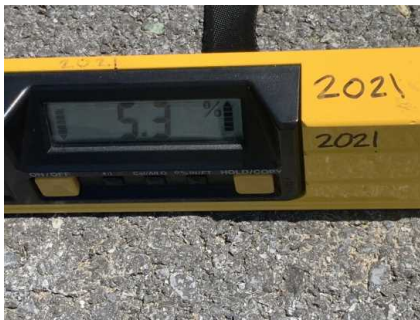
<b>Assembly</b>	Accessible Parking
<b>Type</b>	Parking Space-Car
<b>ADA Standard</b>	UFAS 4.6.3
<b>Barrier Detail</b>	The slope of the standard car access aisle is greater than 1:50 (2%).
<b>Location Description</b>	P1-1 and P1-2
<b>Observed</b>	May 20, 2021 by Ouraccessibleworld@gmail.com
<b>Site Conditions</b>	The access aisle has a running g slope of up to 4.6%.

Remove and replace with an adjacent access aisle that is at least 60" wide and has a maximum slope of 1:50 (2%) in all directions. Parking spaces and access aisles shall be level with surface slopes not exceeding 1:50 in all directions. Parking access aisles shall be part of an accessible route to the building or facility entrance. Parked vehicle overhangs shall not reduce the clear width of an accessible circulation route. The quantity and order of magnitude cost estimate provided for this barrier are limited to the extent of the area identified as non-compliant. Additional costs that may be associated with removal of the barrier are not included.

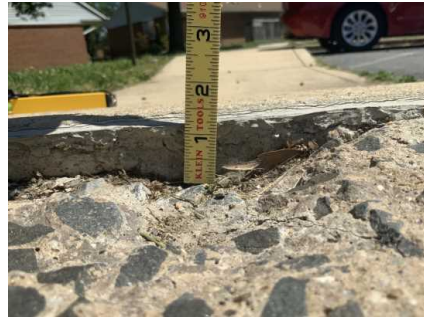
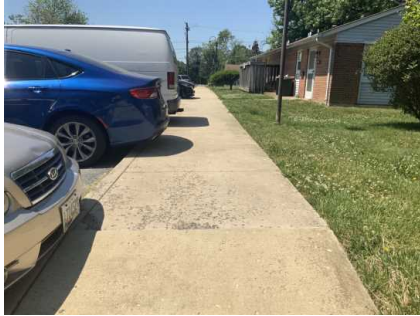
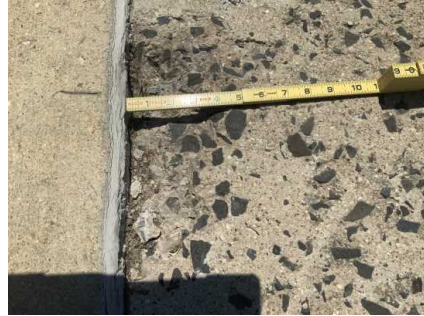
<b>Assembly</b>	Exterior Access Route
<b>Type</b>	Exterior Accessible Route
<b>ADA Standard</b>	UFAS 4.3.7
<b>Barrier Detail</b>	The accessible route cross slope is greater than 1:50 (2%).
<b>Location Description</b>	Sidewalk To Unit 1925
<b>Observed</b>	May 20, 2021 by Ouraccessibleworld@gmail.com

Remove and replace the accessible route with a compliant cross slope not greater than 1:50 (2%). An accessible route has maximum 1:50 (2%) cross slope, maximum 1:20 (5%) running slope, and minimum 36" clear width. [EXCEPTION: The accessible route may be minimum 32" wide at doors/gates or at a point]. An accessible route with a running slope greater than 1:20 is a ramp. Nowhere shall the cross slope of an accessible route exceed 1:50. The minimum clear width of an accessible route shall be 36" except at doors. If an accessible route has less than 60" clear width, then passing spaces at least 60" by 60" shall be located at reasonable intervals not to exceed 200 linear feet. A T-intersection of two corridors or walks is an acceptable passing place. Where grading to maximum running slope of 1:20 (5% running slope) is not possible, provide a compliant ramped surface within the walkway with maximum slope 1:12 (8.33%) and maximum ramp run rise of 6" without handrails. If a ramped surface with running slopes greater than 1:20 (5%) and maximum 1:12 (8.33%) rises more than 6" or extends more than 72", handrails are required. A compliant ramp has maximum 1:12 (8.3%) running slope, maximum ramp run rise 30", landings at the top and bottom of ramp runs, handrails where the ramp run rise is greater than 6" or extends more than 72", and edge protection with exceptions. The cost estimate for this barrier removal is based on grading the running slope to maximum 1:20 (5%). The quantity and order of magnitude cost estimate provided for this barrier are limited to the extent of the area identified as non-compliant. Additional costs that may be associated with removal of the barrier are not included.

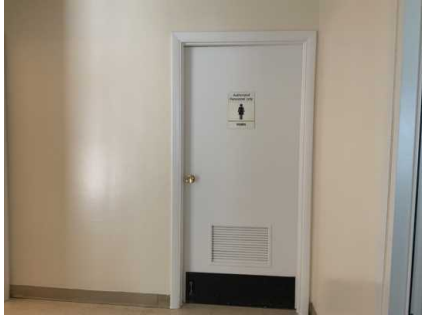
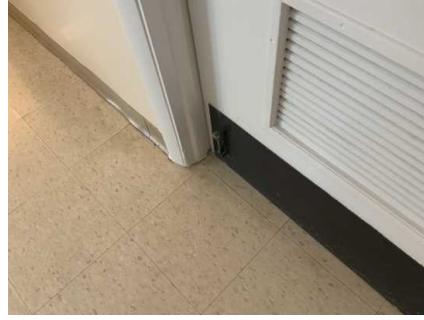
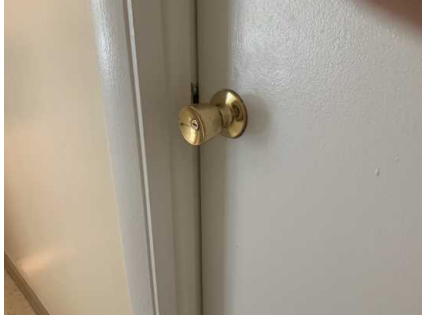
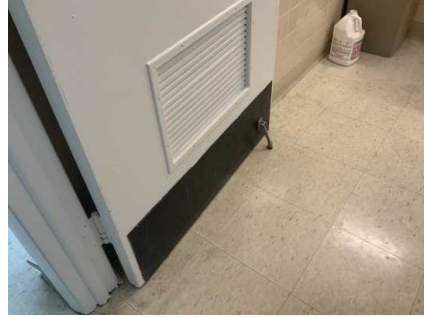
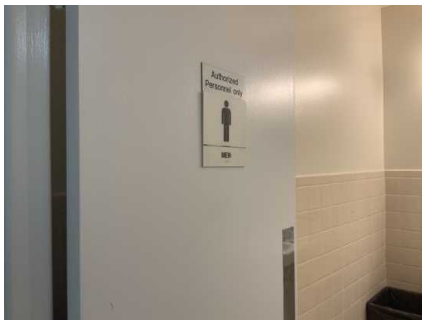
<b>Assembly</b>	Restroom
<b>Type</b>	Restroom/Bathroom-Water Closet
<b>ADA Standard</b>	604
