ACCESSIBILITY ASSESSMENT

145366.21R000-001.160

ADA TITLE II ASSESSMENT

Park Tanglewood
5309 Riverdale Road
Riverdale, Maryland 20737

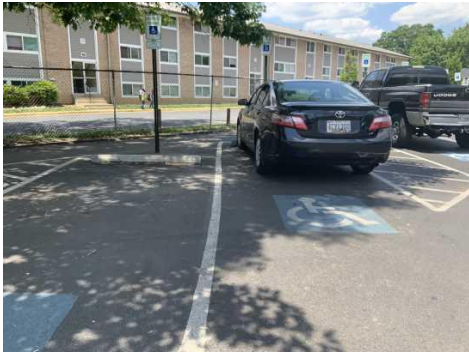
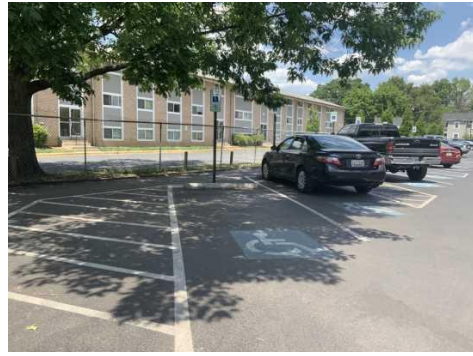
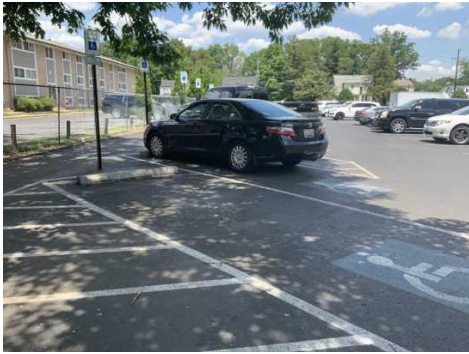
Photos for Barrier ID: AX239809

Assembly	Accessible Parking
Type	Parking Space-Van
ADA Standard	UFAS 4.6.3
Barrier Detail	The slope of the parking space is greater than 1:50 (2%).
Location Description	Accessible Parking Space P1-1
Observed	May 18, 2021 by Ouraccessibleworld@gmail.com

Remove and replace with a van space that has no more than 1:50 (2%) slope in all directions. Parking spaces and access aisles shall be level with surface slopes not exceeding 1:50 (2%) in all directions. Parking access aisles shall be part of an accessible route to the building or facility entrance. Parked vehicle overhangs shall not reduce the clear width of an accessible circulation route. The quantity and order of magnitude cost estimate provided for this barrier are limited to the extent of the area identified as non-compliant. Additional costs that may be associated with removal of the barrier are not included.

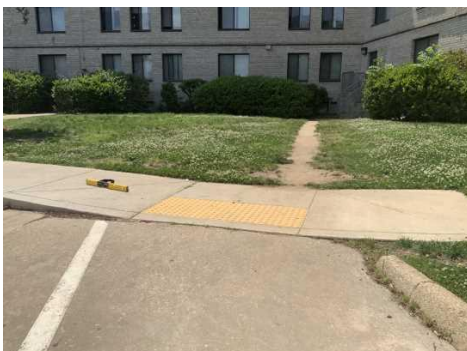
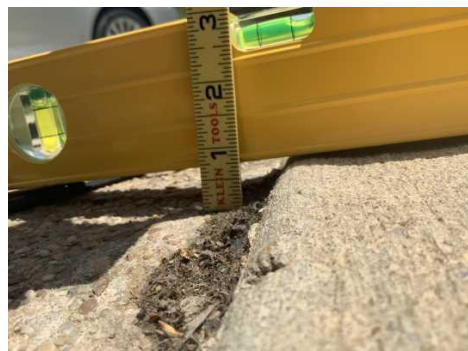
Photos for Barrier ID: AX239811

Assembly	Exterior Access Route
Type	Curb Ramp
ADA Standard	406.2
Barrier Detail	A curb ramp is not provided where the accessible route crosses a curb.
Location Description	Entrance
Observed	May 18, 2021 by Ouraccessibleworld@gmail.com
Site Conditions	A curb ramp is not provided at the accessible drop off area.

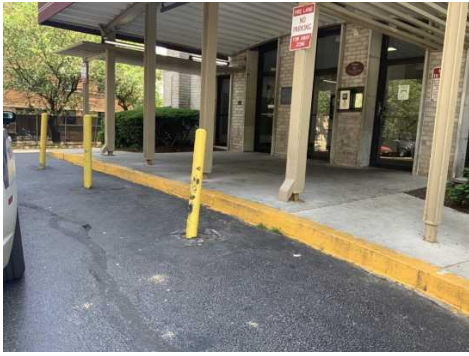
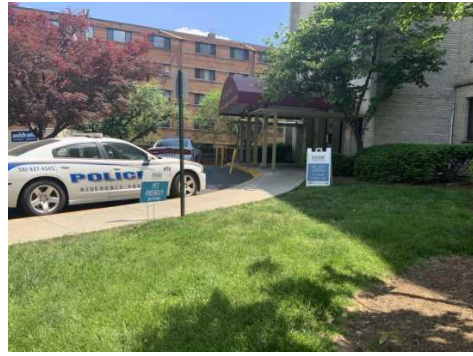
Photos for Barrier ID: AX239831

Assembly	Entrance to Building
Type	Building Entrance-Door
ADA Standard	404.2.8

Adjust closer or remove and replace closer to ensure that the door has a closure time of at least 5 seconds within 12 degrees of the latch. Door closers and gate closers shall be adjusted so that from an open position of 90 degrees, the time required to move the door to a position of 12 degrees from the latch is 5 seconds minimum.

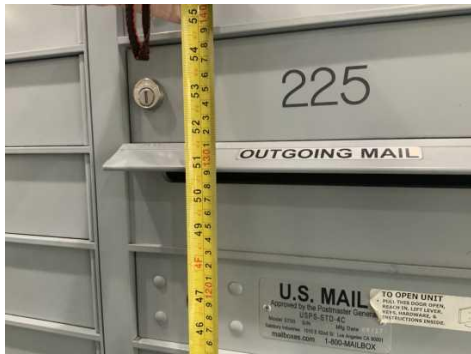
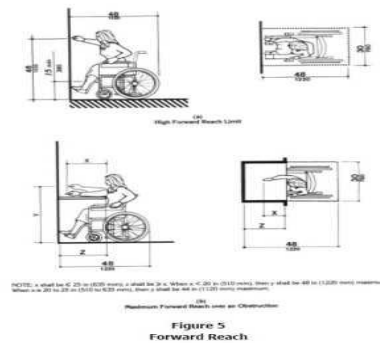
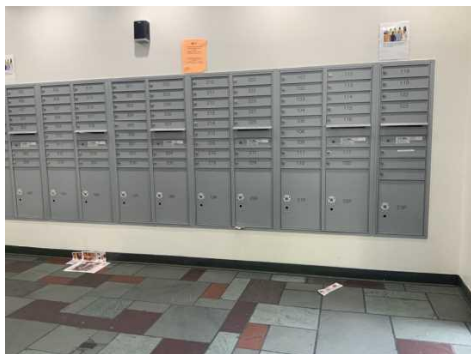
Photos for Barrier ID: AX240453

Assembly	Interior Access Route
Type	Protruding Object
ADA Standard	UFAS 4.4.1
Barrier Detail	The object protrudes more than 4" from the wall.
Location Description	Hallway
Observed	May 18, 2021 by Ouraccessibleworld@gmail.com

Lower object so that the bottom leading edge is maximum 27" above finish floor, replace with a non-protruding model, or install cane detectors. Objects projecting from walls (for example, telephones) with their leading edges between 27" and 80" above the finished floor shall protrude no more than 4" into walks, halls, corridors, passageways, or aisles (see Fig. 8(a)). Objects mounted with their leading edges at or below 27" above the finished floor may protrude any amount (see Fig. 8(a) and (b)). Free-standing objects mounted on posts or pylons may overhang 12" maximum from 27" to 80" above the ground or finished floor (see Fig. 8(c) and (d)). Protruding objects shall not reduce the clear width of an accessible route or maneuvering space (see Fig. 8(e)). Ensure objects do not protrude more than 4" into the accessible route when mounted at 27" or above from the finished floor to their leading edge. Wall- and post-mounted cantilevered units shall have a clear knee space between the bottom of the apron and the floor or ground at least 27" high, 30" wide, and 17" to 19" deep. Such units shall also have a minimum clear floor space 30" by 48" to allow a person in a wheelchair to approach the unit facing forward.

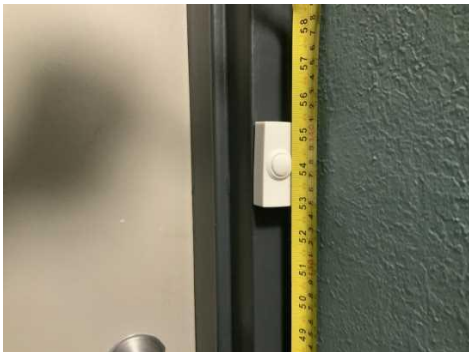
Photos for Barrier ID: AX239814

Site Conditions The door bell at the units is mounted 54" above the floor.

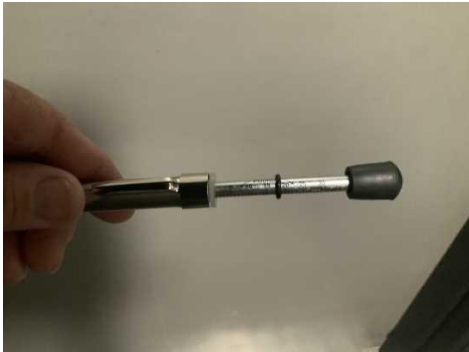
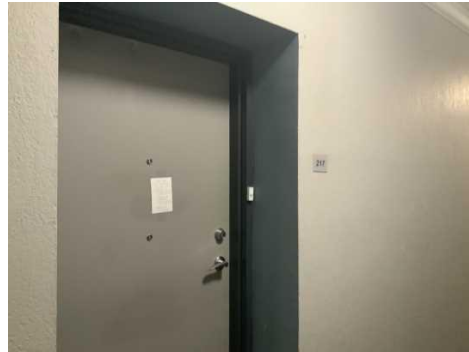
Photos for Barrier ID: AX239821

Assembly	Interior Access Route
Type	Door
ADA Standard	UFAS 4.13.11 (2)b, (2)c
Barrier Detail	The force required to pull or push open the door is more than 5#s.
Location Description	Unit 217
Observed	May 17, 2021 by Ouraccessibleworld@gmail.com
Site Conditions	The door requires 18 pounds of force to operate.

Adjust the closer or replace with an closer that requires no more 5#s of force to open the door or stop the door motion. The maximum allowable force for pushing or pulling open a door for interior hinged, sliding or folding doors is 5 lbf (22.2N). This forces do not apply to the force required to retract latch bolts or disengage other devices that may hold the door in a closed position.

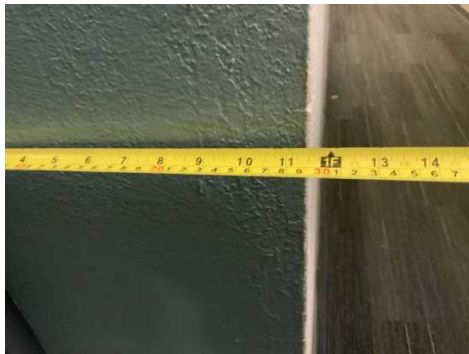
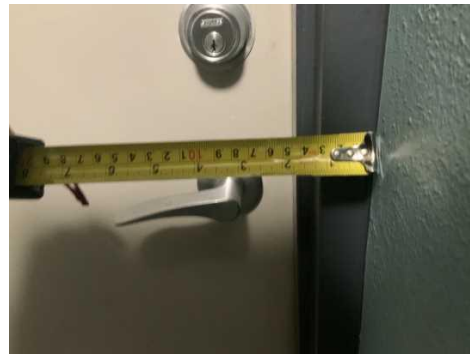
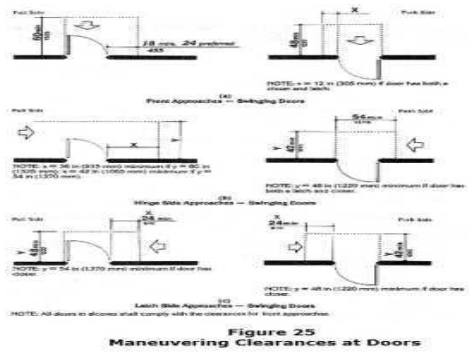
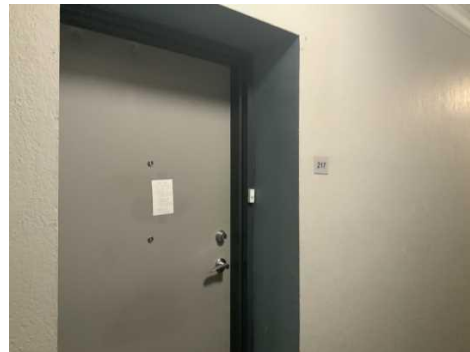
Photos for Barrier ID: AX240449

Assembly	Interior Access Route
Type	Door
ADA Standard	UFAS 4.13.6; Fig. 25
Barrier Detail	The accessible door does not have the required maneuvering clearances.
Location Description	Unit 217
Observed	May 17, 2021 by Ouraccessibleworld@gmail.com

Replace with a compliant maneuvering clearance area that is level and clear. Minimum maneuvering clearances at doors that are not automatic or power-assisted shall be as shown in Figure 25. The required depth of the maneuvering clearance is 48" minimum. The required side clearance is 12" minimum on the latch side of the door. Maneuvering clearance shall extend the full width of the doorway and the required latch side clearance. The floor or ground area within the required clearances shall be level and clear. Entry doors to acute care hospital bedrooms for in-patients shall be exempted from the requirement for space at the latch side of the door (see dimension 'x' in Figure 25), if the door is at least 44" wide.

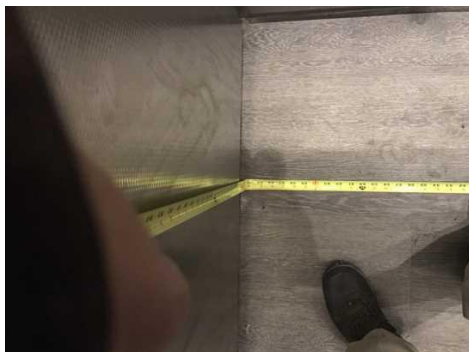
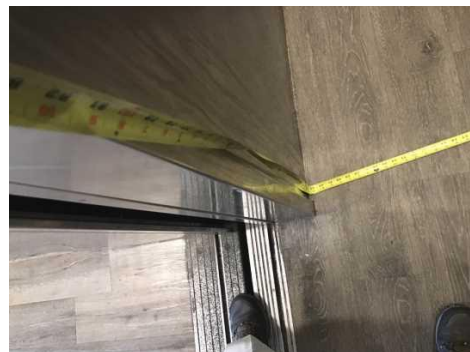
Photos for Barrier ID: AX236459

Assembly	Interior Access Route
Type	Elevator
ADA Standard	407.4.1
Barrier Detail	The elevator car dimensions are not compliant.
Location Description	Elevator
Observed	May 18, 2021 by Bryon.scott@bvna.com

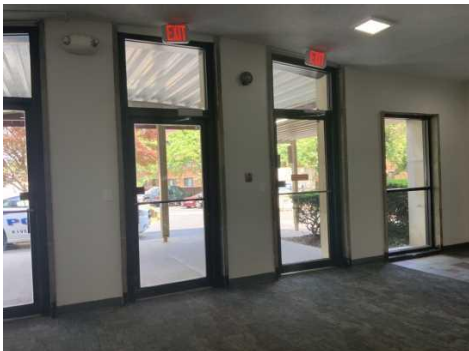
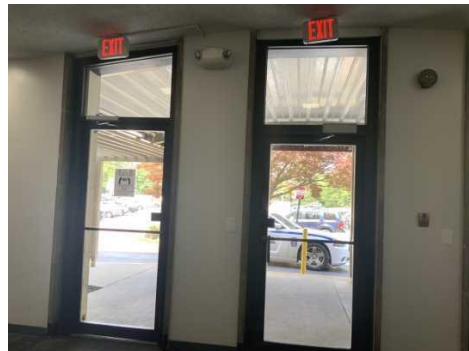
Photos for Barrier ID: AX239824

Assembly	Interior Access Route
Type	Signage
ADA Standard	216.4, 703.1, 703.4
Barrier Detail	Means of egress signage is not provided.
Location Description	Entrance
Observed	May 18, 2021 by Ouraccessibleworld@gmail.com

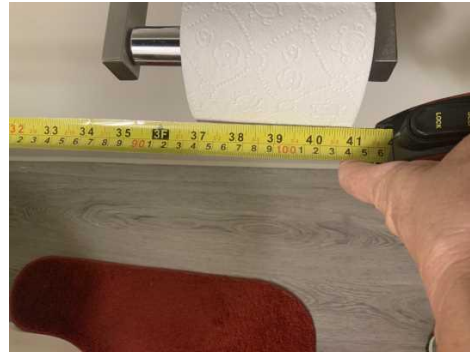
Photos for Barrier ID: AX239817

Assembly	Residential Dwelling
Type	Restroom/Bathroom-Water Closet
ADA Standard	UFAS 4.34.5.2 (4)
Barrier Detail	The toilet paper dispenser is not compliant.
Location Description	Unit 217
Observed	May 18, 2021 by Ouraccessibleworld@gmail.com
Site Conditions	The toilet paper dispenser is mounted 42" to the far edge from the rear wall.
