ACCESSIBILITY ASSESSMENT

DATE OF REPORT:
January 6, 2023

ADA TITLE II ASSESSMENT

GLENARDEN HILLS
3171 RONALD KEENER LOOP
LANHAM MD 20706

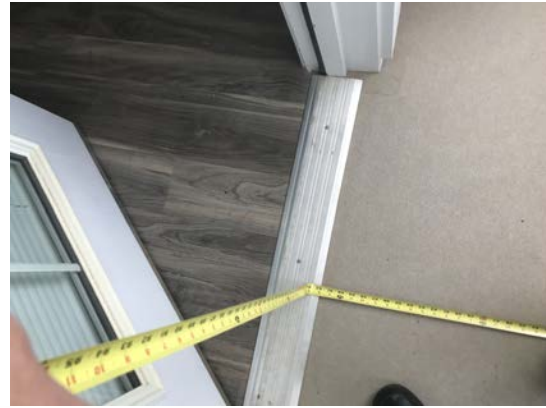
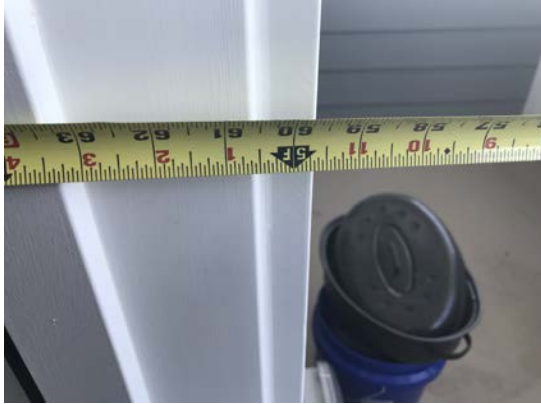
Assembly	Exterior Access Route
Type	Exterior Accessible Route
ADA Standard	UFAS 4.2.3
Barrier Detail	The accessible route does not have a compliant wheelchair turning space.
Location Description	Unit 213
Observed	Jun 8, 2022 by bscott
Site Conditions	The depth of the balcony is 59-1/2" from the face of the door jamb.

Provide a compliant turning space at the change of direction in the accessible route. The space required for a wheelchair to make a 180-degree turn is a clear space of 60" diameter (see Fig. 3(a)) or a T-shaped space (see Fig. 3(b)).

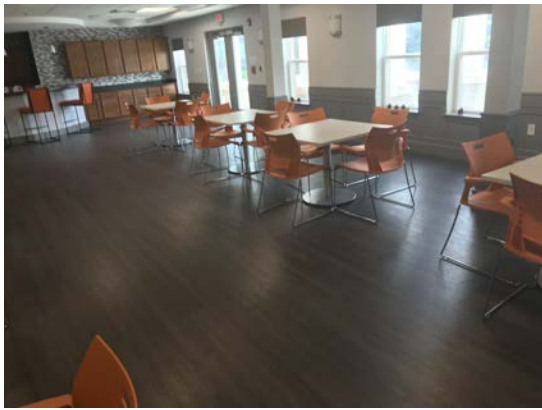
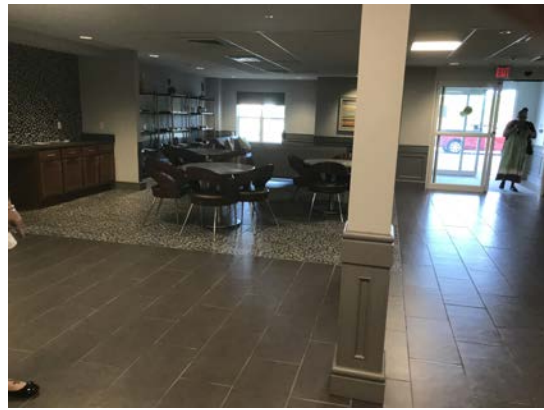
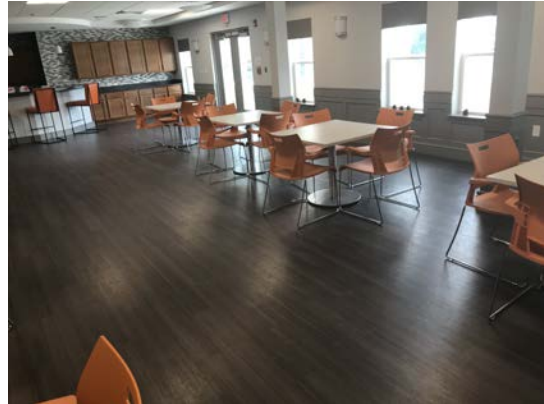
Assembly	Interior Access Route
Type	Dining And Work Surface
ADA Standard	UFAS 4.3.8
Barrier Detail	The dining surface or work surface is not compliant.
Location Description	Commons area
Observed	Jun 8, 2022 by bscott
Site Conditions	The round table bases do not allow for knee and toe clearance.

Provide a dining or work surface with the top of the surface from 28" to 34" high. The tops of tables and work surfaces shall be from 28" to 34" from the floor or ground. If seating for people in wheelchairs is provided at tables, counters, and work surfaces, knee spaces at least 27" high, 30" wide, and 19" deep shall be provided (see Fig. 45).

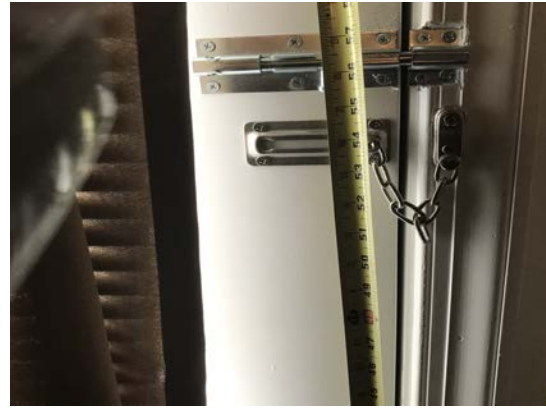
Elements that require a forward reach motion are not within the allowable reach range.

Site Conditions The security latches at the back door are 54" and 57" a.f.f.

Relocate the operable part to within the allowable forward reach range, measured from the finish floor. If the clear floor space allows a forward approach by a person in a wheelchair for an unobstructed forward reach, the high forward reach shall be maximum 48" and the low forward reach shall be minimum 15" above the floor. See Figure 5(a). If the clear floor space allows a forward approach by a person in a wheelchair for an obstructed forward reach, the obstructed forward reach is maximum 48" high, where the horizontal reach is maximum 20". The obstructed forward reach shall be maximum 44" high, where the horizontal reach is between 20" and maximum 25". See Figure 5 (b).

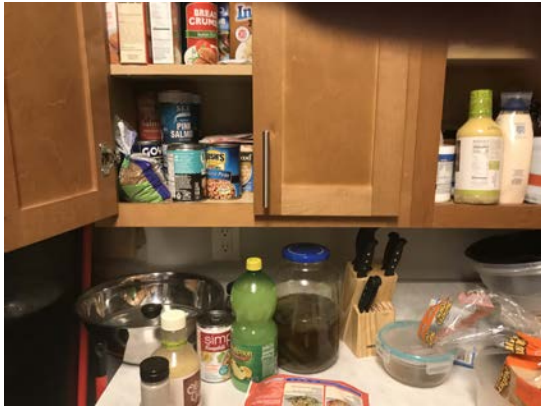
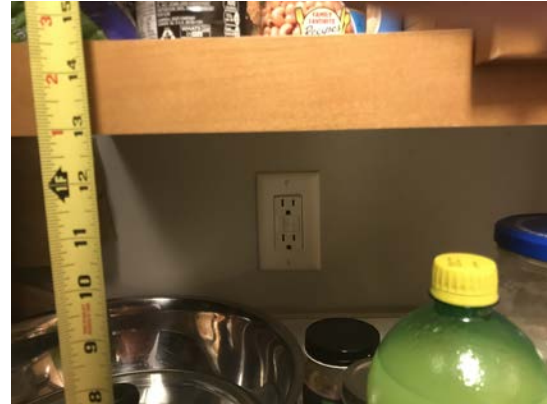
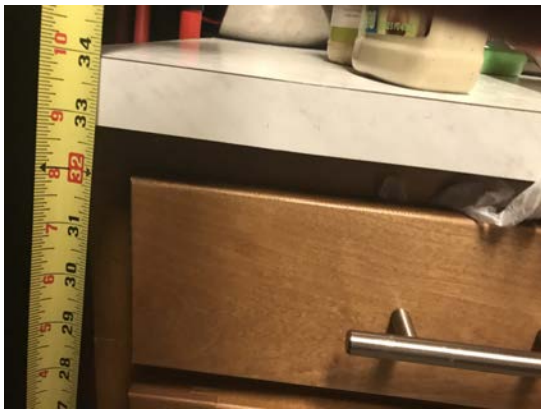
The kitchen cabinet shelving, shelf areas, and drawers are not within reach range.

Location Description	Unit 213
Observed	Jun 8, 2022 by bscott
Site Conditions	The bottom shelf of the cabinets over the workspace is 48-1/2".

Configure the shelving to provide at least one accessible shelf in each cabinet, shelf area and drawers. Cabinets, drawers, and shelf areas shall comply. Provide clear floor space at least 30" by 48" that allows either a forward or a parallel approach. Cabinets shall have the following features: (1) Maximum height shall be 48" for at least one shelf of all cabinets and storage shelves mounted above work counters (see Fig. 50). (2) Door pulls or handles for wall cabinets shall be mounted as close to the bottom of cabinet doors as possible. Door pulls or handles for base cabinets shall be mounted as close to the top of cabinet doors as possible. Shelving shall be located no higher than 48" for an unobstructed side approach or 48" for an unobstructed frontal only approach. If the clear floor space only allows forward approach to an object, the maximum high forward reach allowed shall be 48" (see Figure 5(a)). The minimum low forward reach is 15". If the high forward reach is over an obstruction, where the horizontal obstruction is less than 20" the maximum high forward reach is 48". Where the horizontal obstruction is from 20" to maximum 25", the high forward reach shall be 44" maximum. Forward obstructed reaches shall comply with Figure 5(b). If the clear floor space allows parallel approach by a person in a wheelchair, the maximum high side reach allowed shall be 54", and the low side reach shall be no less than 9" above the floor (Figure 6(a) and (b)). If the side reach is over an obstruction, the maximum horizontal reach shall be 24" and the high side reach shall be 46" maximum. Side obstructed clearances shall be as shown in Figure 6(c).

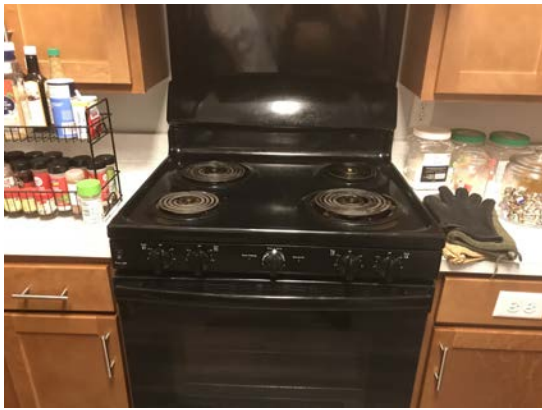
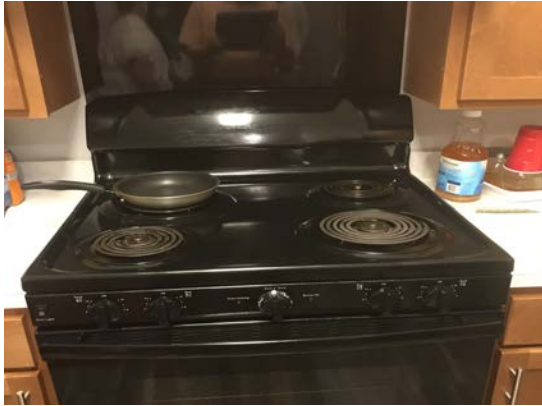
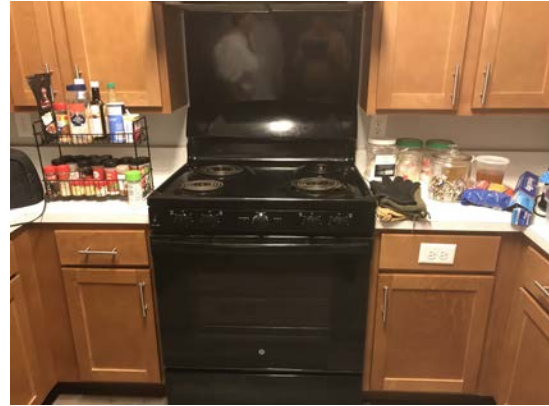
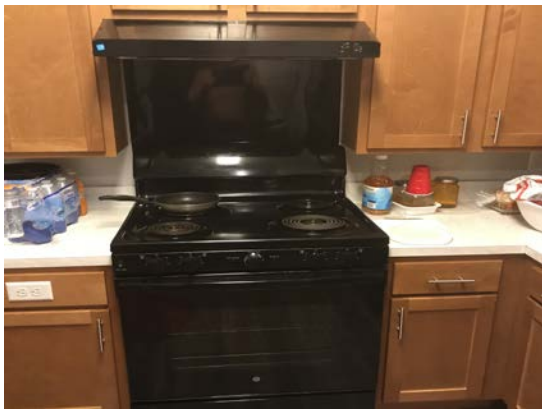
The oven is not self-cleaning or an adjustable height counter with knee space below is not located adjacent to the oven.

Site Conditions The oven is not self-cleaning, and there is no adjacent workspace to the oven.

Either Install a self-cleaning oven, or install an adjustable height counter with knee space below adjacent to the oven. Ovens shall be of the self-cleaning type or be located adjacent to an adjustable height counter with knee space below (see Fig. 52). For side-opening ovens, the door latch side shall be next to the open counter space, and there shall be a pull-out shelf under the oven extending the full width of the oven and pulling out not less than 10" when fully extended. Ovens shall have controls on front panels; they may be located on either side of the door. Controls shall be within an allowable reach range, shall be operable with one hand, and shall not require tight grasping, pinching or twisting of the wrist. The force required to activate controls shall be no greater than 5 pounds (22.2N) of force. A clear floor space at least 30" by 48" that allows either a forward or a parallel approach by a person in a wheelchair shall be provided at the oven.

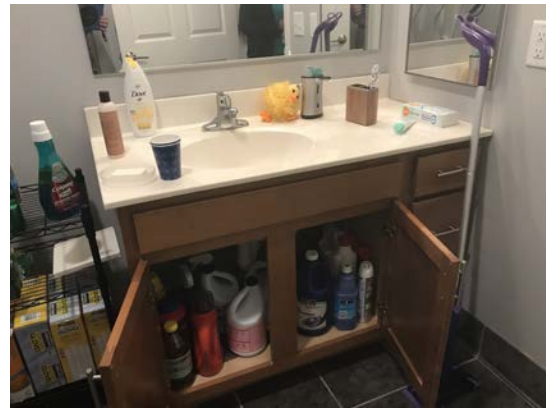
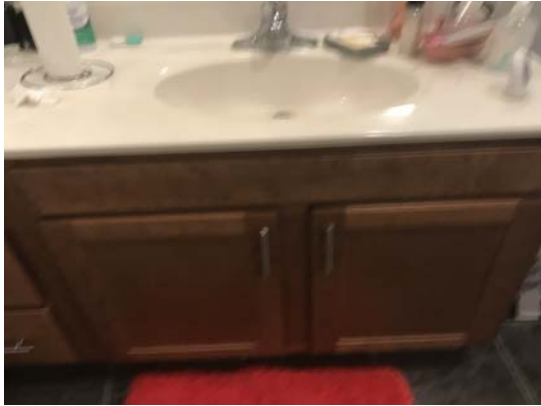
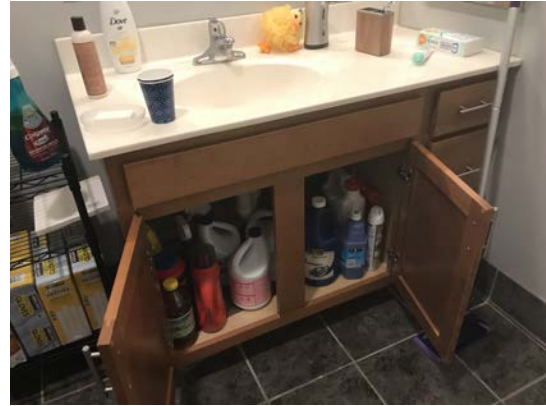
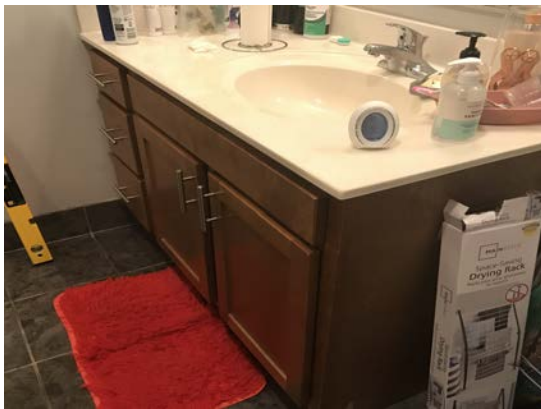
Assembly	Common Areas
Type	Restroom/Bathroom-Lavatory
ADA Standard	UFAS 4.22.6; 4.19.2
Barrier Detail	The lavatory does not have knee and toe clearance.
Location Description	Unit 104, 106, 213
Observed	Jun 8, 2022 by bscott
Site Conditions	The lavatory does not have a removable cabinet face.

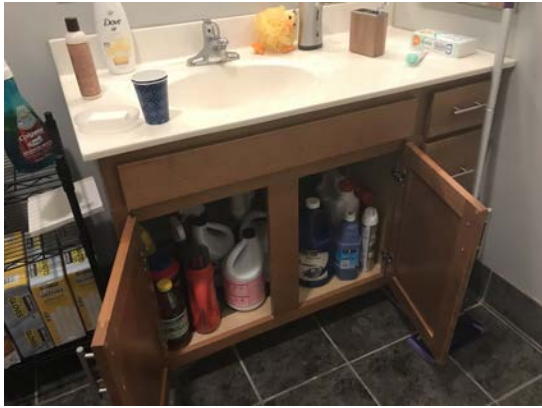
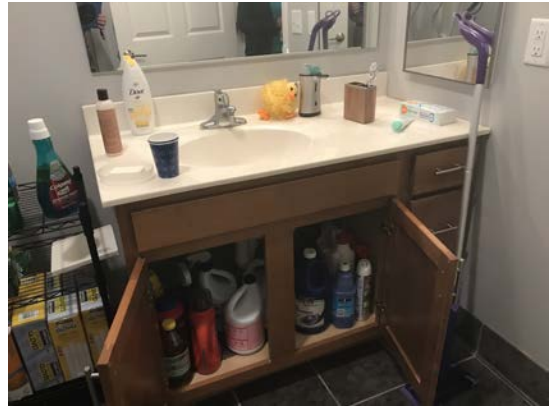
Assembly	Residential Dwelling
Type	Restroom/Bathroom-Lavatory
ADA Standard	UFAS 4.19.4
Barrier Detail	Lavatory hot water and drain pipes are not insulated.
Location Description	Unit 104, 106, 213
Observed	Jun 8, 2022 by bscott
Site Conditions	The pipes under the lavatory are not covered.

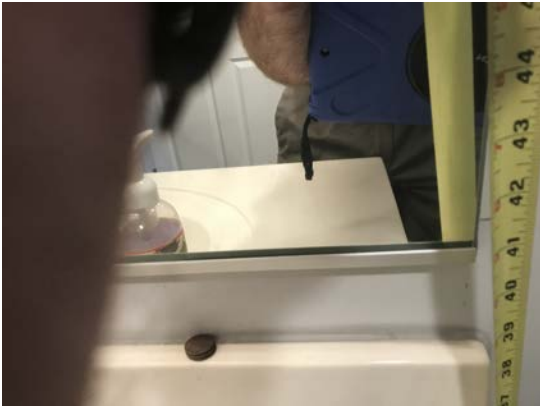
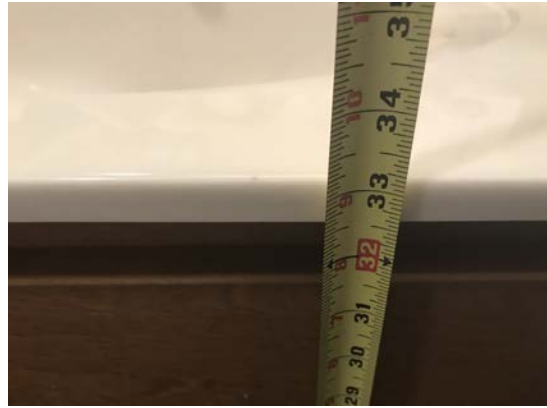
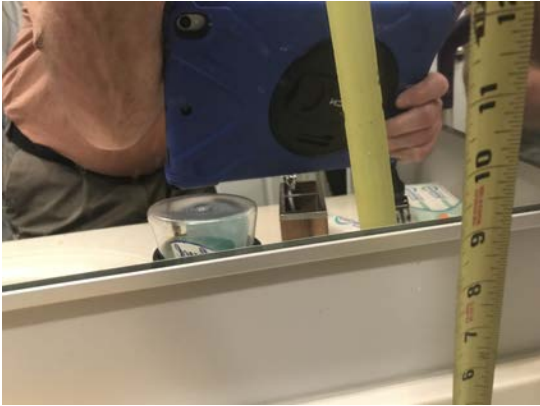
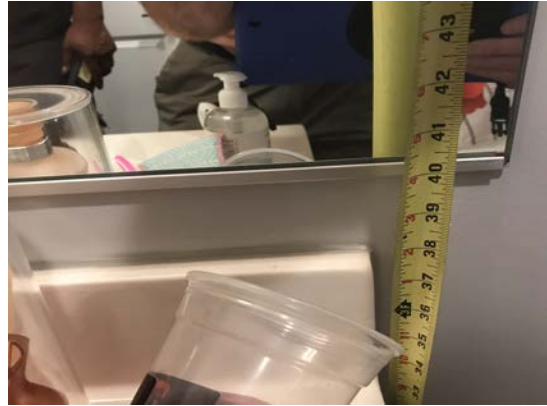
Location Description	Unit 104, 106, 213
Observed	Jun 8, 2022 by bscott
Site Conditions	The reflective surface of the mirror is 41" to 42" a.f.f

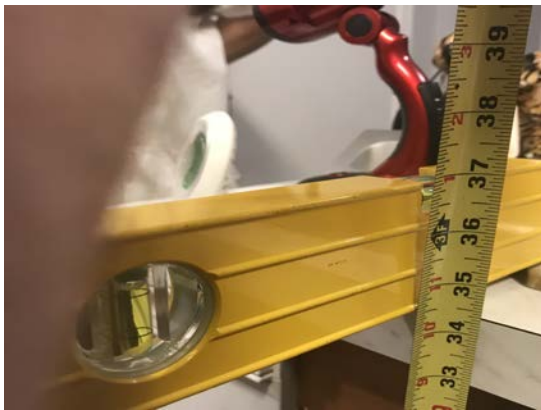
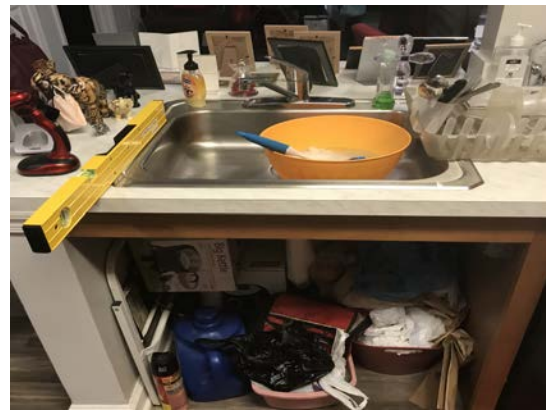
Photos for Barrier ID: AX310695

Assembly	Residential Dwelling
Type	Sink
ADA Standard	UFAS 4.34.6.5. (1)
Barrier Detail	The sink and/or surrounding counter are not compliant.
Location Description	Unit 106
Observed	Jun 8, 2022 by bscott
Site Conditions	The rim of the kitchen sink is 34-1/2" a.f.f.

The sink and surrounding counter shall be mounted at a maximum height of 34" above the floor, measured from the floor to the top of the counter surface, or shall be adjustable or replaceable as a unit to provide alternative heights of 28", 32", and 36", measured from the floor to the top of the counter surface or sink rim. The total width of sink and counter area shall be 30". Relocate sink to compliant height with knee and toe clearances. The sink and surrounding counter shall comply with the following requirements (see Fig. 51): (1) The sink and surrounding counter shall be mounted at a maximum height of 34" above the floor, measured from the floor to the top of the counter surface, or shall be adjustable or replaceable as a unit to provide alternative heights of 28", 32", and 36", measured from the floor to the top of the counter surface or sink rim. The total width of sink and counter area shall be 30". (2) Rough-in plumbing shall be located to accept connections of supply and drain pipes for sinks mounted at the height of 28". (3) The depth of a sink bowl shall be no greater than 6-1/2". Only one bowl of double- or triple-bowl sinks needs to meet this requirement. (4) Faucets shall be operable with one hand and shall not require tight grasping, pinching, or twisting of the wrist. Lever-operated or push-type mechanisms are two acceptable designs. The force required to activate controls shall be no greater than 5lbf. (5) Base cabinets, if provided, shall be removable under the full 30" minimum frontage of the sink and surrounding counter. The finished flooring shall extend under the counter to the wall. (6) Counter thickness and supporting structure shall be 2" maximum over the required clear space. (7) A clear floor space 30" by 48" shall allow forward approach to the sink. Nineteen inches maximum of the clear floor space may extend underneath the sink. The knee space shall have a clear width of 30" and a clear depth of 19". (8) There shall be no sharp or abrasive surfaces under sinks. Hot water and drain pipes under sinks shall be insulated or otherwise covered.

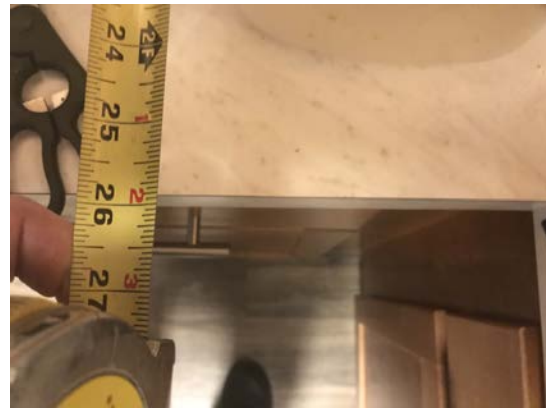
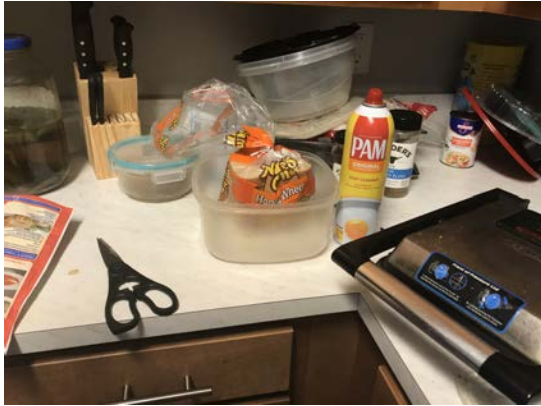
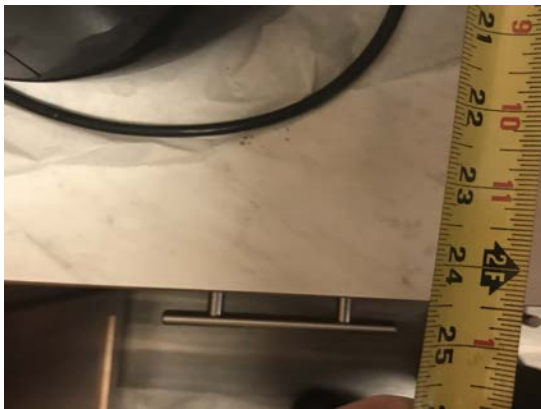
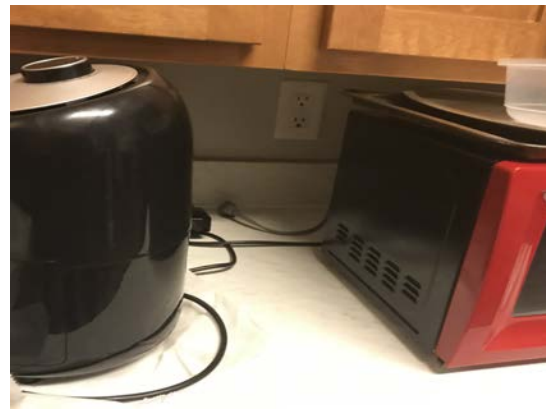
Assembly	Residential Dwelling
Type	Controls And Dispensers
ADA Standard	UFAS 4.2.5, 4.2.6, 4.27
Barrier Detail	The controls and operable parts are not within an allowable reach range.
Location Description	Unit 106, 213
Observed	Jun 8, 2022 by bscott

Provide controls and operable parts within an allowable reach range. A clear floor space 30" by 48" shall be provided that allows either a front approach or a parallel approach by a person using a wheelchair at controls, dispensers, receptacles, and other operable equipment. If the clear floor space only allows forward approach to an object, the maximum high forward reach allowed shall be 48" (see Figure 5(a)). The minimum low forward reach is 15". If the high forward reach is over an obstruction, where the horizontal obstruction is less than 20" the maximum high forward reach is 48". Where the horizontal obstruction is from 20" to maximum 25", the high forward reach shall be 44" maximum. Forward obstructed reaches shall comply with Figure 5(b). If the clear floor space allows parallel approach by a person in a wheelchair, the maximum high side reach allowed shall be 54", and the low side reach shall be no less than 9" above the floor (Figure 6(a) and (b)). If the side reach is over an obstruction, the maximum horizontal reach shall be 24" and the high side reach shall be 46" maximum. Side obstructed clearances shall be as shown in Figure 6(c). Those portions of heating, ventilating and air conditioning equipment requiring regular, periodic maintenance and adjustment by the resident of a dwelling shall be accessible people in wheelchairs. If air distribution registers must be placed in or close to ceiling for proper air circulation, this specification shall not apply to the registers.
