# ACCESSIBILITY ASSESSMENT

145366.21R000-003.160

## **ADA TITLE II ASSESSMENT**

Brinkley Hills  
6021 Thunder Hill Court  
Fort Washington, Maryland 20744

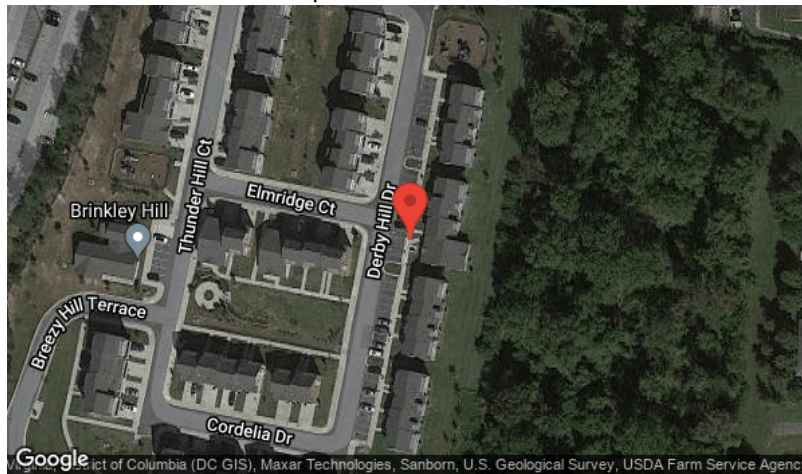
Map for Barrier ID: AX240383

Assembly	Accessible Parking
Type	Parking Space-Van
ADA Standard	UFAS 4.6.3
Barrier Detail	The slope of the parking space is greater than 1:50 (2%).
Location Description	Accessible Parking Space P1
Observed	May 19, 2021 by Ouraccessibleworld@gmail.com
Site Conditions	The accessible space has slope of up to 5.9%.

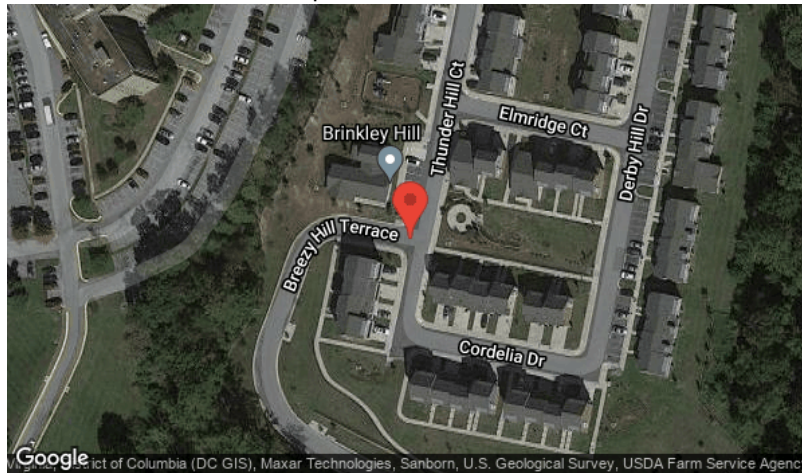
Map for Barrier ID: AX240352

Location Description	Curb Ramp 2 to Curb Ramp3
Observed	May 19, 2021 by Ouraccessibleworld@gmail.com
Site Conditions	A marked access route at the street crossing is not provided.

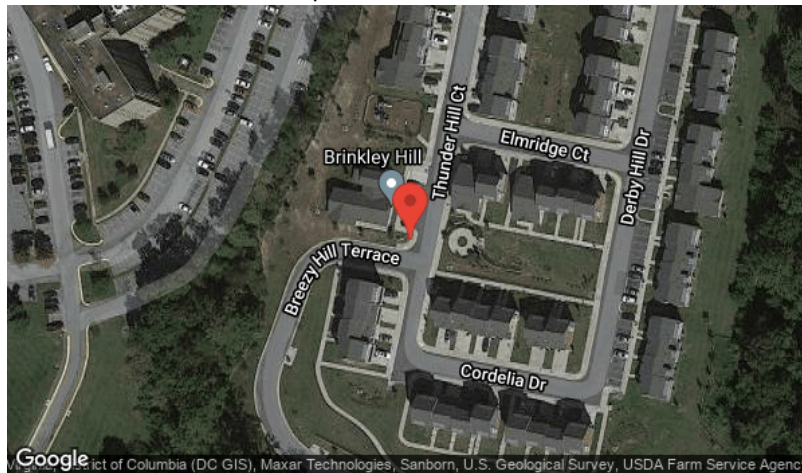
Map for Barrier ID: AX240360

Assembly	Exterior Access Route
Type	Exterior Accessible Route
ADA Standard	403.3
Barrier Detail	The accessible route has cross slopes greater than 1:50 (2%).
Location Description	Curb Ramp CR2 to Office
Observed	May 18, 2021 by Ouraccessibleworld@gmail.com

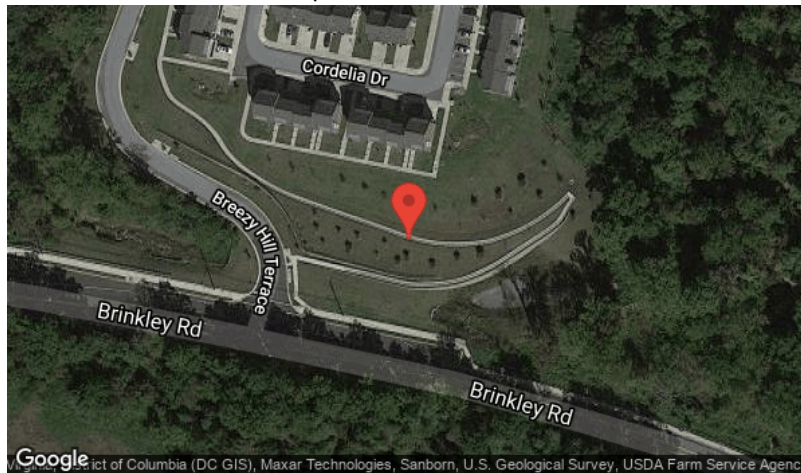
Map for Barrier ID: AX240356

<b>Assembly</b>	Exterior Access Route
<b>Type</b>	Exterior Accessible Route
<b>ADA Standard</b>	403.3
<b>Barrier Detail</b>	The accessible route has cross slopes greater than 1:50 (2%).
<b>Location Description</b>	PROW From Street to Leasing Office - East Side
<b>Observed</b>	May 18, 2021 by Ouraccessibleworld@gmail.com

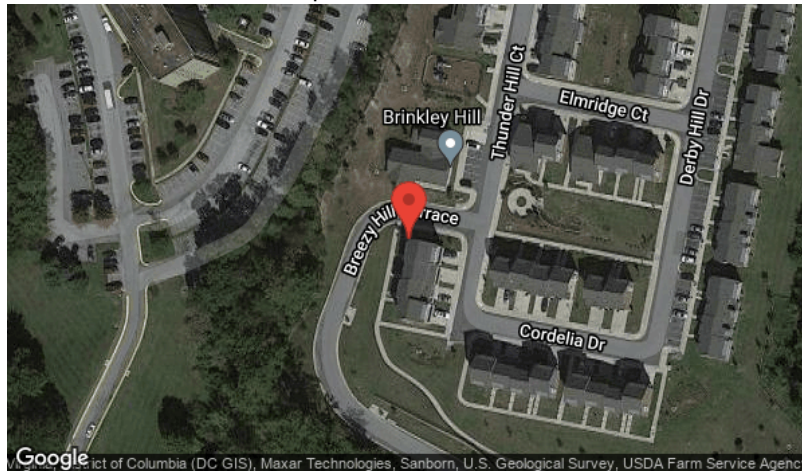
Map for Barrier ID: AX240357

<b>Assembly</b>	Exterior Access Route
<b>Type</b>	Ramp
<b>ADA Standard</b>	405.8 and 505
<b>Barrier Detail</b>	The ramp run has a rise greater than 6"; however, handrails are not provided.
<b>Location Description</b>	Ramp R2
<b>Observed</b>	May 18, 2021 by Ouraccessibleworld@gmail.com

Provide compliant handrails or provide ramp runs with maximum 6" rise. Handrails are required on ramp runs which rise more than 6". Replace with continuous handrails at a consistent height above the ramp on both sides of the ramp. Inside handrails on switchback or dogleg stairs and ramps shall be continuous between runs. Top of gripping surfaces of handrails shall be 34" minimum and 38" maximum vertically above ramp surfaces. Handrails shall be at a consistent height above ramp surfaces. Clearance between handrail gripping surfaces and adjacent surfaces shall be 1-1/2" minimum. Handrail gripping surfaces shall be continuous along their length and shall not be obstructed along their tops or sides. The bottoms of handrail gripping surfaces shall not be obstructed for more than 20% of their length. Where provided, horizontal projections shall occur 1-1/2" minimum below the bottom of the handrail gripping surface. [EXCEPTIONS: 1. Where handrails are provided along walking surfaces with slopes not steeper than 1:20, the bottoms of handrail gripping surfaces shall be permitted to be obstructed along their entire length where they are integral to crash rails or bumper guards. 2. The distance between horizontal projections and the bottom of the gripping surface shall be permitted to be reduced by 1/8" for each 1/2" of additional handrail perimeter dimension that exceeds 4".] Handrail gripping surfaces with a circular cross section shall have an outside diameter of 1-1/4" minimum and 2" maximum. Handrail gripping surfaces with a non-circular cross section shall have a perimeter dimension of 4" minimum and 6-1/4" maximum, and a cross-section dimension of 2-1/4" maximum. Handrail gripping surfaces and any surfaces adjacent to them shall be free of sharp or abrasive elements and shall have rounded edges. Handrails shall not rotate within their fittings. Handrail gripping surfaces shall extend beyond and in the same direction of ramp runs. [EXCEPTIONS: 1. Extensions shall not be required for continuous handrails at the inside turn of switchback or dogleg ramps AND 3. In alterations, full extensions of handrails shall not be required where such extensions would be hazardous due to plan configuration.] Ramp handrails shall extend horizontally above the landing for 12" minimum beyond the top and bottom of ramp runs. Extensions shall return to a wall, guard, or the landing surface, or shall be continuous to the handrail of an adjacent ramp run.

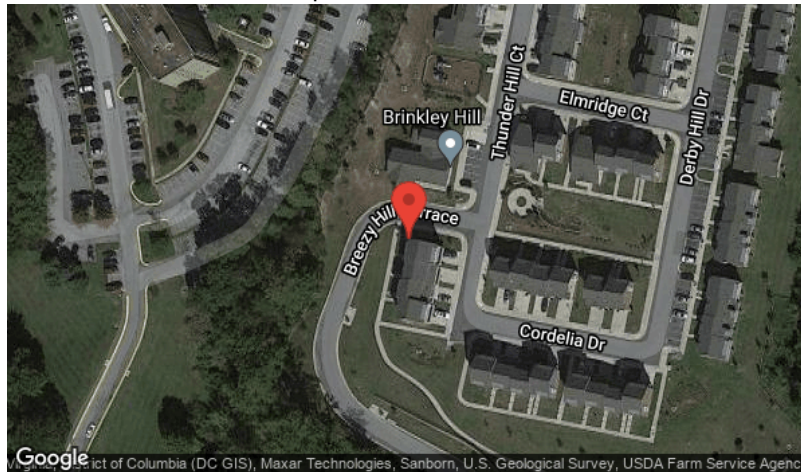
Map for Barrier ID: AX240462

Assembly	Exterior Access Route
Type	Ramp
ADA Standard	405.2

Location Description	Ramp R2
Observed	May 18, 2021 by Ouraccessibleworld@gmail.com

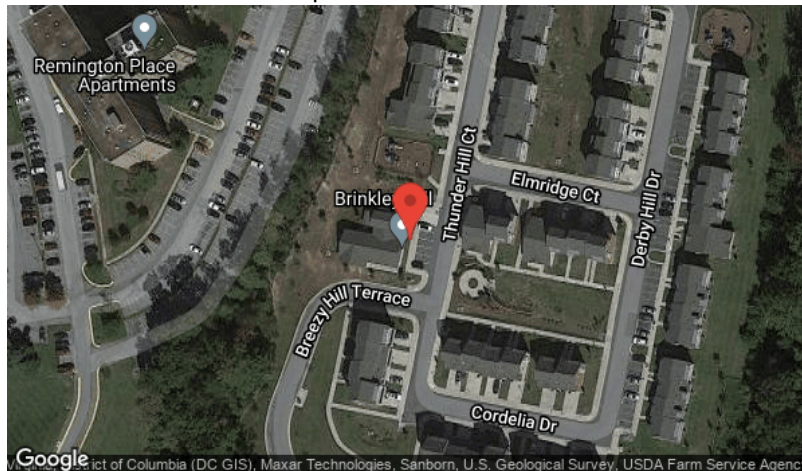
Map for Barrier ID: AX240361

<b>Assembly</b>	Exterior Access Route
<b>Type</b>	Ramp
<b>ADA Standard</b>	405.8 and 505
<b>Barrier Detail</b>	The ramp run has a rise greater than 6"; however, handrails are not provided.
<b>Location Description</b>	Ramp R3
<b>Observed</b>	May 18, 2021 by Ouraccessibleworld@gmail.com

Provide compliant handrails or provide ramp runs with maximum 6" rise. Handrails are required on ramp runs which rise more than 6". Replace with continuous handrails at a consistent height above the ramp on both sides of the ramp. Inside handrails on switchback or dogleg stairs and ramps shall be continuous between runs. Top of gripping surfaces of handrails shall be 34" minimum and 38" maximum vertically above ramp surfaces. Handrails shall be at a consistent height above ramp surfaces. Clearance between handrail gripping surfaces and adjacent surfaces shall be 1-1/2" minimum. Handrail gripping surfaces shall be continuous along their length and shall not be obstructed along their tops or sides. The bottoms of handrail gripping surfaces shall not be obstructed for more than 20% of their length. Where provided, horizontal projections shall occur 1-1/2" minimum below the bottom of the handrail gripping surface. [EXCEPTIONS: 1. Where handrails are provided along walking surfaces with slopes not steeper than 1:20, the bottoms of handrail gripping surfaces shall be permitted to be obstructed along their entire length where they are integral to crash rails or bumper guards. 2. The distance between horizontal projections and the bottom of the gripping surface shall be permitted to be reduced by 1/8" for each 1/2" of additional handrail perimeter dimension that exceeds 4".] Handrail gripping surfaces with a circular cross section shall have an outside diameter of 1-1/4" minimum and 2" maximum. Handrail gripping surfaces with a non-circular cross section shall have a perimeter dimension of 4" minimum and 6-1/4" maximum, and a cross-section dimension of 2-1/4" maximum. Handrail gripping surfaces and any surfaces adjacent to them shall be free of sharp or abrasive elements and shall have rounded edges. Handrails shall not rotate within their fittings. Handrail gripping surfaces shall extend beyond and in the same direction of ramp runs. [EXCEPTIONS: 1. Extensions shall not be required for continuous handrails at the inside turn of switchback or dogleg ramps AND 3. In alterations, full extensions of handrails shall not be required where such extensions would be hazardous due to plan configuration.] Ramp handrails shall extend horizontally above the landing for 12" minimum beyond the top and bottom of ramp runs. Extensions shall return to a wall, guard, or the landing surface, or shall be continuous to the handrail of an adjacent ramp run.

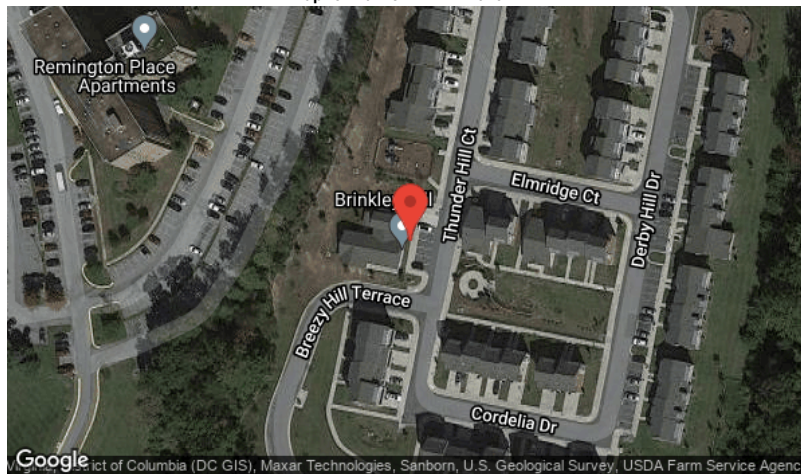
Map for Barrier ID: AX240464

Location Description	Ramp R3
Observed	May 18, 2021 by Ouraccessibleworld@gmail.com

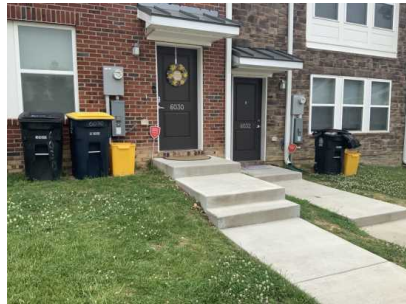
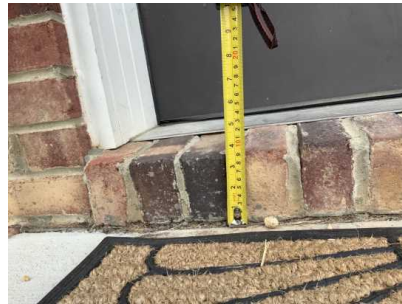
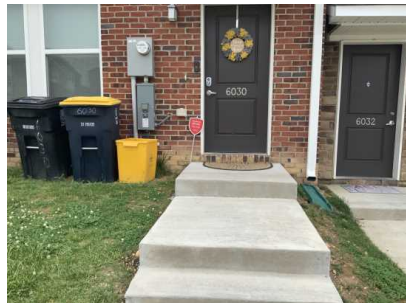
### Photos for Barrier ID: AX240377

<b>Assembly</b>	Entrance to Building
<b>Type</b>	Building Entrance-Door
<b>ADA Standard</b>	UFAS 4.1 4.3.2; 4.14
<b>Barrier Detail</b>	An accessible entrance is not provided to the facility.
<b>Location Description</b>	Entrances - Unit 6026, 6028 and 6030
<b>Observed</b>	May 18, 2021 by Ouraccessibleworld@gmail.com

Provide at least one accessible entrance on an accessible route. Entrances shall be provided as necessary to achieve access to and egress from buildings and facilities. [EXCEPTION: In projects consisting of one-to-four family dwellings where accessible entrances would be extraordinarily costly due to site conditions or local code restrictions, accessible entrances are required only to those buildings containing accessible dwelling units.] Entrances required to be accessible shall be part of an accessible route. Such entrances shall be connected by an accessible route to public transportation stops, to accessible parking and passenger loading zones, and to public streets or sidewalks if available. They shall also be connected by an accessible route to all accessible spaces or elements within the building or facility. A service entrance shall not be the sole accessible entrance, unless it is the only entrance to a building or facility (for example, in a factory or garage).

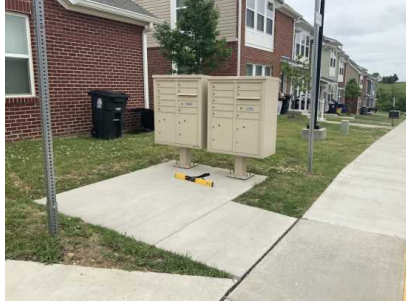
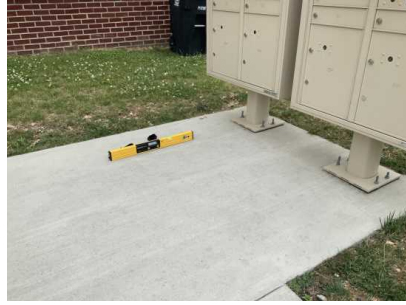
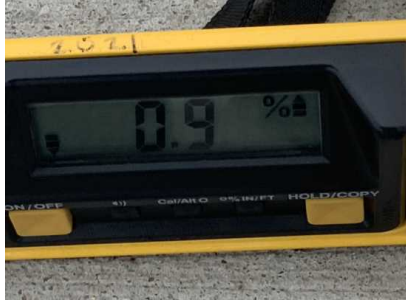
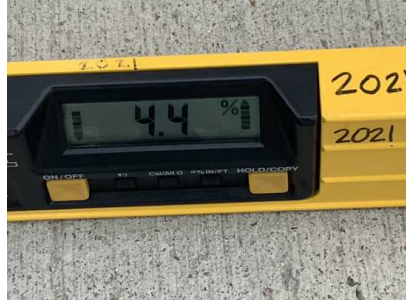
Map for Barrier ID: AX240385

<b>Assembly</b>	Exterior Access Route
<b>Type</b>	Exterior Accessible Route
<b>ADA Standard</b>	305, 309
<b>Barrier Detail</b>	Clear ground space is not provided at the operable part.
<b>Location Description</b>	Mailboxes for Units
<b>Observed</b>	May 19, 2021 by Ouraccessibleworld@gmail.com
<b>Site Conditions</b>	The clear space at the mailboxes has a slope of up to 4.4%.

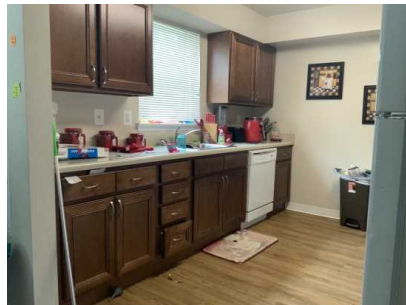
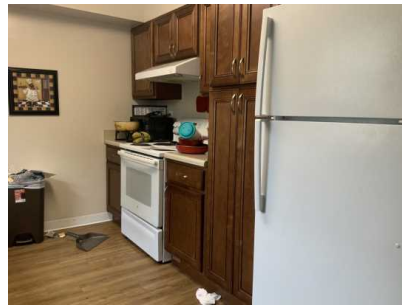
<b>Location Description</b>	Unit 6026, 6028, 6030
<b>Observed</b>	May 19, 2021 by Ouraccessibleworld@gmail.com
<b>Site Conditions</b>	The bottom shelf at the upper cabinets at the kitchen are 54" above the floor.

Configure the shelving to provide at least one accessible shelf in each cabinet, shelf area and drawers. Cabinets, drawers, and shelf areas shall comply. Provide clear floor space at least 30" by 48" that allows either a forward or a parallel approach. Cabinets shall have the following features: (1) Maximum height shall be 48" for at least one shelf of all cabinets and storage shelves mounted above work counters (see Fig. 50). (2) Door pulls or handles for wall cabinets shall be mounted as close to the bottom of cabinet doors as possible. Door pulls or handles for base cabinets shall be mounted as close to the top of cabinet doors as possible. Shelving shall be located no higher than 48" for an unobstructed side approach or 48" for an unobstructed frontal only approach. If the clear floor space only allows forward approach to an object, the maximum high forward reach allowed shall be 48" (see Figure 5(a)). The minimum low forward reach is 15". If the high forward reach is over an obstruction, where the horizontal obstruction is less than 20" the maximum high forward reach is 48". Where the horizontal obstruction is from 20" to maximum 25", the high forward reach shall be 44" maximum. Forward obstructed reaches shall comply with Figure 5(b). If the clear floor space allows parallel approach by a person in a wheelchair, the maximum high side reach allowed shall be 54", and the low side reach shall be no less than 9" above the floor (Figure 6(a) and (b)). If the side reach is over an obstruction, the maximum horizontal reach shall be 24" and the high side reach shall be 46" maximum. Side obstructed clearances shall be as shown in Figure 6(c).

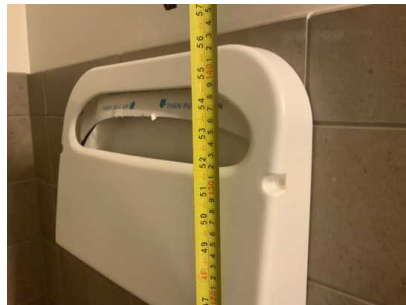
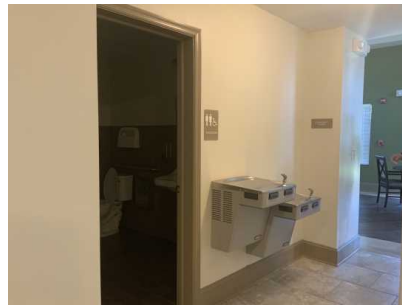
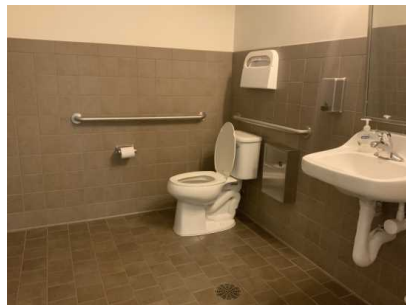
**Photos for Barrier ID: AX240340**

<b>Assembly</b>	Restroom
<b>Type</b>	Controls And Dispensers
<b>ADA Standard</b>	606.1; 309.3
<b>Barrier Detail</b>	The height of controls are not compliant.
<b>Location Description</b>	Common Area Restroom
<b>Observed</b>	May 19, 2021 by Ouraccessibleworld@gmail.com
<b>Site Conditions</b>	The seat cover dispenser is mounted at 52" above the floor.

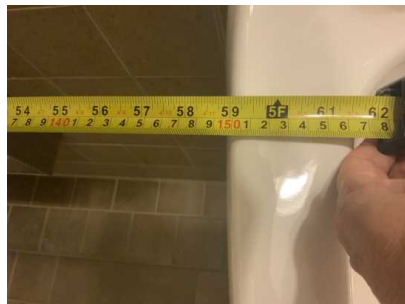
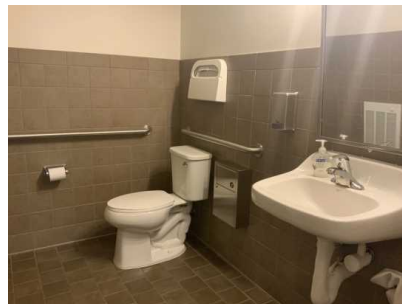
**Photos for Barrier ID: AX240341**

<b>Assembly</b>	Restroom
<b>Type</b>	Restroom/Bathroom-Water Closet
<b>ADA Standard</b>	604

<b>Location Description</b>	Common Area Restroom
<b>Observed</b>	May 19, 2021 by Ouraccessibleworld@gmail.com

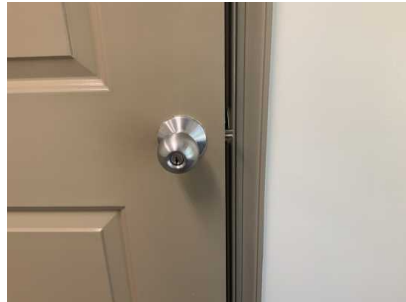
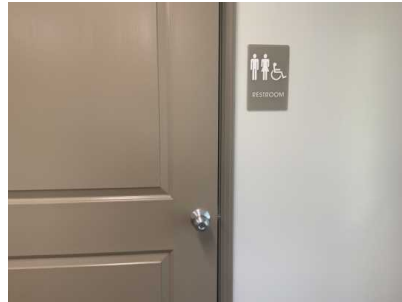
### Photos for Barrier ID: AX240343

<b>Location Description</b>	Laundry Restroom
<b>Observed</b>	May 19, 2021 by Ouraccessibleworld@gmail.com

Remove hardware and replace with hardware that has a shape that is easy to grasp such as lever, push-type or U-shaped handles. Handles, pulls, latches, locks, and other operating devices on accessible doors shall have a shape that is easy to grasp with one hand and does not require tight grasping, tight pinching, or twisting of the wrist to operate. Lever-operated mechanisms, push-type mechanisms, and U-shaped handles are acceptable designs. When sliding doors are fully open, operating hardware shall be exposed and usable from both sides. In dwelling units, only doors at accessible entrances to the unit itself shall comply. Mount hardware required for accessible door passage no higher than 48" above finished floor. Doors to hazardous areas shall have hardware complying with the following: Doors that lead to areas that might prove dangerous to a blind person (for example, doors to loading platforms, boiler rooms, stages, and the like) shall be made identifiable to the touch by a textured surface on the door handle, knob, pull or other operating hardware. This textured surface may be made by knurling or roughing or by a material applied to the contact surface. Such textured surfaces shall not be provided for emergency exit doors or any doors other than those to hazardous areas.

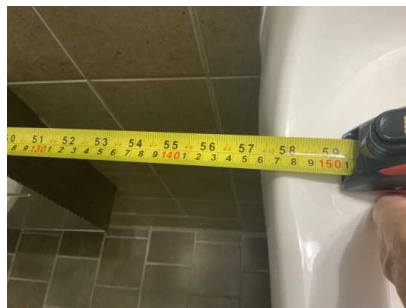
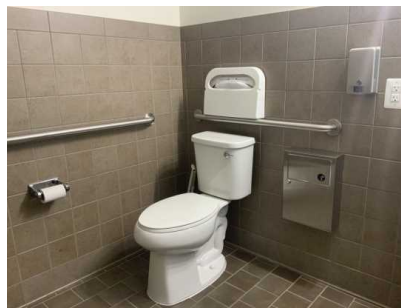
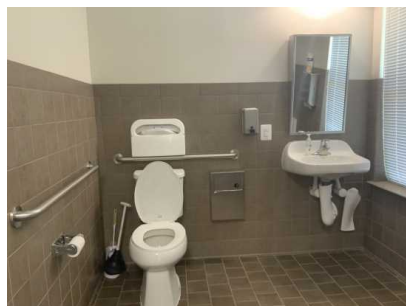
**Photos for Barrier ID: AX240350**

<b>Assembly</b>	Restroom
<b>Type</b>	Restroom/Bathroom-Water Closet
<b>ADA Standard</b>	604

<b>Location Description</b>	Laundry Restroom
<b>Observed</b>	May 19, 2021 by Ouraccessibleworld@gmail.com

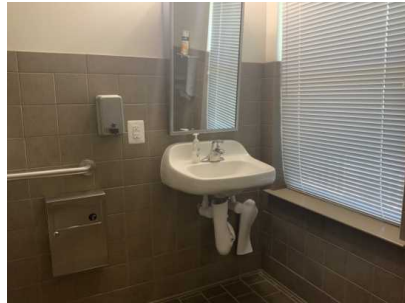
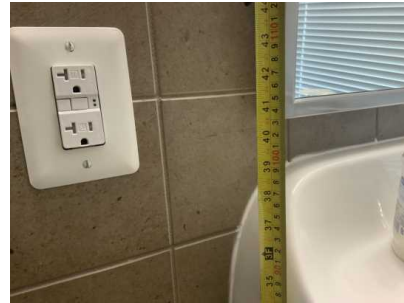
**Photos for Barrier ID: AX240351**

<b>Assembly</b>	Restroom
<b>Type</b>	Restroom/Bathroom-Mirror
<b>ADA Standard</b>	213.3.5; 603.3

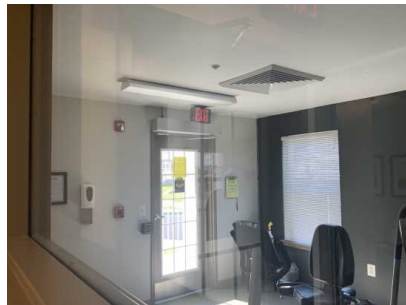
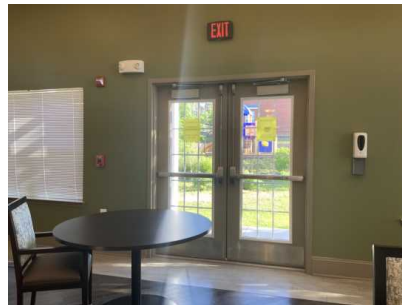
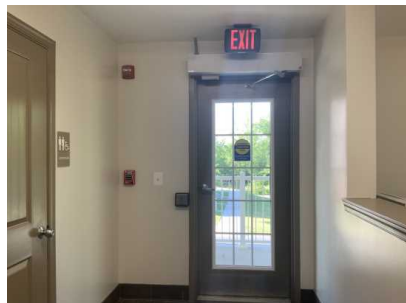
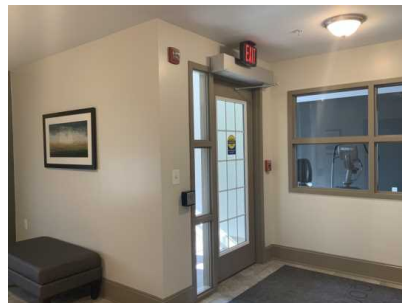
### Photos for Barrier ID: AX240344

<b>Assembly</b>	Interior Access Route
<b>Type</b>	Signage
<b>ADA Standard</b>	216.4, 703.1, 703.4
<b>Barrier Detail</b>	Means of egress signage is not provided.
<b>Location Description</b>	Office
<b>Observed</b>	May 19, 2021 by Ouraccessibleworld@gmail.com

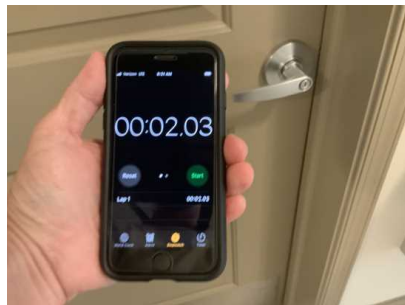
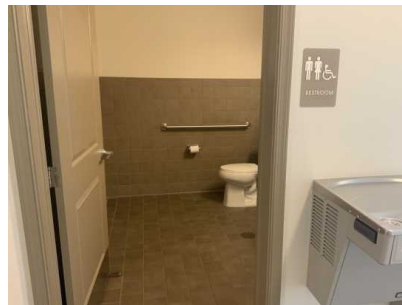
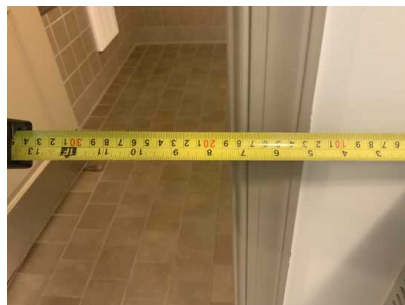
**Photos for Barrier ID: AX240346**

<b>Location Description</b>	Office Restroom
<b>Observed</b>	May 19, 2021 by Ouraccessibleworld@gmail.com

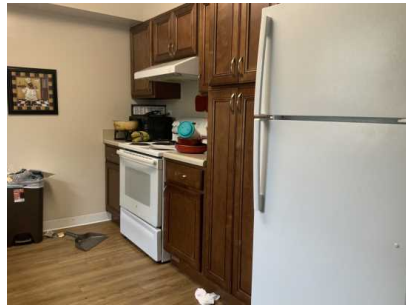
<b>Assembly</b>	Residential Dwelling
<b>Type</b>	Kitchen-General
<b>ADA Standard</b>	UFAS 4.34.6.4
<b>Barrier Detail</b>	A compliant work surface is not provided in the kitchen.
<b>Location Description</b>	Unit 6026, 6028, 6030
<b>Observed</b>	May 18, 2021 by Ouraccessibleworld@gmail.com

Install at least one compliant work surface. At least one 30" section of counter shall provide a work surface that complies with the following requirements (see Figure 50): (1) The counter shall be mounted at a maximum height of 34" above the floor, measured from the floor to the top of the counter surface, or shall be adjustable or replaceable as a unit to provide alternative heights of 28", 32", and 36", measured from the top of the counter surface. (2) Base cabinets, if provided, shall be removable under the full 30" minimum frontage of the counter. The finished floor shall extend under the counter to the wall. (3) Counter thickness and supporting structure shall be 2" maximum over the required clear area. (4) A clear floor space 30" by 48" shall allow a forward approach to the counter. 19" maximum of the clear floor space may extend underneath the counter. The knee space shall have a minimum clear width of 30" and a minimum clear depth of 19". (5) There shall be no sharp or abrasive surfaces under such counters. .

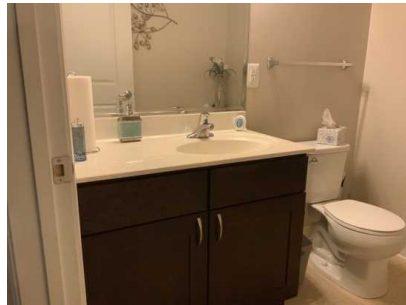
<b>Assembly</b>	Residential Dwelling
<b>Type</b>	Restroom/Bathroom-Water Closet
<b>ADA Standard</b>	UFAS 4.34.5.2 (3)
<b>Barrier Detail</b>	Grab bars are not provided at the water closet.
<b>Location Description</b>	Unit 6026, 6028, 6030
<b>Observed</b>	May 18, 2021 by Ouraccessibleworld@gmail.com
<b>Site Conditions</b>	Grab bars are not provided at the water closet.

Install compliant grab bars. The side grab bar shall be at least 42" in length. The side grab bar shall be mounted to the side of the water closet 12" maximum from the back wall, and shall extend a minimum of 54" from the back wall. Install a compliant rear grab bar that is at least 36" long, with one end mounted a minimum of 12" from the centerline of the water closet in each direction. Horizontal grab bars shall be installed at a height between 33" and 36" above the finish floor. Grab bars for water closets not located in stalls shall comply with Figure 29. Grab bars for water closets located in toilet stalls shall comply with the length and positioning shown in Figures 30(a), (b), (c), and (d). Grab bars shall have a diameter or width of the gripping surface between 1- $\frac{1}{4}$ " to 1- $\frac{1}{2}$ " or a shape which provides an equivalent gripping surface. The space between the wall and the grab bar shall be 1- $\frac{1}{2}$ ". Handrails may be located in a recess if the recess is a maximum of 3" deep and extends at least 18" above the top of the rail. The structural strength of grab bars shall meet the following specification: (1) Bending stress in a grab bar or seat induced by the maximum bending moment from the application of 250 lbf (1112N) shall be less than the allowable stress for the material of the grab bar or seat. (2) Shear stress induced in a grab bar or seat by the application of 250 lbf (1112N) shall be less than the allowable shear stress for the material of the grab bar or seat. If the connection between the grab bar or seat and its mounting bracket or other support is considered to be fully restrained, then direct and torsional shear stresses shall be totaled for the combined shear stress, which shall not exceed the allowable shear stress. (3) Shear force induced in a fastener or mounting device from the application of 250 lbf (1112N) shall be less than the allowable lateral load of either the fastener or mounting device or the supporting structure, whichever is the smaller allowable load. (4) Tensile force induced in a fastener by a direct tension force of 250 lbf (1112N) plus the maximum moment from the application of 250 lbf (1112N) shall be less than the allowable withdrawal and the supporting structure. (5) Grab bars shall not rotate within their fittings.

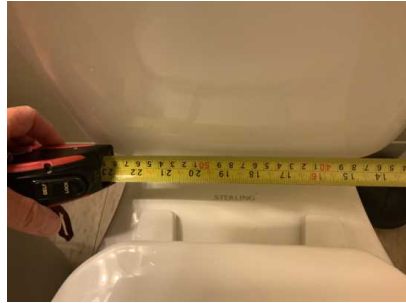
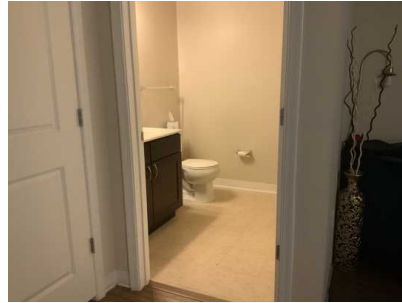
<b>Assembly</b>	Residential Dwelling
<b>Type</b>	Restroom/Bathroom-Water Closet
<b>ADA Standard</b>	UFAS 4.16.2, Fig. 28, 4.34.5.2(1); Fig. 47(a)
<b>Barrier Detail</b>	The centerline of the water closet is not exactly 18" from the side wall.
<b>Location Description</b>	Unit 6026, 6028, 6030
<b>Observed</b>	May 18, 2021 by Ouraccessibleworld@gmail.com
<b>Site Conditions</b>	The centerline of the water closet is mounted 18-3/4" from the side wall.

Relocate the centerline of the water closet so that it is exactly 18" from the side wall. Clear floor space at the water closet shall be as shown in Figure 28, and Figure 47(a) for adaptable units. The water closet may be located with the clear area at either the right or left side of the toilet.

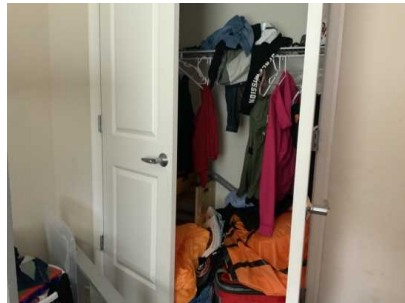
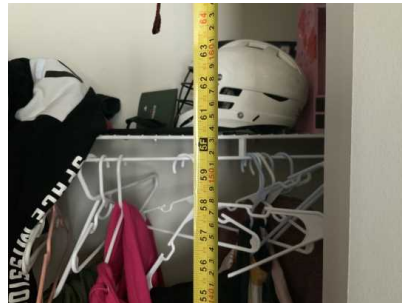
### Photos for Barrier ID: AX240370

<b>Assembly</b>	Residential Dwelling
<b>Type</b>	Reach Range
<b>ADA Standard</b>	UFAS 4.25.3
<b>Barrier Detail</b>	The clothes rod is mounted higher than 54".
<b>Location Description</b>	Unit 6026, 6028, 6030
<b>Observed</b>	May 19, 2021 by Ouraccessibleworld@gmail.com
<b>Site Conditions</b>	The closet rods and shelves are mounted up to 60" above the floor.
