ACCESSIBILITY ASSESSMENT

ADA TITLE II ASSESSMENT

Central Gardens
6804 Central Avenue
Pepper Mill Village, Maryland 20743

145366.21R000-008.160

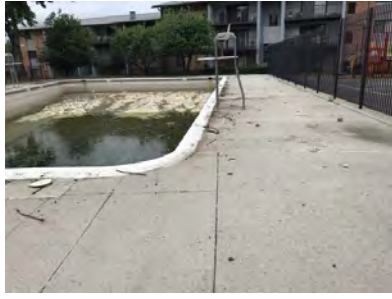
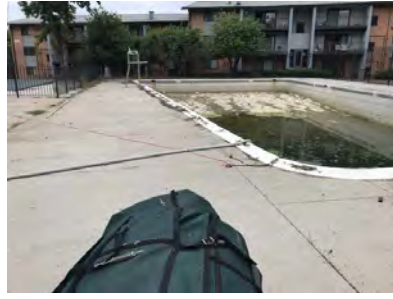
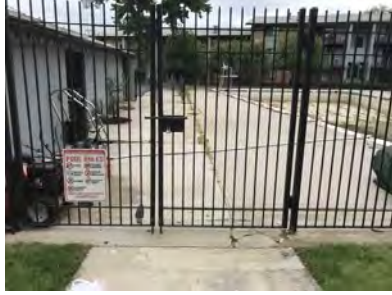
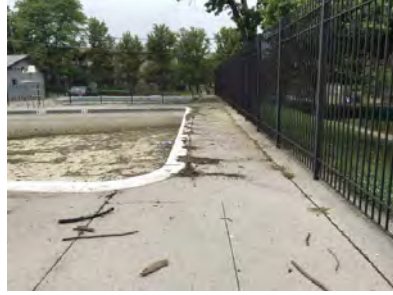
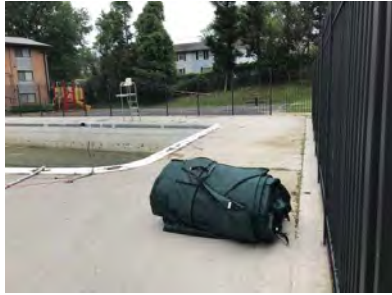
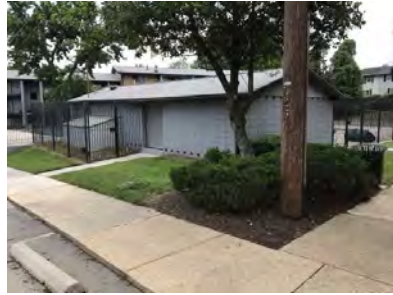
Assembly	Amenity Not Evaluated
Type	Amenity Not Evaluated
ADA Standard	None
Barrier Detail	The amenity cannot be accessed and, therefore, cannot be evaluated.
Location Description	Adult Pool
Observed	May 28, 2021 by Lloyd.fojas@bureauveritas.com

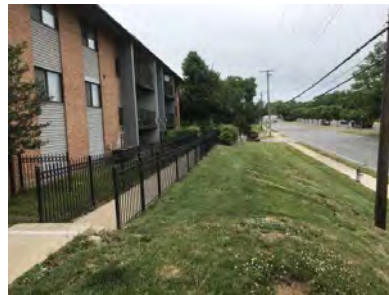
Photos for Barrier ID: AX240214

Assembly	Amenity Not Evaluated	
Type	Amenity Not Evaluated	
ADA Standard	None	
Barrier Detail	The amenity is not a part of the accessible route and was not evaluated.	
Location Description	Building 6800	
Observed	May 28, 2021 by Lloyd.fojas@bureauveritas.com	
Site Conditions	The stairs are not a part of the accessible route to the building and were not evaluated.	
Resolution	The amenity is not a part of the accessible route and was not evaluated.	
Quantity	Unit Cost	Total Cost
1 EA	0	\$ 0
Priority	0

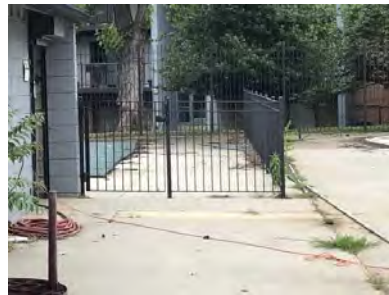
Photos for Barrier ID: AX239665

Assembly	Amenity Not Evaluated
Type	Amenity Not Evaluated
ADA Standard	None
Barrier Detail	The amenity cannot be accessed and, therefore, cannot be evaluated.
Location Description	Children's Pool
Observed	May 28, 2021 by Lloyd.fojas@bureauveritas.com

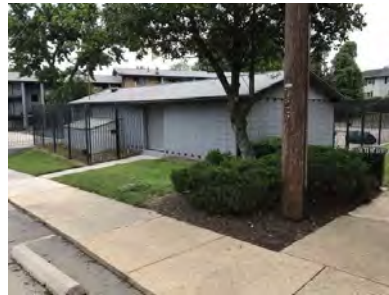
Photos for Barrier ID: AX240309

Assembly	Amenity Not Evaluated
Type	Amenity Not Evaluated
ADA Standard	None
Barrier Detail	The amenity cannot be accessed and, therefore, cannot be evaluated.
Location Description	Pool House
Observed	May 28, 2021 by Lloyd.fojas@bureauveritas.com
Site Conditions	The pool house was locked with no access, therefore it was not evaluated.

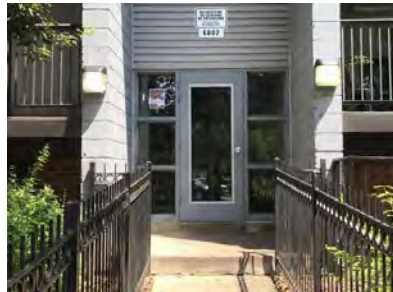
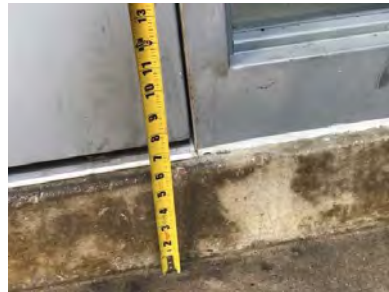
Photos for Barrier ID: AX239669

Assembly	Entrance to Building
Type	Building Entrance-Door
ADA Standard	305.2; 404.2
Barrier Detail	The maneuvering clearance at the accessible door is not level and clear.
Location Description	6802-Building Entrance Door
Observed	May 28, 2021 by Lloyd.fojas@bureauveritas.com

Remove and replace the surface within the required maneuvering clearance area so that the surface is level and clear with maximum slope 1:48 (2.08%) in any direction. The required depth of the maneuvering clearance is 60" minimum. The required side clearance is 18" minimum on the latch side of the door. Maneuvering clearance shall extend the full width of the doorway and the required latch side clearance. Floor or ground space within the required maneuvering clearance shall be maximum 1:48 (2.08%) slope. Changes in level are not permitted.

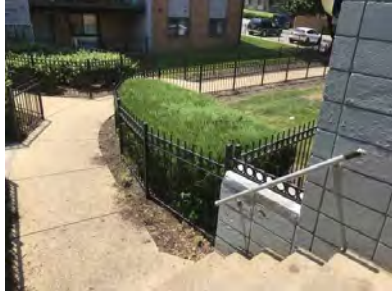
Assembly	Entrance to Building
Type	Building Entrance-Door
ADA Standard	305.2; 404.2
Barrier Detail	The maneuvering clearance at the accessible door is not level and clear.
Location Description	6806-Building Entrance Door
Observed	May 28, 2021 by Lloyd.fojas@bureauveritas.com

Remove and replace the surface within the required maneuvering clearance area so that the surface is level and clear with maximum slope 1:48 (2.08%) in any direction. The required depth of the maneuvering clearance is 60" minimum. The required side clearance is 18" minimum on the latch side of the door. Maneuvering clearance shall extend the full width of the doorway and the required latch side clearance. Floor or ground space within the required maneuvering clearance shall be maximum 1:48 (2.08%) slope. Changes in level are not permitted.

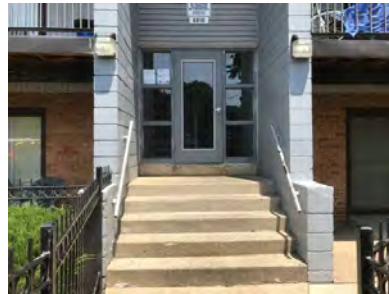
Photos for Barrier ID: AX239674

Assembly	Entrance to Building
Type	Building Entrance-Door
ADA Standard	305.2; 404.2
Barrier Detail	The maneuvering clearance at the accessible door is not level and clear.
Location Description	6810-Building Entrance Door
Observed	May 28, 2021 by Lloyd.fojas@bureauveritas.com

Remove and replace the surface within the required maneuvering clearance area so that the surface is level and clear with maximum slope 1:48 (2.08%) in any direction. The required depth of the maneuvering clearance is "X" minimum. The required side clearance is "Y" minimum on the latch/hinge side of the door. Maneuvering clearance shall extend the full width of the doorway and the required latch side or hinge side clearance. Floor or ground space within the required maneuvering clearance shall be maximum 1:48 (2.08%) slope. Changes in level are not permitted.

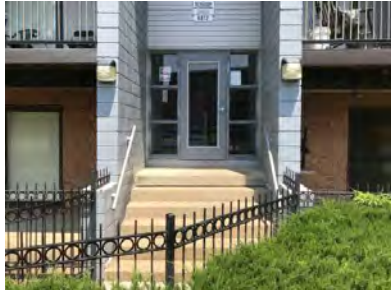
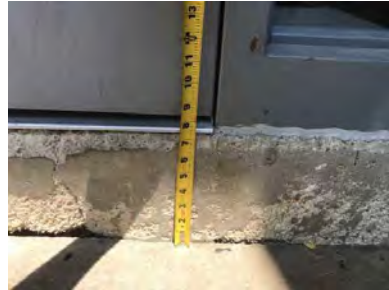
Photos for Barrier ID: AX240224

Assembly	Entrance to Building
Type	Building Entrance-Door
ADA Standard	305.2; 404.2
Barrier Detail	The maneuvering clearance at the accessible door is not level and clear.
Location Description	6812-Building Entrance Door
Observed	May 28, 2021 by Lloyd.fojas@bureauveritas.com

Remove and replace the surface within the required maneuvering clearance area so that the surface is level and clear with maximum slope 1:48 (2.08%) in any direction. The required depth of the maneuvering clearance is 60" minimum. The required side clearance is 18" minimum on the latch side of the door. Maneuvering clearance shall extend the full width of the doorway and the required latch side clearance. Floor or ground space within the required maneuvering clearance shall be maximum 1:48 (2.08%) slope. Changes in level are not permitted.

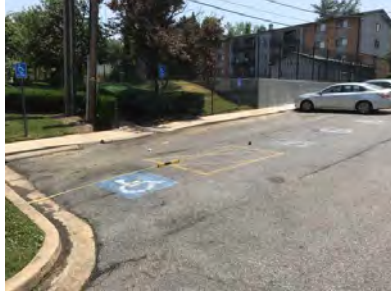
Photos for Barrier ID: AX240322

Assembly	Accessible Parking
Type	Parking Space-Car
ADA Standard	502.1, 502.2
Barrier Detail	Accessible car aisle markings do not define the aisle width.
Location Description	Access Aisle at Accessible Parking Space P1-G and P1-H
Observed	May 28, 2021 by Lloyd.fojas@bureauveritas.com
Site Conditions	The access aisle markings are faded.

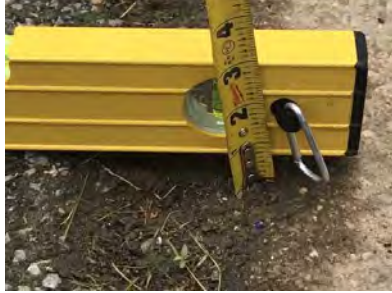
Assembly	Exterior Access Route
Type	Parking Space-Van
ADA Standard	502.4, State of MD 05.07.C (2)(d)
Barrier Detail	MARYLAND: The access aisle slope is greater than 1:50 (2%).
Location Description	Access Aisle at Accessible Parking Space P1-I
Observed	May 28, 2021 by Lloyd.fojas@bureauveritas.com

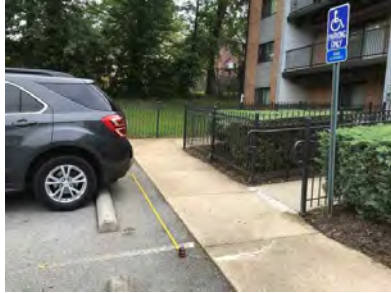
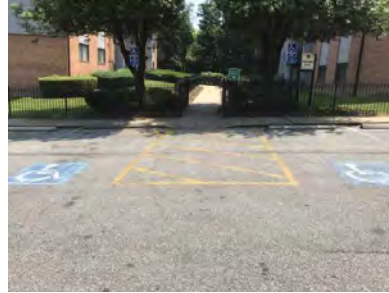
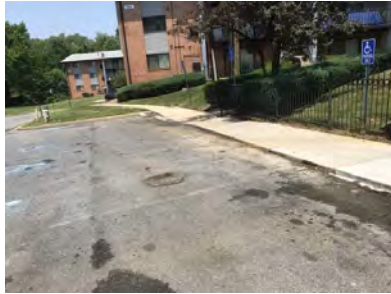
Photos for Barrier ID: AX240320

Assembly	Accessible Parking
Type	Parking Space-Van
ADA Standard	502.1, 502.3
Barrier Detail	Accessible van aisle markings do not define the aisle width.
Location Description	Access Aisle at Accessible Parking Spaces P1-A, P-1 B, P1-E and P1-I
Observed	May 28, 2021 by Lloyd.fojas@bureauveritas.com
Site Conditions	The van access aisle markings are faded.

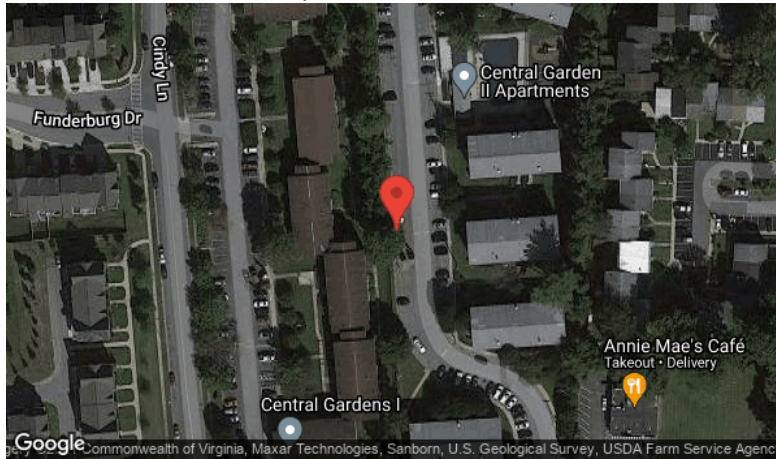
Map for Barrier ID: AX239619

Assembly	Accessible Parking
Type	Parking Space-Van
ADA Standard	502.4
Barrier Detail	The parking space slope is greater than 1:50 (2%).
Location Description	Accessible Parking Space P1-A and P1-B
Observed	May 28, 2021 by Lloyd.fojas@bureauveritas.com

Remove and replace with a van space which has a slope of maximum 1:50 (2%) in all directions. [EXCEPTION: Slopes not steeper than 1:48 (2.08%) shall be permitted.] Changes in level are not permitted. Parking spaces and access aisles serving them shall be compliant. Width measurements shall be made from the centerline of the markings. [EXCEPTION: Where parking spaces or access aisles are not adjacent to another parking space or access aisle, measurements shall be permitted to include the full width of the line defining the parking space or access aisle.] The quantity and order of magnitude cost estimate provided for this barrier are limited to the extent of the area identified as non-compliant. Additional costs that may be associated with removal of the barrier are not included.

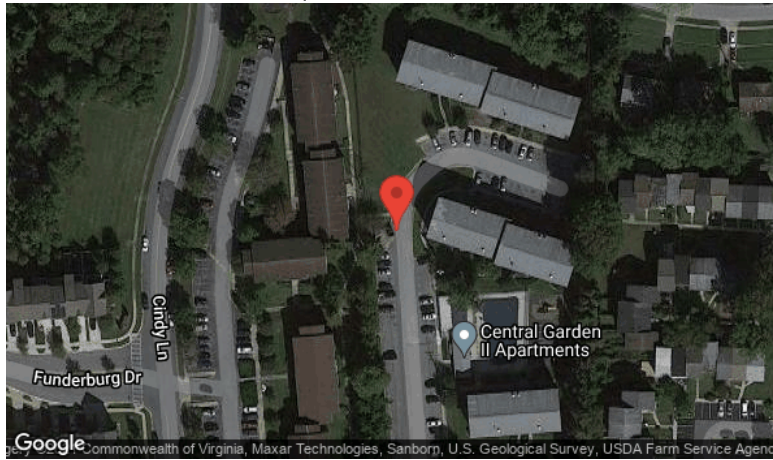
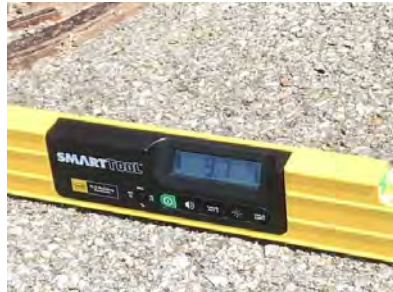
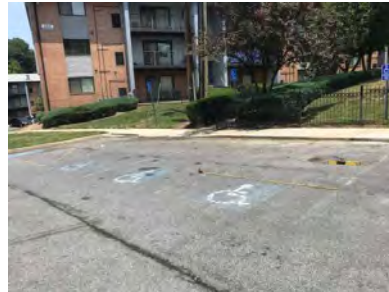
Photos for Barrier ID: AX239626

Assembly	Accessible Parking
Type	Parking Space-Car
ADA Standard	502.4
Barrier Detail	The slope of the parking space is greater than 1:50 (2%).
Location Description	Accessible Parking Space P1-C
Observed	May 28, 2021 by Lloyd.fojas@bureauveritas.com
Site Conditions	The accessible parking space has a cross slope of 9.7%

Remove and replace with a parking space that has no more than 1:50 (2%) slope in all directions. [EXCEPTION: Slopes not steeper than 1:48 (2.08%) shall be permitted.] Changes in level are not permitted. Parking spaces and access aisles shall be level with surface slopes not exceeding 1:50 in all directions. Parking spaces and access aisles serving them shall be compliant. Access aisles shall be at the same level as the parking spaces they serve. The quantity and order of magnitude cost estimate provided for this barrier are limited to the extent of the area identified as non-compliant. Additional costs that may be associated with removal of the barrier are not included.

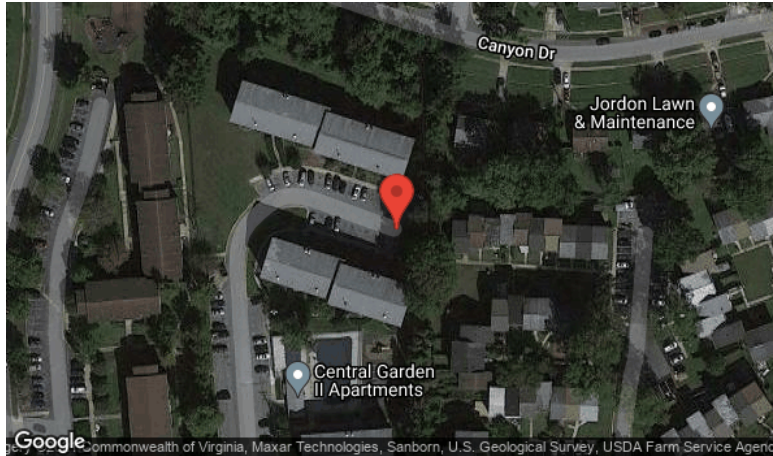
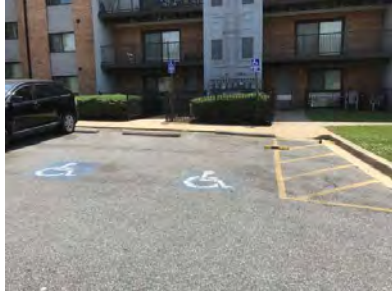
Map for Barrier ID: AX240319

Assembly	Accessible Parking
Type	Parking Space-Car
ADA Standard	502.3; 502.4; 502.5
Barrier Detail	An access aisle is not provided.
Location Description	Accessible Parking Space P1-C, P1-D, and P1-H
Observed	May 28, 2021 by Lloyd.fojas@bureauveritas.com

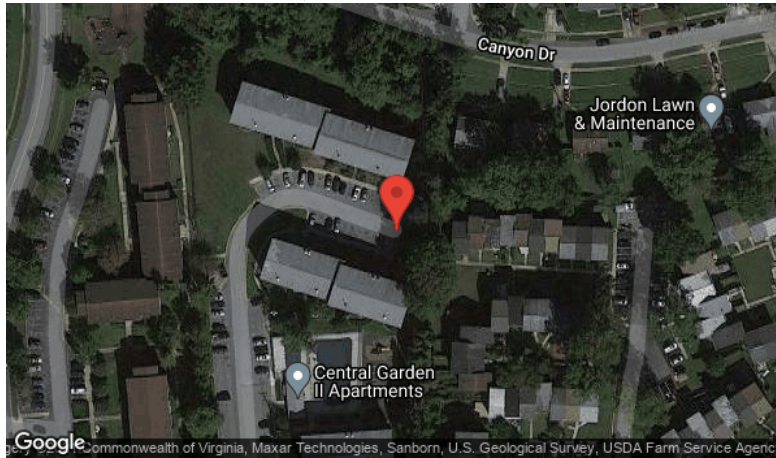
Map for Barrier ID: AX240067

Assembly	Accessible Parking
Type	Parking Space-Car
ADA Standard	502.1, 502.2
Barrier Detail	Accessible car stall markings do not define the stall width.
Location Description	Accessible Parking Space P1-C, P1-D, P1-F, P1-G and P1-H
Observed	May 28, 2021 by Lloyd.fojas@bureauveritas.com
Site Conditions	The accessible parking space markings are faded.

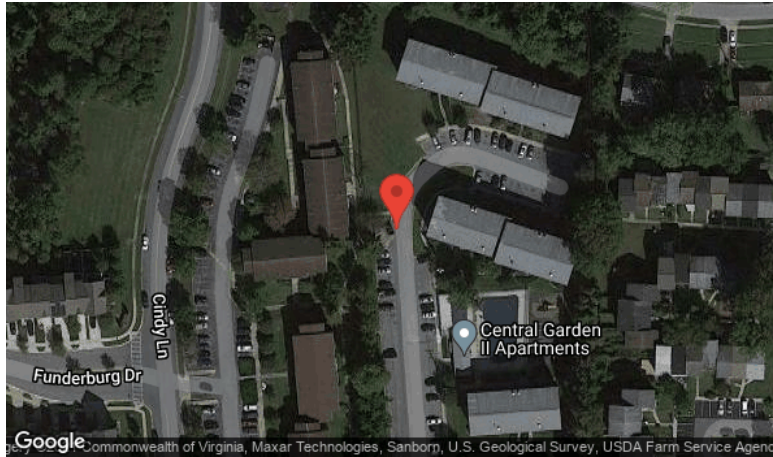
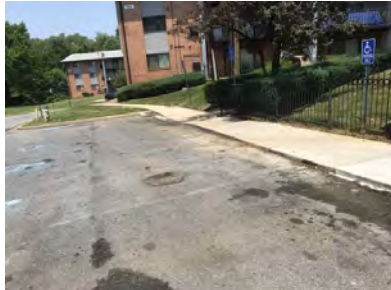
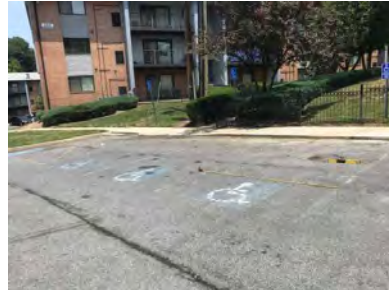
Photos for Barrier ID: AX240313

Assembly	Accessible Parking
Type	Parking Space-Car
ADA Standard	State of MD 05.07.D (2)(a)and (b),(3) & (6)
Barrier Detail	MARYLAND: Compliant signage is not provided at the space.
Location Description	Accessible Parking Space P1-D
Observed	May 28, 2021 by Lloyd.fojas@bureauveritas.com
Site Conditions	A sign is not provided at the accessible parking space.

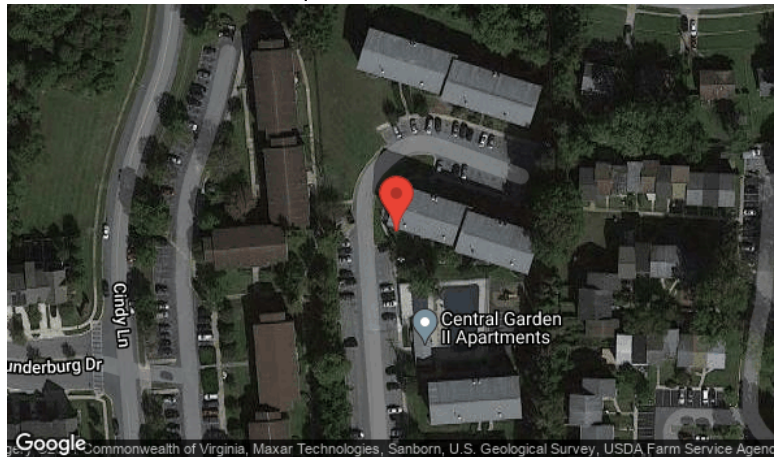
Map for Barrier ID: AX239625

Assembly	Accessible Parking
Type	Parking Space-Van
ADA Standard	502.4
Barrier Detail	The parking space slope is greater than 1:50 (2%).
Location Description	Accessible Parking Space P1-E
Observed	May 28, 2021 by Lloyd.fojas@bureauveritas.com
Site Conditions	The van accessible parking space has a cross slope of 4.1%.

Remove and replace with a van space which has a slope of maximum 1:50 (2%) in all directions. [EXCEPTION: Slopes not steeper than 1:48 (2.08%) shall be permitted.] Changes in level are not permitted. Parking spaces and access aisles serving them shall be compliant. Width measurements shall be made from the centerline of the markings. [EXCEPTION: Where parking spaces or access aisles are not adjacent to another parking space or access aisle, measurements shall be permitted to include the full width of the line defining the parking space or access aisle.] The quantity and order of magnitude cost estimate provided for this barrier are limited to the extent of the area identified as non-compliant. Additional costs that may be associated with removal of the barrier are not included.

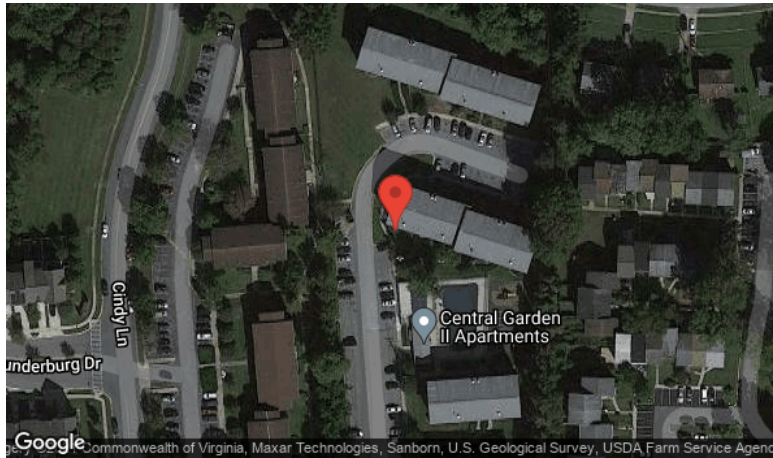
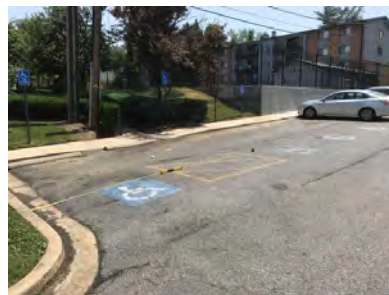
Photos for Barrier ID: AX240312

Assembly	Exterior Access Route
Type	Parking Space-Car
ADA Standard	502.4
Barrier Detail	The slope of the parking space is greater than 1:50 (2%).
Location Description	Accessible Parking Space P1-F
Observed	May 28, 2021 by Lloyd.fojas@bureauveritas.com
Site Conditions	The accessible parking space has a cross slope of 5.2%.

Remove and replace with a parking space that has no more than 1:50 (2%) slope in all directions. [EXCEPTION: Slopes not steeper than 1:48 (2.08%) shall be permitted.] Changes in level are not permitted. Parking spaces and access aisles shall be level with surface slopes not exceeding 1:50 in all directions. Parking spaces and access aisles serving them shall be compliant. Access aisles shall be at the same level as the parking spaces they serve. The quantity and order of magnitude cost estimate provided for this barrier are limited to the extent of the area identified as non-compliant. Additional costs that may be associated with removal of the barrier are not included. Re-stripe for a van accessible space at a location closest to an accessible facility entrance. For every six or fraction of six parking spaces required to comply, at least one shall be a van parking space. Van parking spaces shall be 132" wide minimum, shall be marked to define the width, and shall have a compliant adjacent access aisle. [EXCEPTION: Van parking spaces shall be permitted to be 96" wide minimum where the access aisle is 96" wide minimum.] Measurements shall be made to the centerline of the stripe. [EXCEPTION: Where accessible stalls and aisles are not adjacent to another stall or aisle, measurements shall be permitted to include the full width of the line defining the accessible parking space or aisle.] Parking spaces for vans, access aisles serving van spaces, and vehicular routes serving them shall provide a vertical clearance of 98" minimum.

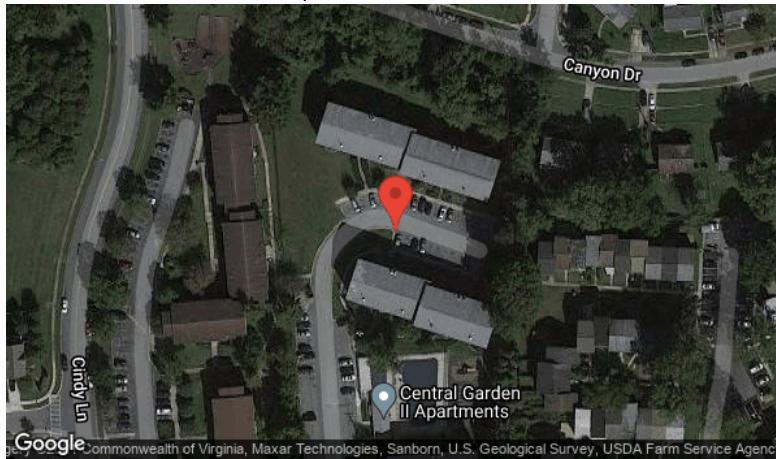
Map for Barrier ID: AX239628

Assembly	Exterior Access Route
Type	Parking Space-Car
ADA Standard	502.4
Barrier Detail	The slope of the parking space is greater than 1:50 (2%).
Location Description	Accessible Parking Space P1-G and P1-H
Observed	May 28, 2021 by Lloyd.fojas@bureauveritas.com
Site Conditions	The accessible parking space has a cross slope of 4.2%.

Remove and replace with a parking space that has no more than 1:50 (2%) slope in all directions. [EXCEPTION: Slopes not steeper than 1:48 (2.08%) shall be permitted.] Changes in level are not permitted. Parking spaces and access aisles shall be level with surface slopes not exceeding 1:50 in all directions. Parking spaces and access aisles serving them shall be compliant. Access aisles shall be at the same level as the parking spaces they serve. The quantity and order of magnitude cost estimate provided for this barrier are limited to the extent of the area identified as non-compliant. Additional costs that may be associated with removal of the barrier are not included. Re-stripe for a car accessible space at a location closest to an accessible facility entrance. Car parking spaces shall be 96" wide minimum, shall be marked to define the width, and shall have a compliant adjacent access aisle. Measurements shall be made to the centerline of the stripe. [EXCEPTION: Where accessible stalls and aisles are not adjacent to another stall or aisle, measurements shall be permitted to include the full width of the line defining the accessible parking space or aisle.] Parking spaces for cats, access aisles serving parking spaces, and vehicular routes serving them shall provide a vertical clearance of 98" minimum.

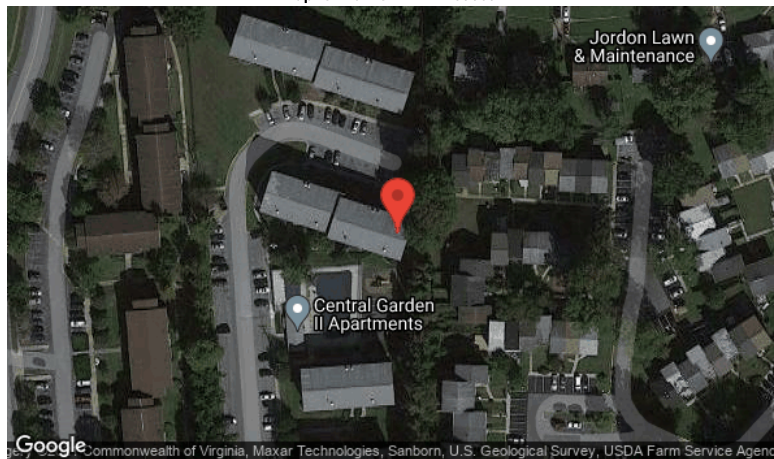
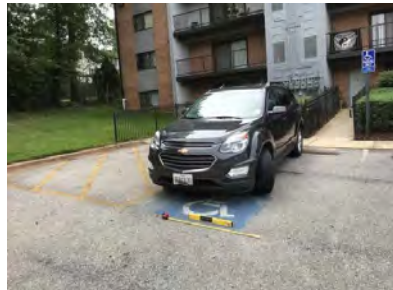
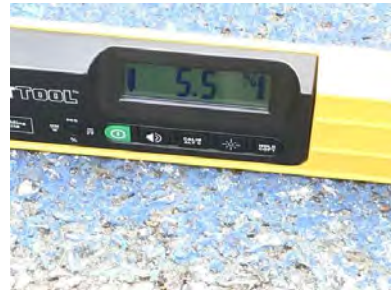
Photos for Barrier ID: AX239569

Assembly	Exterior Access Route
Type	Parking Space-Van
ADA Standard	502.4
Barrier Detail	The parking space slope is greater than 1:50 (2%).
Location Description	Accessible Parking Space P1-I
Observed	May 28, 2021 by Lloyd.fojas@bureauveritas.com
Site Conditions	The accessible parking space has a cross slope of 5.5%.

Remove and replace with a van space which has a slope of maximum 1:50 (2%) in all directions. [EXCEPTION: Slopes not steeper than 1:48 (2.08%) shall be permitted.] Changes in level are not permitted. Parking spaces and access aisles serving them shall be compliant. Width measurements shall be made from the centerline of the markings. [EXCEPTION: Where parking spaces or access aisles are not adjacent to another parking space or access aisle, measurements shall be permitted to include the full width of the line defining the parking space or access aisle.] The quantity and order of magnitude cost estimate provided for this barrier are limited to the extent of the area identified as non-compliant. Additional costs that may be associated with removal of the barrier are not included.

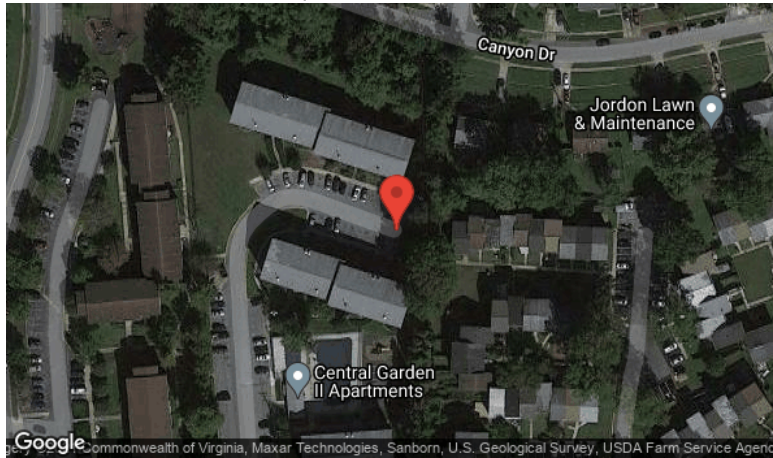
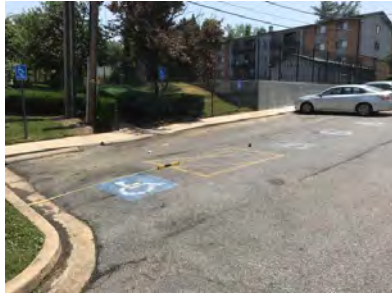
Map for Barrier ID: AX240323

Assembly	Accessible Parking
Type	Parking Spaces-General
ADA Standard	UFAS 4.1.1, 4.6.1

Provide the required minimum number of accessible parking spaces per table 4.1.1. In addition, where parking stalls are assigned to individual dwelling units, at least one accessible space should be provided for each mobility accessible dwelling unit. Where parking is provided for all residents, one accessible parking space shall be provided for each accessible dwelling unit; and where parking is provided for only a portion of the residents, an accessible parking space shall be provided on request of the occupant of an accessible dwelling unit. Parking spaces for disabled people shall be at least 96" wide and shall have an adjacent access aisle 60" wide minimum (see Fig. 9). [EXCEPTION: If accessible parking spaces for vans are provided, each should have an adjacent access aisle at least 96" wide.] Parking access aisles shall be part of an accessible route to the building or facility entrance. Two accessible parking spaces may share a common access aisle. Parked vehicle overhangs shall not reduce the clear width of an accessible circulation route. Parking spaces and access aisles shall be level with surface slopes not exceeding 1:50 (2%) in all directions. Accessible parking spaces shall be designated as reserved for the disabled by a sign showing the International Symbol of Accessibility. Such signs shall not be obscured by a vehicle parked in the space. This barrier applies only to non-public parking in residential developments. Other applicable federal, state and local regulations may supercede this barrier, and have stricter requirements. The quantity and order of magnitude cost estimate provided for this barrier are limited to the extent of the area identified as non-compliant. Additional costs that may be associated with removal of the barrier are not included.

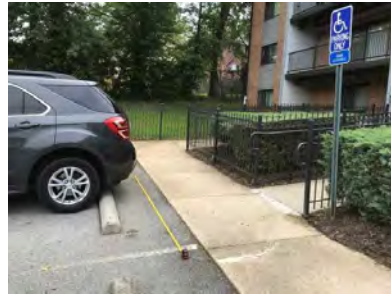
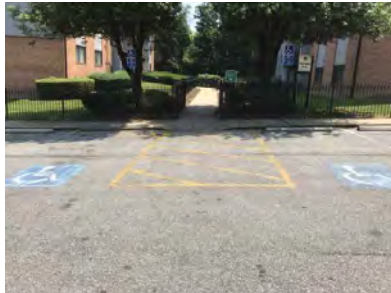
Photos for Barrier ID: AX240314

Assembly	Accessible Parking
Type	Parking Space-Van
ADA Standard	State of MD 05.07.D (2)(a)and (b),(3) & (6)
Barrier Detail	MARYLAND: Compliant signage is not provided at the space.
Location Description	Accessible Parking Spaces P1-A, P-1 B, P1-E and P1-I
Observed	May 28, 2021 by Lloyd.fojas@bureauveritas.com

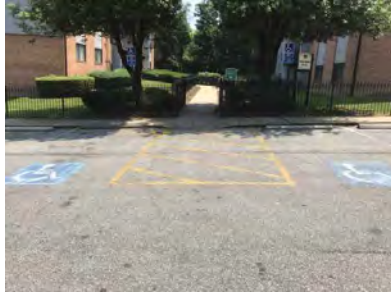
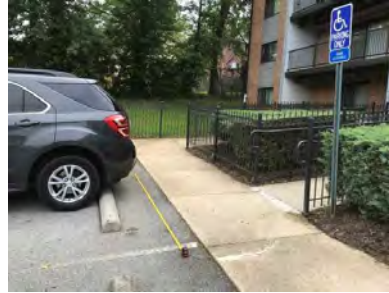
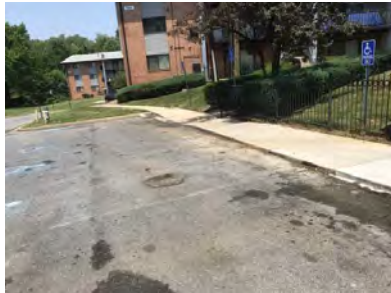
Photos for Barrier ID: AX240318

Assembly	Accessible Parking
Type	Parking Space-Van
ADA Standard	502.1, 502.3
Barrier Detail	Accessible van stall markings do not define the stall width.
Location Description	Accessible Parking Spaces P1-A, P-1 B, P1-E and P1-I
Observed	May 28, 2021 by Lloyd.fojas@bureauveritas.com
Site Conditions	The van accessible parking spaces are faded.

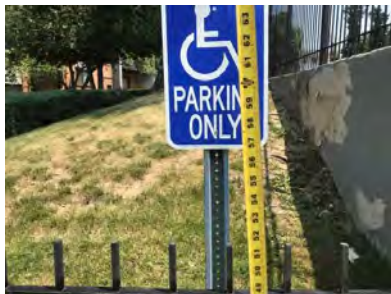
Photos for Barrier ID: AX240066

Assembly	Exterior Access Route
Type	Parking Space-Car
ADA Standard	State of MD 05.07.D (2)(a)and (b),(3) & (6)
Barrier Detail	MARYLAND: Compliant signage is not provided at the space.
Location Description	Accessible Parking Spaces P1-C, P-1 F, P1-G and P1-H
Observed	May 28, 2021 by Lloyd.fojas@bureauveritas.com

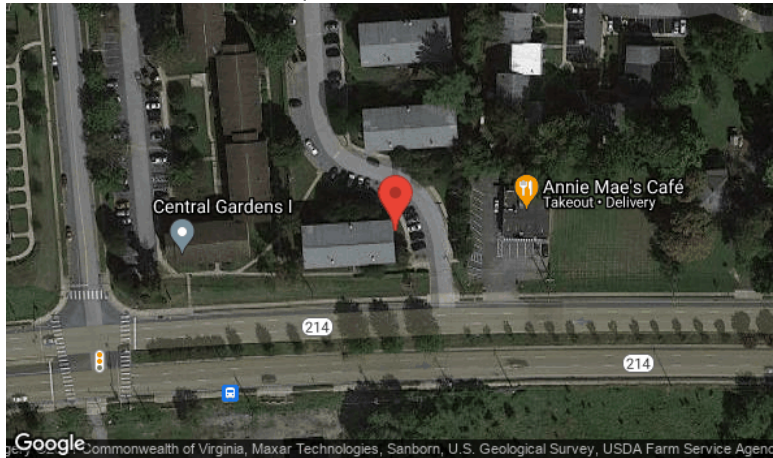
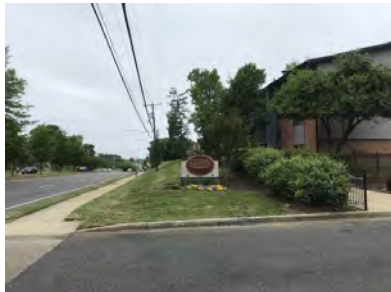
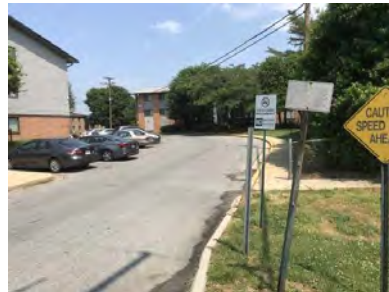
Photos for Barrier ID: AX240244

Assembly	Exterior Access Route
Type	Curb Ramp
ADA Standard	406.2
Barrier Detail	A curb ramp is not provided where the accessible route crosses a curb.
Location Description	Curb Ramp CR-1 and CR-2
Observed	May 28, 2021 by Lloyd.fojas@bureauveritas.com
Site Conditions	Curb ramps are not provided where the accessible route crosses the curbs.

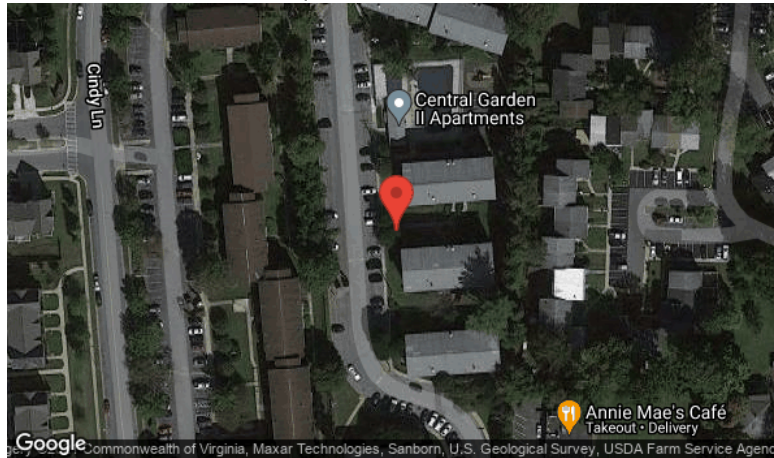
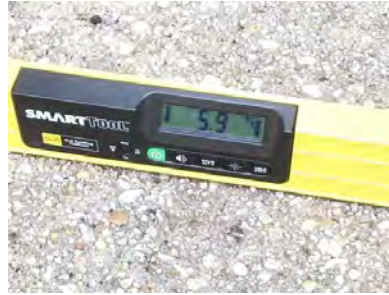
Map for Barrier ID: AX239620

Assembly	Exterior Access Route
Type	Curb Ramp
ADA Standard	304, 406
Barrier Detail	A compliant parallel curb ramp is not provided.
Location Description	Curb Ramp CR-3
Observed	May 28, 2021 by Lloyd.fojas@bureauveritas.com

Replace the standard curb ramp with a parallel curb ramp. The bottom landing clear width at the bottom of the curb ramp runs shall be 60" minimum to allow for a 90 degree turn. The top landings shall be minimum 36" deep in the direction of travel. The slope of the landings, where the landing connects to a sidewalk aligned perpendicular or angled to the curb ramp run requiring a wheelchair turn, shall be maximum 1:48 (2.08%). The slope of the landing shall be maximum 1:48 (2.08%). The curb ramp should be removed and replaced with a compliant ramp with no greater than the maximum allowable slopes of a ramp. Ramp runs shall have a running slope not steeper than 1:12 (8.33%). Cross slope of ramp runs shall not be steeper than 1:48. The running slope in new construction shall be 1:12 (8.33%) maximum. [EXCEPTION: In existing sites, buildings, and facilities built before 1/26/92, ramps shall be permitted to have running slopes steeper than 1:12 where such slopes are necessary due to space limitations. In facilities built before 1/26/92, the running slope can be 1:10 to 1:8 (10% to 12.5%) for a maximum rise of 3" OR 1:10 to 1:12 (8.3% to 10%) for a maximum rise of 6".]

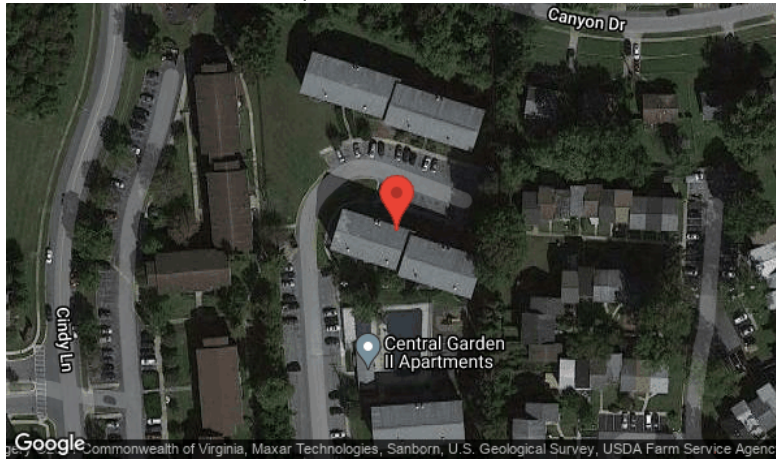
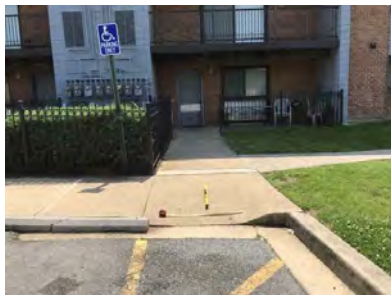
Photos for Barrier ID: AX239629

Assembly	Exterior Access Route
Type	Curb Ramp
ADA Standard	405.2; Table 405.2; 406; 406.2
Barrier Detail	The curb ramp does not meet the slope requirements.
Location Description	Curb Ramp CR-5
Observed	May 28, 2021 by Lloyd.fojas@bureauveritas.com

The curb ramp should be removed and replaced with a compliant curb ramp with no greater than the maximum allowable slopes of a ramp. Curb ramp runs shall have a running slope not steeper than 1:12 (8.33%). Cross slope of curb ramp runs shall not be steeper than 1:48. The running slope in new construction shall be 1:12 (8.33%) maximum. [EXCEPTION: In existing sites, buildings, and facilities built before 1/26/92, ramps and curb ramps shall be permitted to have running slopes steeper than 1:12 where such slopes are necessary due to space limitations. In facilities built before 1/26/92, the running slope can be 1:10 to 1:8 (10% to 12.5%) for a maximum rise of 3" OR 1:10 to 1:12 (8.3% to 10%) for a maximum rise of 6".] Where flares are provided, flare slopes shall not be greater than 1:10 (10%). [EXCEPTION: In alterations, where there is no landing at the top of curb ramps, curb ramp flares shall be provided and shall not be steeper than 1:12.]

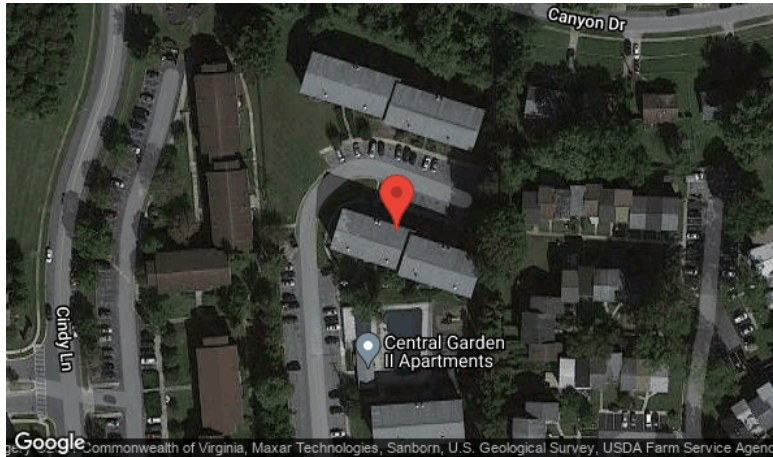
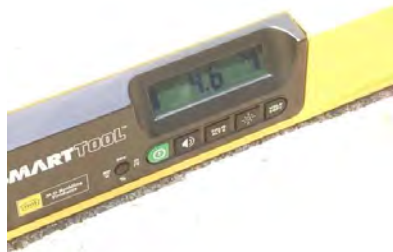
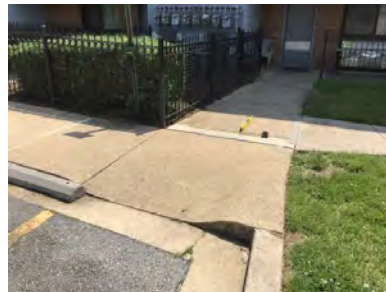
Photos for Barrier ID: AX240243

Location Description	Curb Ramp CR-5
Observed	May 28, 2021 by Lloyd.fojas@bureauveritas.com
Site Conditions	The top curb ramp landing has a cross slope of 4.6%.

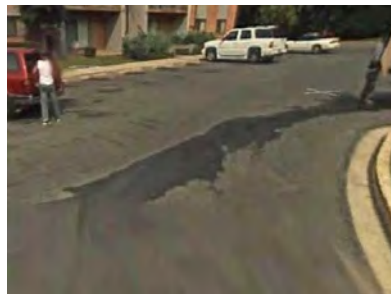
Photos for Barrier ID: AX240311

Assembly	Exterior Access Route
Type	Curb Ramp
ADA Standard	406.2
Barrier Detail	A curb ramp is not provided where the accessible route crosses a curb.
Location Description	Curb Ramp CR-6
Observed	May 28, 2021 by Lloyd.fojas@bureauveritas.com
Site Conditions	A curb ramp is not provided where the accessible route crosses the curb.

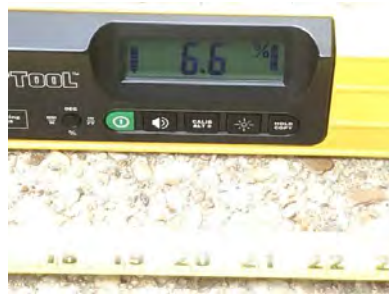
Photos for Barrier ID: AX239589

Assembly	Exterior Access Route
Type	Exterior Accessible Route
ADA Standard	403.3
Barrier Detail	The accessible route has cross slopes greater than 1:50 (2%).
Location Description	From Accessible Parking to Building 6812 Entrance
Observed	May 28, 2021 by Lloyd.fojas@bureauveritas.com
Site Conditions	The accessible route has cross slopes up to 6.6%.

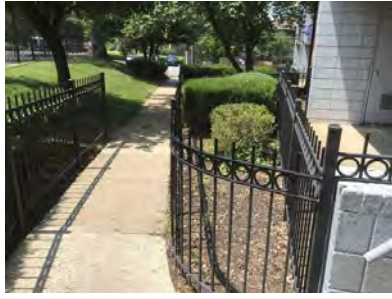
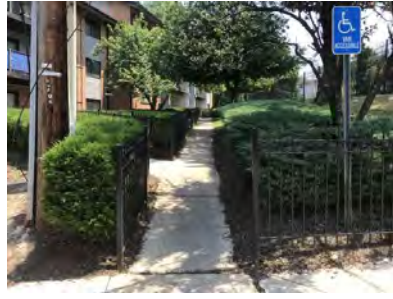
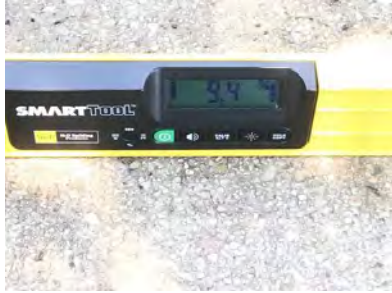
Assembly	Exterior Access Route
Type	Exterior Accessible Route
ADA Standard	403.3
Barrier Detail	The accessible route has running slopes greater than 1:20 (5%).
Location Description	From Accessible Parking to Buildings 6810 and 6812 Entrances
Observed	May 28, 2021 by Lloyd.fojas@bureauveritas.com
Site Conditions	The accessible route has running slopes up to 9.4%.

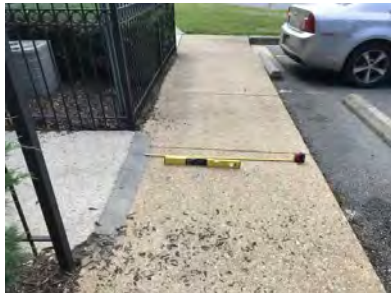
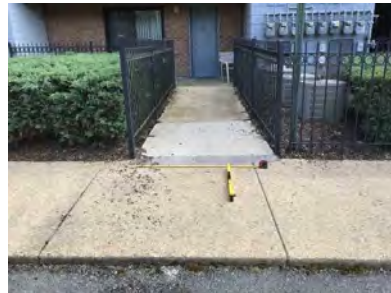
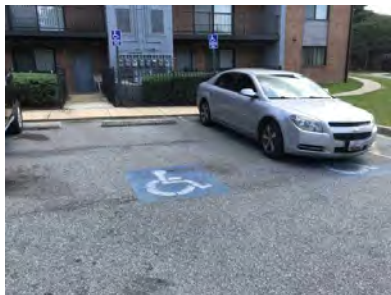
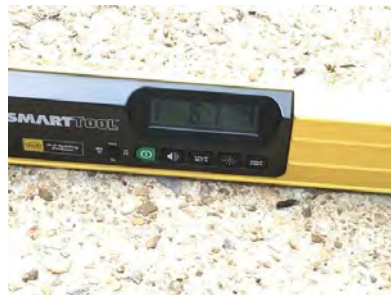
Photos for Barrier ID: AX239663

Site Conditions	The accessible route has cross slopes up to 6.7%.
------------------------	---

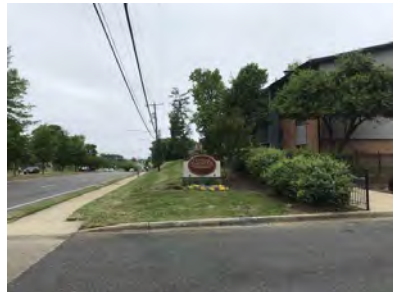
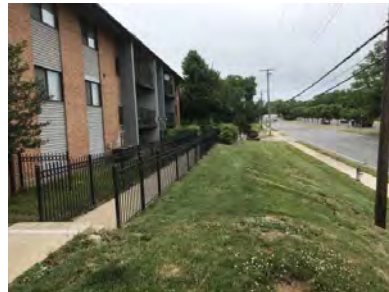
Photos for Barrier ID: AX239560

Location Description	From City Sidewalk to Building 6800
Observed	May 28, 2021 by Lloyd.fojas@bureauveritas.com

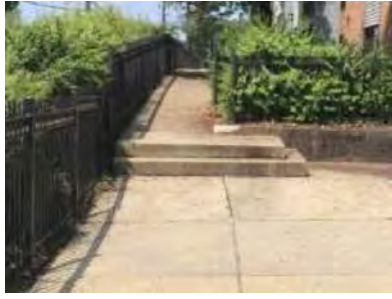
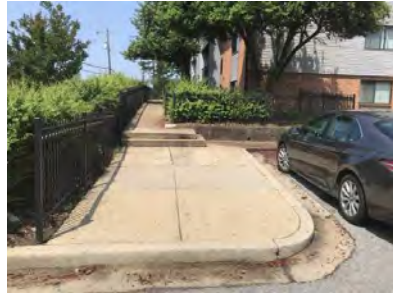
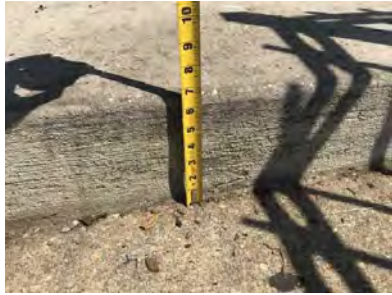
Assembly	Exterior Access Route
Type	Ramp
ADA Standard	405.8 and 505
Barrier Detail	The ramp run has a rise greater than 6"; however, handrails are not provided.
Location Description	From Parking to Building 6800
Observed	May 28, 2021 by Lloyd.fojas@bureauveritas.com

Provide compliant handrails or provide ramp runs with maximum 6" rise. Handrails are required on ramp runs which rise more than 6". Replace with continuous handrails at a consistent height above the ramp on both sides of the ramp. Inside handrails on switchback or dogleg stairs and ramps shall be continuous between runs. Top of gripping surfaces of handrails shall be 34" minimum and 38" maximum vertically above ramp surfaces. Handrails shall be at a consistent height above ramp surfaces. Clearance between handrail gripping surfaces and adjacent surfaces shall be 1-1/2" minimum. Handrail gripping surfaces shall be continuous along their length and shall not be obstructed along their tops or sides. The bottoms of handrail gripping surfaces shall not be obstructed for more than 20% of their length. Where provided, horizontal projections shall occur 1-1/2" minimum below the bottom of the handrail gripping surface. [EXCEPTIONS: 1. Where handrails are provided along walking surfaces with slopes not steeper than 1:20, the bottoms of handrail gripping surfaces shall be permitted to be obstructed along their entire length where they are integral to crash rails or bumper guards. 2. The distance between horizontal projections and the bottom of the gripping surface shall be permitted to be reduced by 1/8" for each 1/2" of additional handrail perimeter dimension that exceeds 4".] Handrail gripping surfaces with a circular cross section shall have an outside diameter of 1-1/4" minimum and 2" maximum. Handrail gripping surfaces with a non-circular cross section shall have a perimeter dimension of 4" minimum and 6-1/4" maximum, and a cross-section dimension of 2-1/4" maximum. Handrail gripping surfaces and any surfaces adjacent to them shall be free of sharp or abrasive elements and shall have rounded edges. Handrails shall not rotate within their fittings. Handrail gripping surfaces shall extend beyond and in the same direction of ramp runs. [EXCEPTIONS: 1. Extensions shall not be required for continuous handrails at the inside turn of switchback or dogleg ramps AND 3. In alterations, full extensions of handrails shall not be required where such extensions would be hazardous due to plan configuration.] Ramp handrails shall extend horizontally above the landing for 12" minimum beyond the top and bottom of ramp runs. Extensions shall return to a wall, guard, or the landing surface, or shall be continuous to the handrail of an adjacent ramp run.

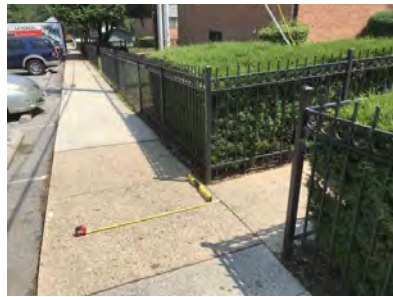
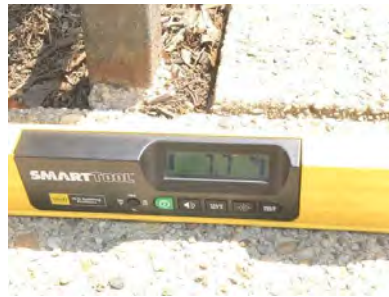
Photos for Barrier ID: AX239618

Assembly	Exterior Access Route
Type	Exterior Accessible Route
ADA Standard	403.3
Barrier Detail	The accessible route has running slopes greater than 1:20 (5%).
Location Description	Near Building 6804
Observed	May 28, 2021 by Lloyd.fojas@bureauveritas.com
Site Conditions	The accessible route has a running slope of 7.7%.
