ACCESSIBILITY ASSESSMENT

July 19, 2021

ADA TITLE II ASSESSMENT

Cottage City Towers
4142 Bunker Hill Road
Cottage City, Maryland 20722

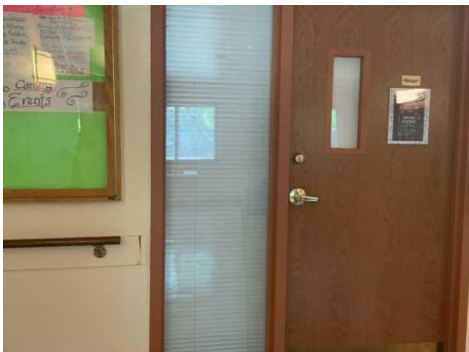
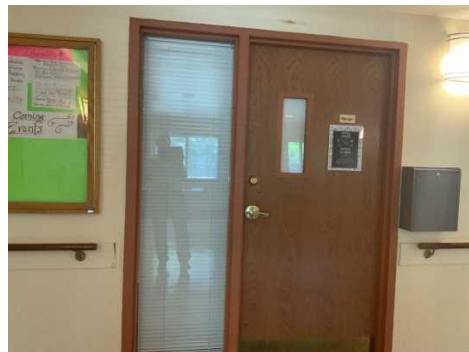
Photos for Barrier ID: AX240393

Assembly	Exterior Access Route
Type	Reach Range
ADA Standard	308, 309

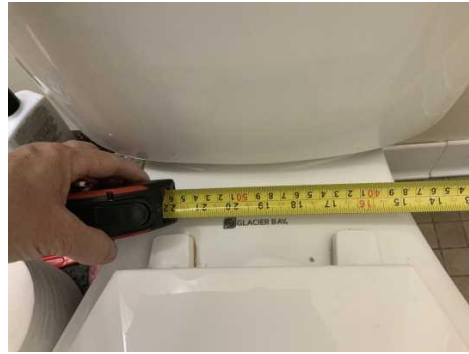
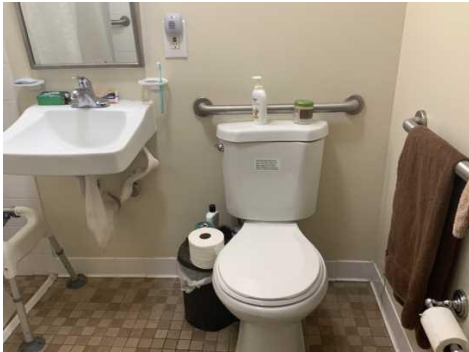
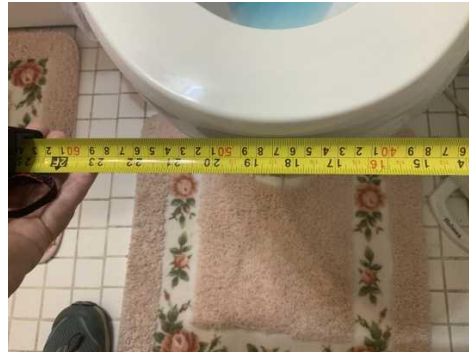
Assembly	Residential Dwelling
Type	Restroom/Bathroom-Water Closet
ADA Standard	UFAS 4.16.2, Fig. 28, 4.34.5.2(1); Fig. 47(a)
Barrier Detail	The centerline of the water closet is not exactly 18" from the side wall.
Location Description	Unit 107,110, 511, 603
Observed	May 17, 2021 by Ouraccessibleworld@gmail.com
Site Conditions	The centerline of the water closet is 18-1/4" to 19" from the side wall.
Resolution	Relocate the centerline of the water closet so that it is exactly 18" from the side wall. Clear floor space at the water closet shall be as shown in Figure 28, and Figure 47(a) for adaptable units. The water closet may be located with the clear area at either the right or left side of the toilet.
Quantity	4 EA
Priority	3
