# ACCESSIBILITY ASSESSMENT

July 13, 2021

## **ADA TITLE II ASSESSMENT**

Marlborough Town  
1847 Tanow Place  
District Heights, Maryland 20747

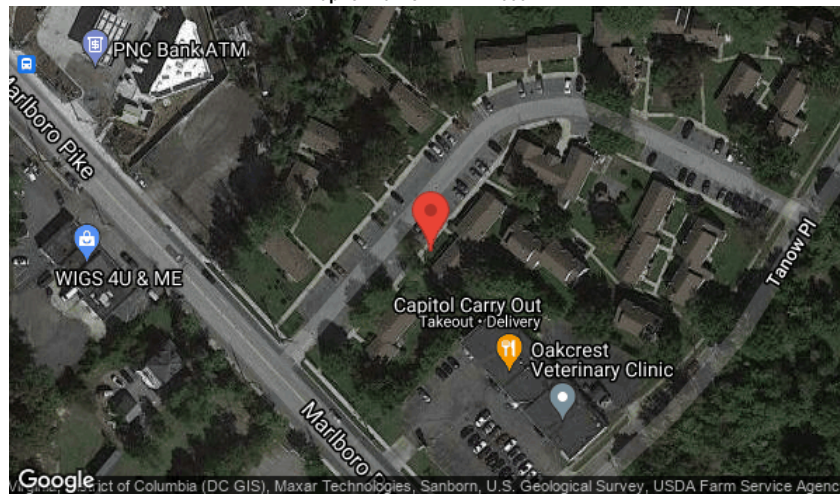
Map for Barrier ID: AX240004

<b>Assembly</b>	Exterior Access Route
<b>Type</b>	Curb Ramp
<b>ADA Standard</b>	405.2; Table 405.2; 406; 406.2
<b>Barrier Detail</b>	The curb ramp does not meet the slope requirements.
<b>Location Description</b>	Curb Ramp CR1
<b>Observed</b>	May 20, 2021 by Ouraccessibleworld@gmail.com

The curb ramp should be removed and replaced with a compliant curb ramp with no greater than the maximum allowable slopes of a ramp. Curb ramp runs shall have a running slope not steeper than 1:12 (8.33%). Cross slope of curb ramp runs shall not be steeper than 1:48. The running slope in new construction shall be 1:12 (8.33%) maximum. [EXCEPTION: In existing sites, buildings, and facilities built before 1/26/92, ramps and curb ramps shall be permitted to have running slopes steeper than 1:12 where such slopes are necessary due to space limitations. In facilities built before 1/26/92, the running slope can be 1:10 to 1:8 (10% to 12.5%) for a maximum rise of 3" OR 1:10 to 1:12 (8.3% to 10%) for a maximum rise of 6".] Where flares are provided, flare slopes shall not be greater than 1:10 (10%). [EXCEPTION: In alterations, where there is no landing at the top of curb ramps, curb ramp flares shall be provided and shall not be steeper than 1:12.]

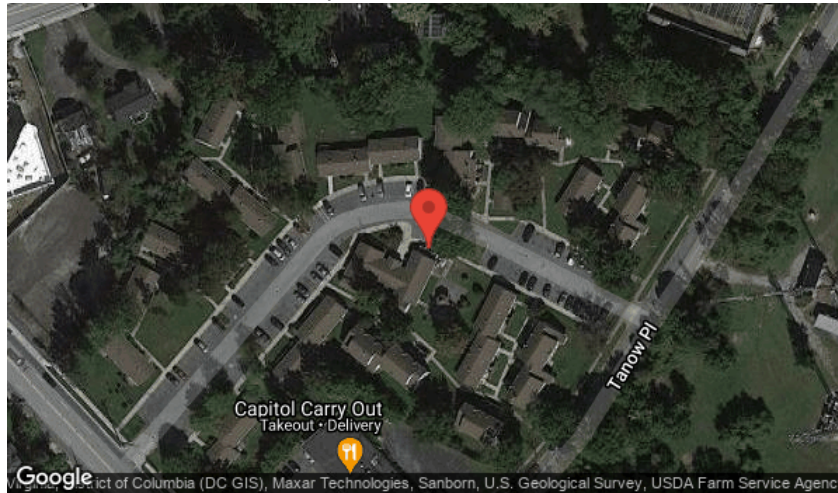
Map for Barrier ID: AX240005

**Site Conditions** The bottom curb ramp landing has a slope of up to 3.7%.

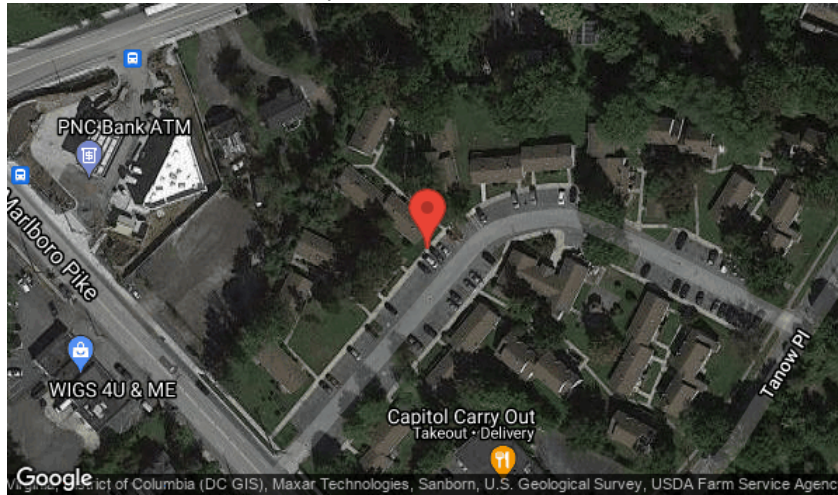
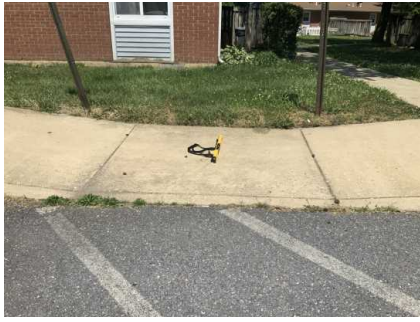
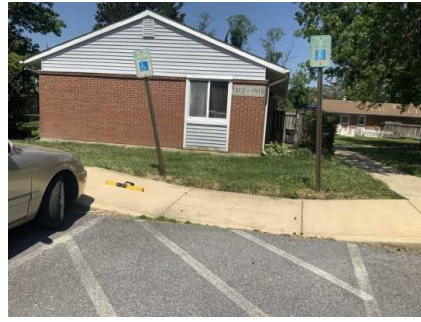
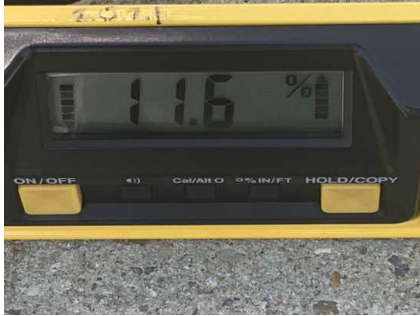
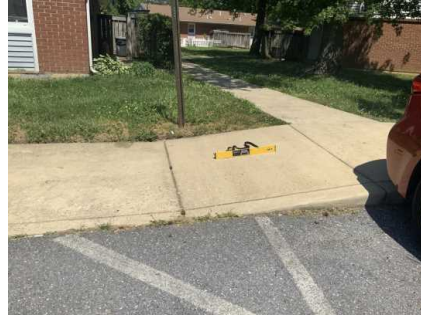
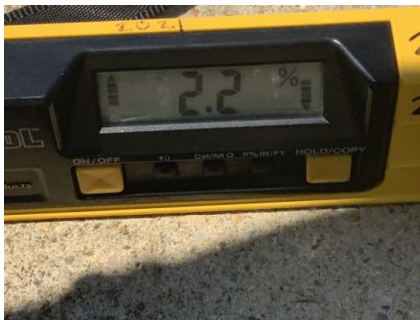
Map for Barrier ID: AX240046

<b>Assembly</b>	Exterior Access Route
<b>Type</b>	Curb Ramp
<b>ADA Standard</b>	405.2; Table 405.2; 406; 406.2
<b>Barrier Detail</b>	The curb ramp does not meet the slope requirements.
<b>Location Description</b>	Curb Ramp CR3
<b>Observed</b>	May 20, 2021 by Ouraccessibleworld@gmail.com
<b>Site Conditions</b>	The right ramp run and the left ramp run has running slopes of up to 11.6%.

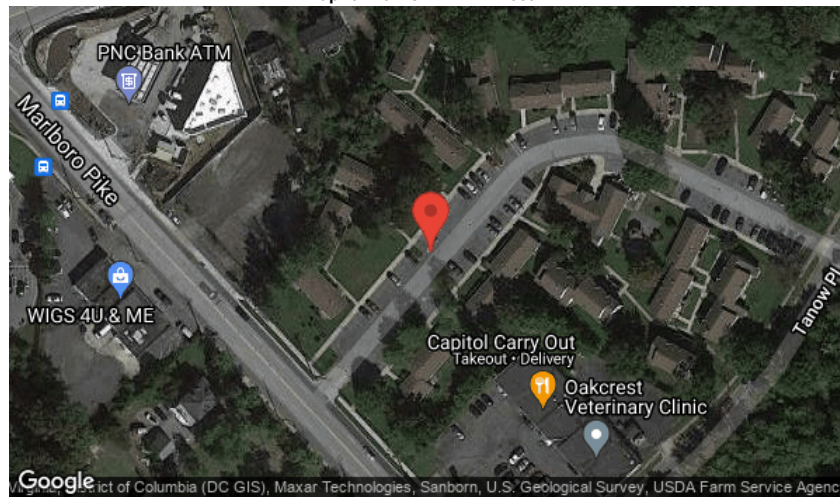
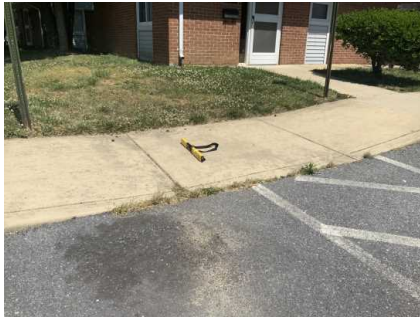
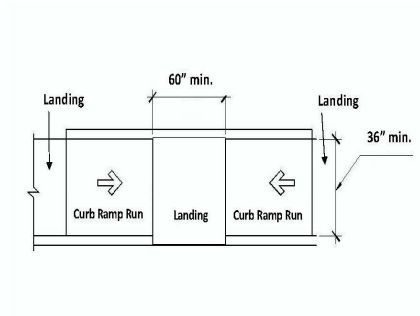
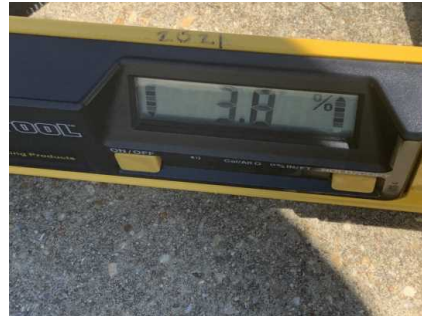
Map for Barrier ID: AX241389

<b>Assembly</b>	Exterior Access Route
<b>Type</b>	Curb Ramp
<b>ADA Standard</b>	304, 406.4
<b>Barrier Detail</b>	The parallel curb ramp landing is not compliant.
<b>Location Description</b>	Curb Ramp CR4
<b>Observed</b>	May 20, 2021 by Ouraccessibleworld@gmail.com
<b>Site Conditions</b>	The bottom curb ramp landing has a running slope of up to 3.8%.

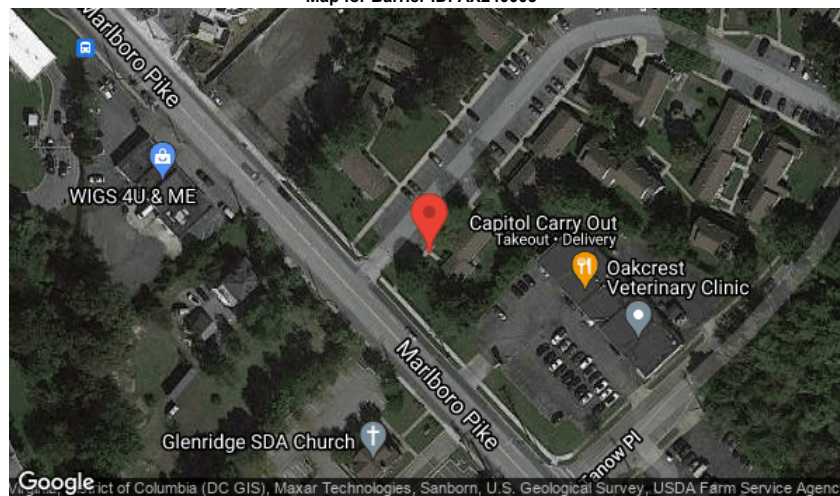
Map for Barrier ID: AX240003

<b>Assembly</b>	Exterior Access Route
<b>Type</b>	Exterior Accessible Route
<b>ADA Standard</b>	403.3
<b>Barrier Detail</b>	The accessible route has cross slopes greater than 1:50 (2%).
<b>Location Description</b>	From Marlboro Pike to Leasing Office
<b>Observed</b>	May 20, 2021 by Ouraccessibleworld@gmail.com

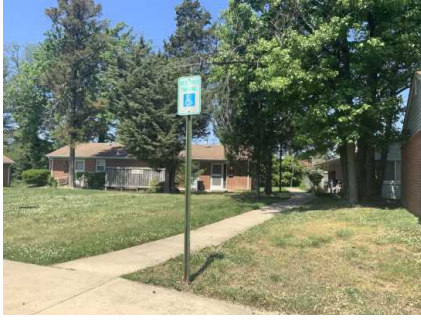
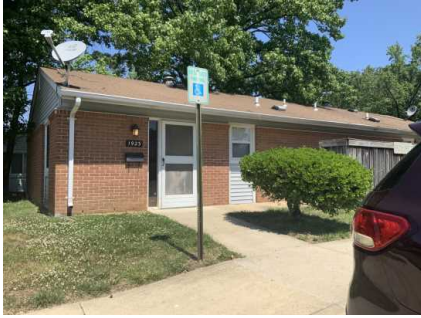
184 +38.863579, -76.913139

<b>Assembly</b>	Accessible Parking
<b>Type</b>	Parking Space-Car
<b>ADA Standard</b>	UFAS 4.6.4
<b>Barrier Detail</b>	The standard car parking stall signage is not compliant.
<b>Location Description</b>	P1-1 and P1-2
<b>Observed</b>	May 20, 2021 by Ouraccessibleworld@gmail.com
<b>Site Conditions</b>	The standard space signage does not have fine information provided.

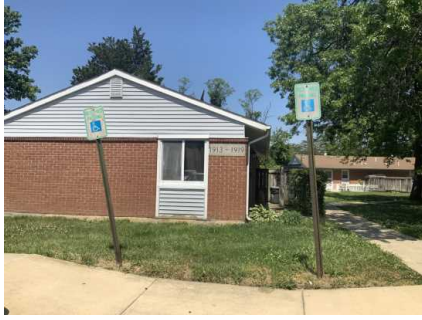
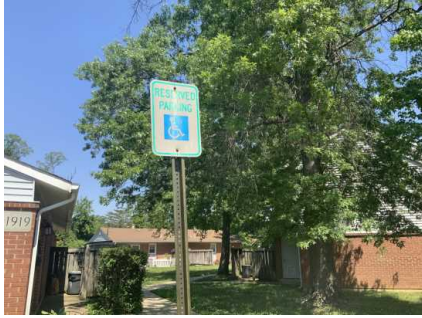
187 +38.863834, -76.912905

<b>Assembly</b>	Accessible Parking
<b>Type</b>	Parking Space-Car
<b>ADA Standard</b>	UFAS 4.6.4
<b>Barrier Detail</b>	The standard car parking stall signage is not compliant.
<b>Location Description</b>	P1-3 and P1-4
<b>Observed</b>	May 20, 2021 by Ouraccessibleworld@gmail.com
<b>Site Conditions</b>	The standard accessible signage does not contain information on fines.

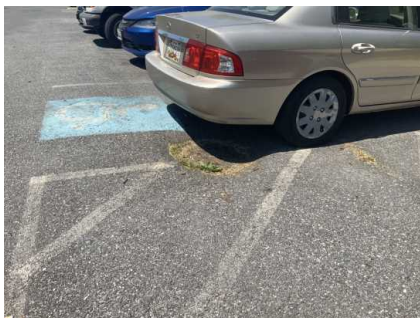
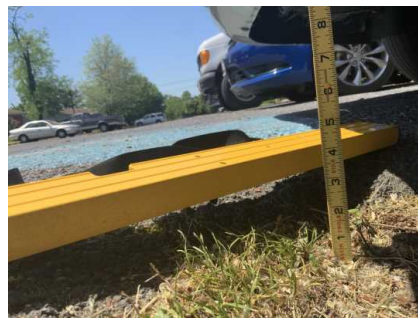
### Photos for Barrier ID: AX240048

<b>Assembly</b>	Accessible Parking
<b>Type</b>	Parking Space-Car
<b>ADA Standard</b>	UFAS 4.6.3
<b>Barrier Detail</b>	The slope of the standard car parking space is greater than 1:50 (2%).
<b>Location Description</b>	P1-4
<b>Observed</b>	May 17, 2021 by Ouraccessibleworld@gmail.com
<b>Site Conditions</b>	The accessible space has a vertical change of up to 3 1/2".

Remove and replace with a parking space that has no more than 1:50 (2%) slope in all directions. Parking spaces for disabled people shall be at least 96" wide and shall have an adjacent access aisle 60" wide minimum (see Fig. 9). [EXCEPTION: If accessible parking spaces for vans are provided, each should have an adjacent access aisle at least 96" wide.] Parking access aisles shall be part of an accessible route to the building or facility entrance. Two accessible parking spaces may share a common access aisle. Parked vehicle overhangs shall not reduce the clear width of an accessible circulation route. Parking spaces and access aisles shall be level with surface slopes not exceeding 1:50 in all directions. The quantity and order of magnitude cost estimate provided for this barrier are limited to the extent of the area identified as non-compliant. Additional costs that may be associated with removal of the barrier are not included.

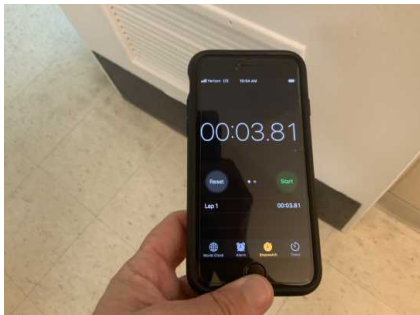
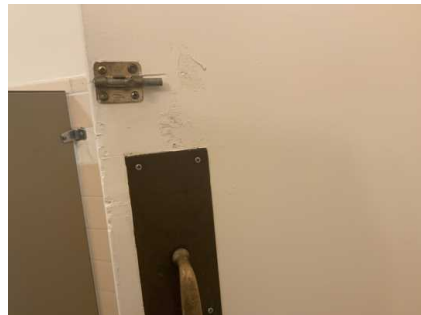
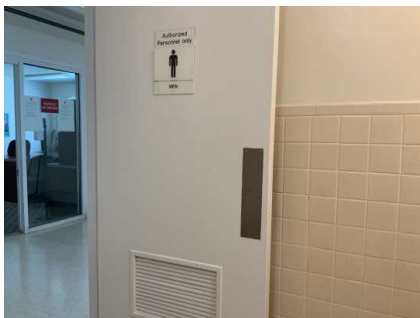
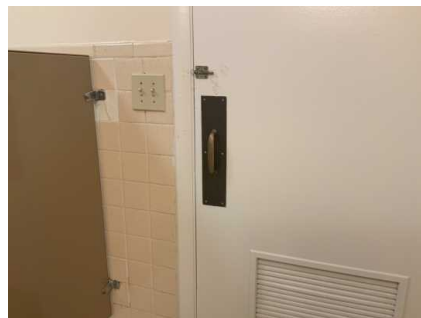
**Photos for Barrier ID: AX240009**

<b>Location Description</b>	Leasing Office Men's Restroom
<b>Observed</b>	May 20, 2021 by Ouraccessibleworld@gmail.com
<b>Site Conditions</b>	The door has locking hardware that requires tight grasping to operate.
