ACCESSIBILITY ASSESSMENT

145366.21R000-001.160

ADA TITLE II ASSESSMENT

Park Tanglewood
5309 Riverdale Road
Riverdale, Maryland 20737

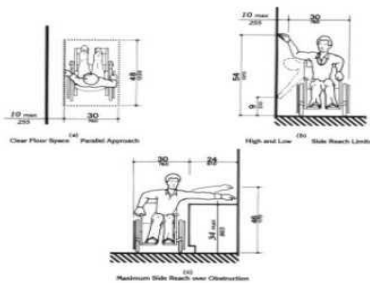
Photos for Barrier ID: AX239819

Assembly Residential Dwelling

Locate operable parts within allowable reach ranges. Operable parts shall be located no higher than 54" for an unobstructed side approach or 48" for an unobstructed frontal only approach. If the clear floor space only allows forward approach to an object, the maximum high forward reach allowed shall be 48" (see Figure 5(a)). The minimum low forward reach is 15". If the high forward reach is over an obstruction, where the horizontal obstruction is less than 20" the maximum high forward reach is 48". Where the horizontal obstruction is from 20" to maximum 25", the high forward reach shall be 44" maximum. Forward obstructed reaches shall comply with Figure 5(b). If the clear floor space allows parallel approach by a person in a wheelchair, the maximum high side reach allowed shall be 54", and the low side reach shall be no less than 9" above the floor (Figure 6(a) and (b)). If the side reach is over an obstruction, the maximum horizontal reach shall be 24" and the high side reach shall be 46" maximum. Side obstructed clearances shall be as shown in Figure 6(c).

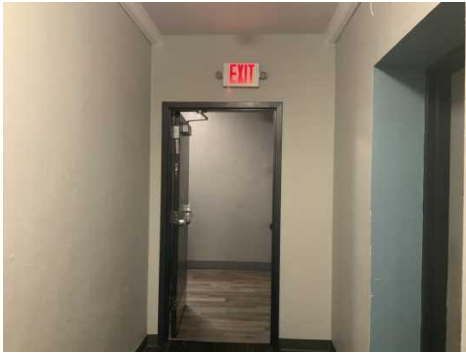
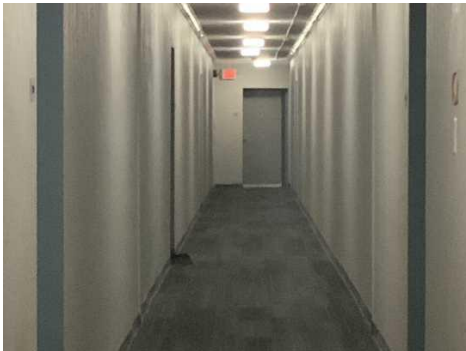
Assembly	Interior Access Route
Type	Signage
ADA Standard	216.4, 703.1, 703.4
Barrier Detail	Means of egress signage is not provided.
Location Description	Exterior Exit Doors at Stairs
Observed	May 17, 2021 by Ouraccessibleworld@gmail.com
Site Conditions	Means of egress signage with tactile characters is not provided at the exits.

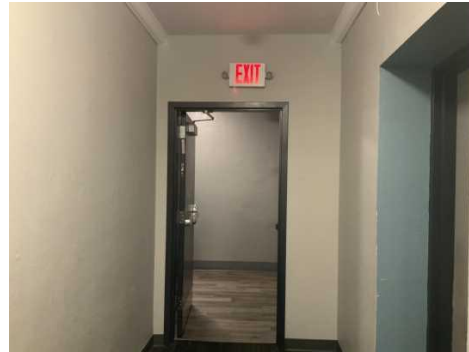
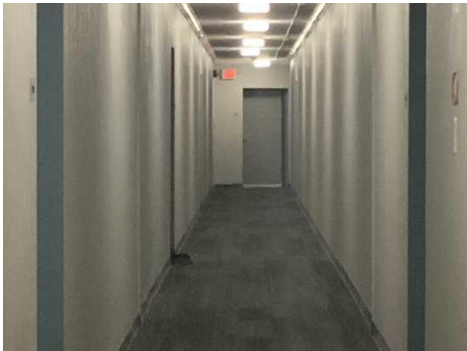
Assembly	Interior Access Route
Type	Signage
ADA Standard	216.4, 703.1, 703.4
Barrier Detail	Means of egress signage is not provided.
Location Description	Hallway
Observed	May 18, 2021 by Ouraccessibleworld@gmail.com
Site Conditions	Means of egress signage is not provided at the doors to the stairs.

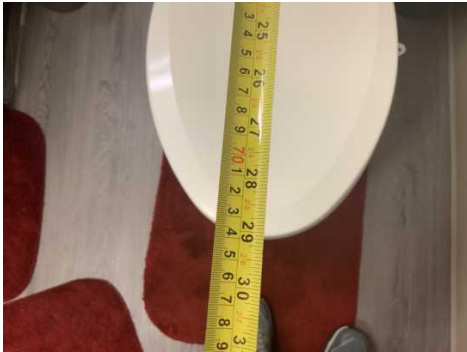
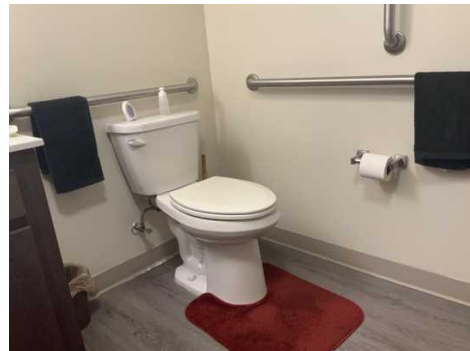
Photos for Barrier ID: AX239817

Assembly	Residential Dwelling
Type	Restroom/Bathroom-Water Closet
ADA Standard	UFAS 4.34.5.2 (4)
Barrier Detail	The toilet paper dispenser is not compliant.
Location Description	Unit 217
Observed	May 18, 2021 by Ouraccessibleworld@gmail.com
Site Conditions	The toilet paper dispenser is mounted 42" to the far edge from the rear wall.
