ACCESSIBILITY ASSESSMENT

DATE OF REPORT:
January 6, 2023

ADA TITLE II ASSESSMENT

GLENARDEN HILLS
3171 RONALD KEENER LOOP
LANHAM MD 20706

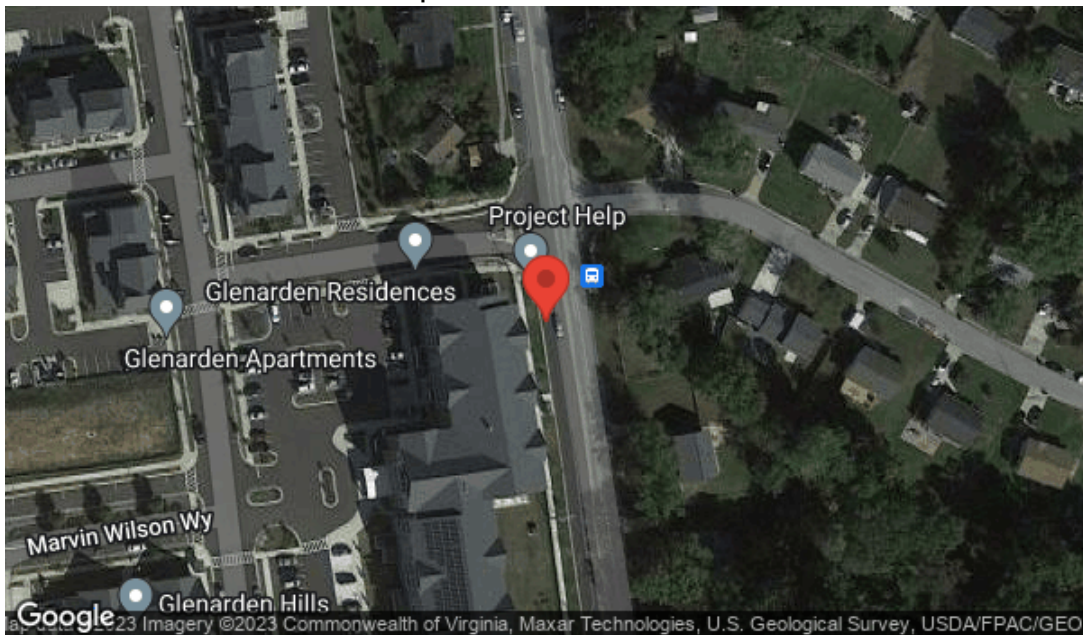
Map for Barrier ID: AX310693

Assembly	Residential Dwelling
Type	Restroom/Bathroom-Lavatory
ADA Standard	UFAS 4.19.4
Barrier Detail	Lavatory hot water and drain pipes are not insulated.
Location Description	Unit 104, 106, 213
Observed	Jun 8, 2022 by bscott
Site Conditions	The pipes under the lavatory are not covered.

Quantity	Unit Cost	Total Cost
3 EA	65.00	\$ 195
Priority	3
